**Exhibit CS-BW-63**

*Docket 8302*

*Supplemental Aesthetic Assessment*

## **Supplemental Aesthetic Assessment Report Chelsea Solar Project September 26, 2014**

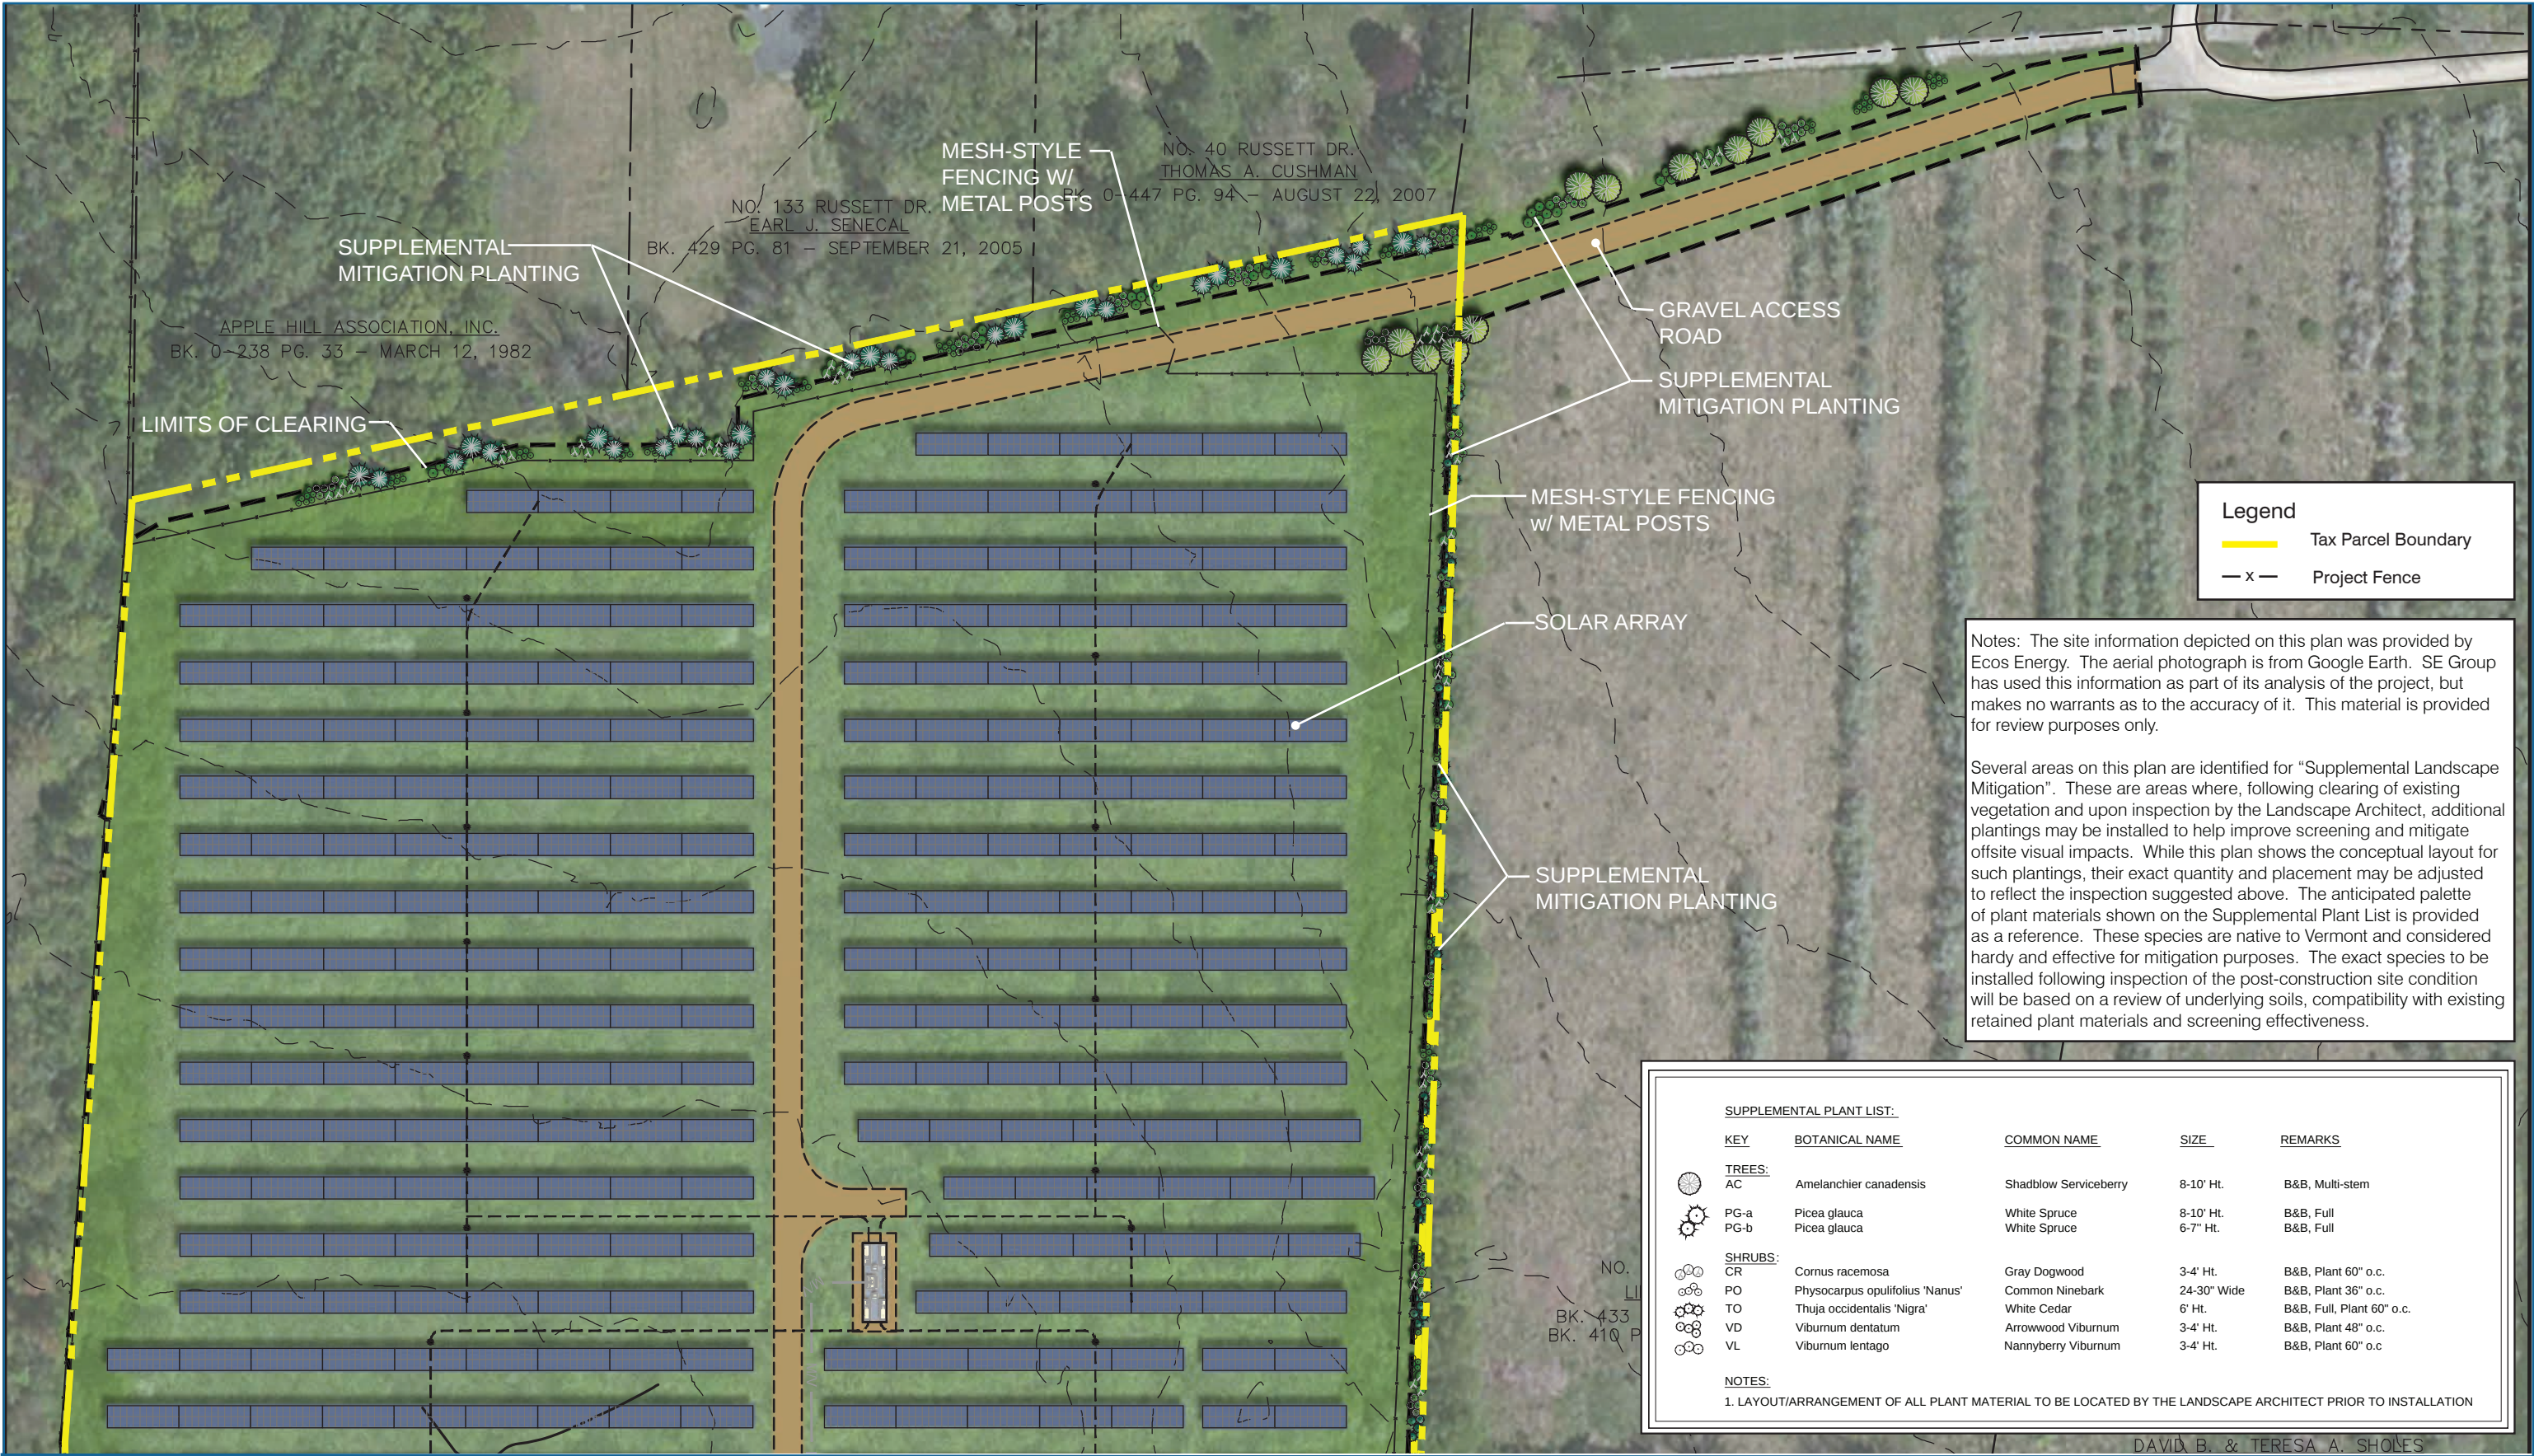
SUPPLEMENTAL MITIGATION PLAN | Figure 2

Several areas on this plan are identified for "Supplemental Landscape Mitigation". These are areas where, following clearing of existing vegetation and upon inspection by the Landscape Architect, additional plantings may be installed to help improve screening and mitigate offsite visual impacts. While this plan shows the conceptual layout for such plantings, their exact quantity and placement may be adjusted to reflect the inspection suggested above. The anticipated palette of plant materials shown on the Supplemental Plant List is provided as a reference. These species are native to Vermont and considered hardy and effective for mitigation purposes. The exact species to be installed following inspection of the post-construction site condition will be based on a review of underlying soils, compatibility with existing retained plant materials and screening effectiveness.

area which will allow retention of some of the understory to help enhance screening. This area also coincides with the shared boundary with the neighbor directly north of the Project (Residence #1). This neighbor has cleared a portion of their property and maintenance of some understory could help limit views of the array. Much of the remainder of the northern boundary is densely wooded north of the Project site. This area is shown in detail on Figure 2.

In general, our recommendation for using mitigation plantings is to address clearly identified impacts where new landscape can be effective and is reasonable given other considerations. We had previously included landscape mitigation along a short stretch of the western property line in the vicinity of the inverter enclosure and still believe this mitigation is necessary. Our only additional recommendation to this landscape is to add some evergreen species (white cedar) which has been incorporated into the supplemental landscape mitigation plan (See Figure 2).

1. Move the Project fence southward to conform more closely to the array layout in the area of the “notch” and reduce, to the degree possible, clearing in this location (See Figure 2).
2. Provide supplemental landscaping along the northern boundary as necessary to mitigate offsite visibility. Following clearing of existing vegetation and upon our inspection, we would develop a more formal plan for adding new plantings to improve screening and mitigate offsite visual impacts. On a conceptual basis, we have recommended (See Figure 2) that a variety of native deciduous and coniferous trees and shrubs (including spruce, serviceberry, cedar, and dogwood) be planted to bolster in areas where clearing

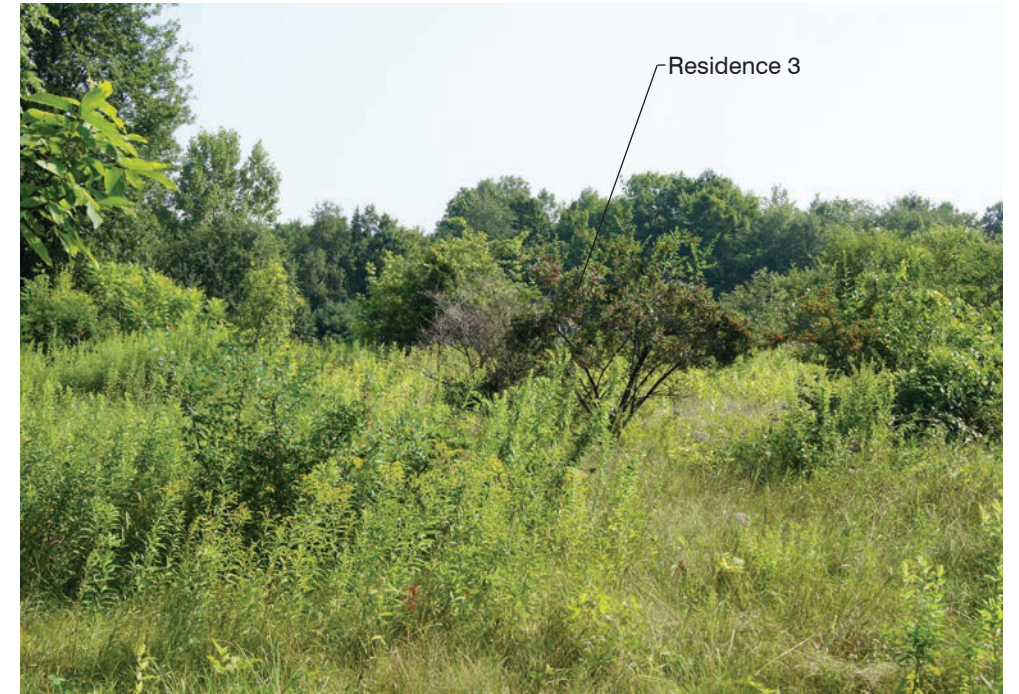
C - VIEW LOOKING NORTH AND EAST FROM EDGE OF PROJECT SITE BACK TOWARDS RESIDENCE 3 (SEE FIG. 1)

On the east side of the Project site, the neighboring parcel includes remnants of an old apple orchard along with new successional growth which is becoming quite dense. This adjacent property is under the control of the Petitioner. A Photograph taken from the apple orchard to the west (See Figure 3, Viewpoint D) shows this condition. The Project access road will move along the northern part of this adjacent property. Views from the third residential structure towards the Project site will be limited by this existing vegetation with the exception of where the new access road will enter the Project Site (See Figure 2 and Figure 3, Viewpoint C).

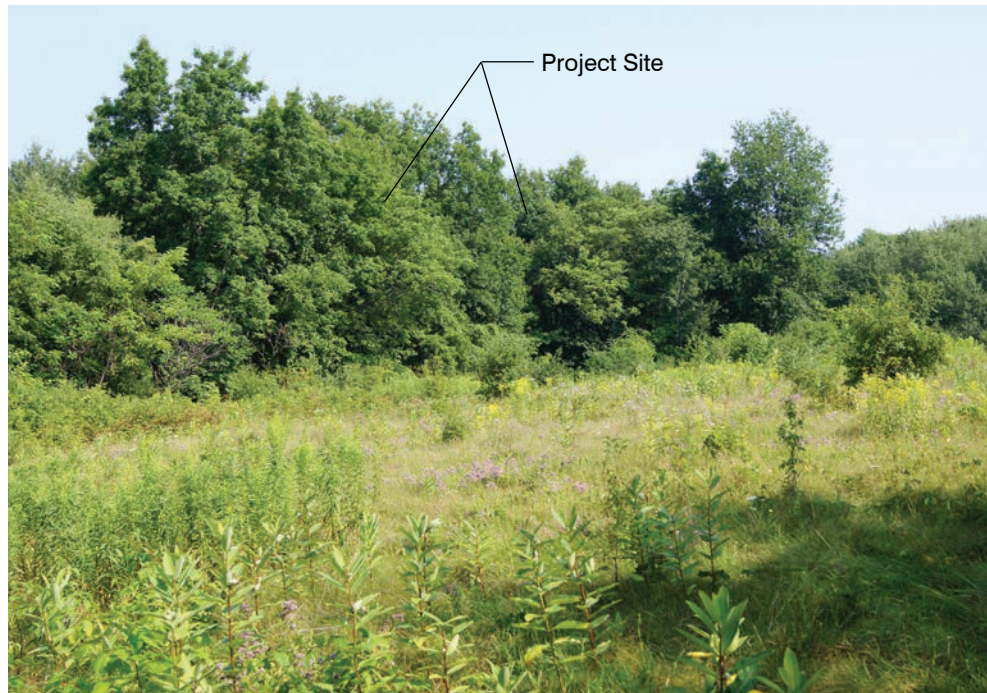
D - VIEW LOOKING NORTH AND WEST FROM APPLE ORCHARD TOWARDS PROJECT SITE

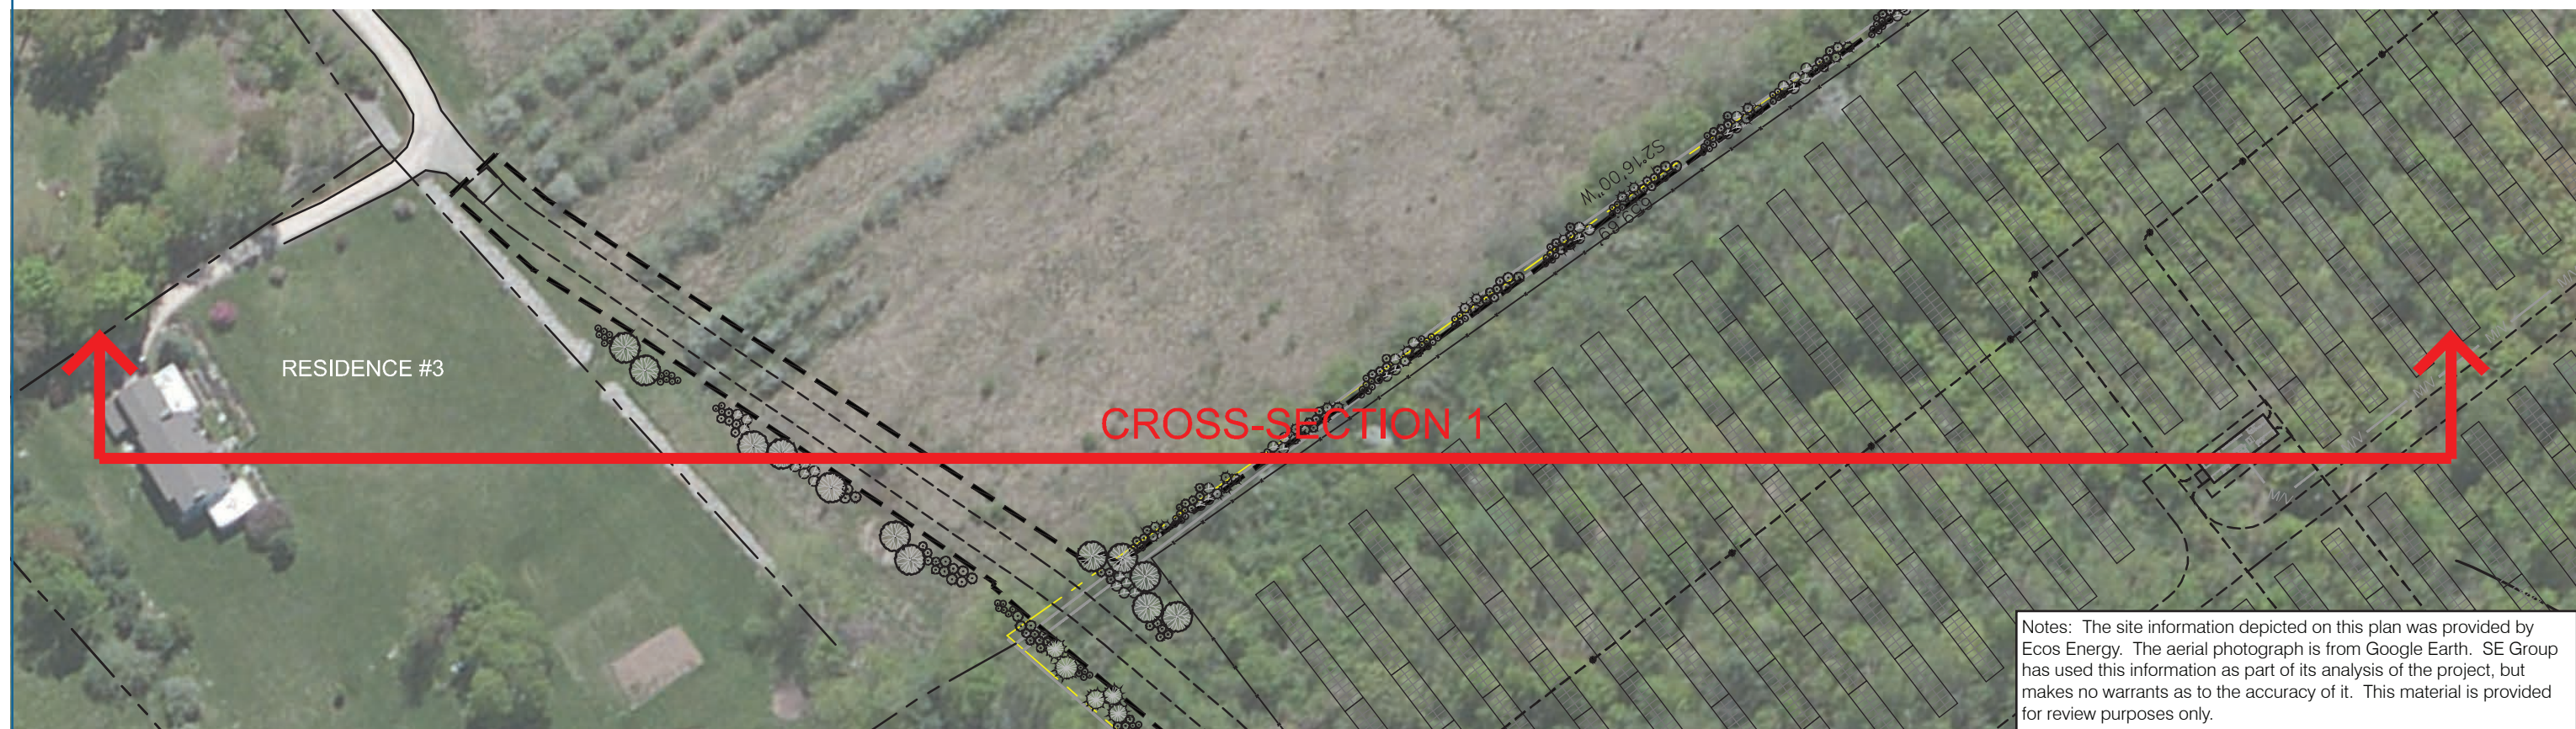
**SUPPLEMENTAL SITE SECTION 1 | Figure 4**

Cross Section 1 (Figure 4): This section is drawn from Apple Hill Road residence #3 south and west through the proposed array to the inverter skid. Along this section line the terrain falls away significantly (over 30 feet) between the residential structure and the nearest array. The array is set back 520 feet from this residential structure. The section also depicts both existing and new supplemental landscaping which will intervene between the residential structure and the Project site.

We have also expanded our analysis of the Project by creating two additional cross-sections (See Figures 4 and 5). These cross-sections illustrate the nature of terrain/vegetation patterns following development of the Project. We have extended the section lines to intersect with specific residential structures for reference.

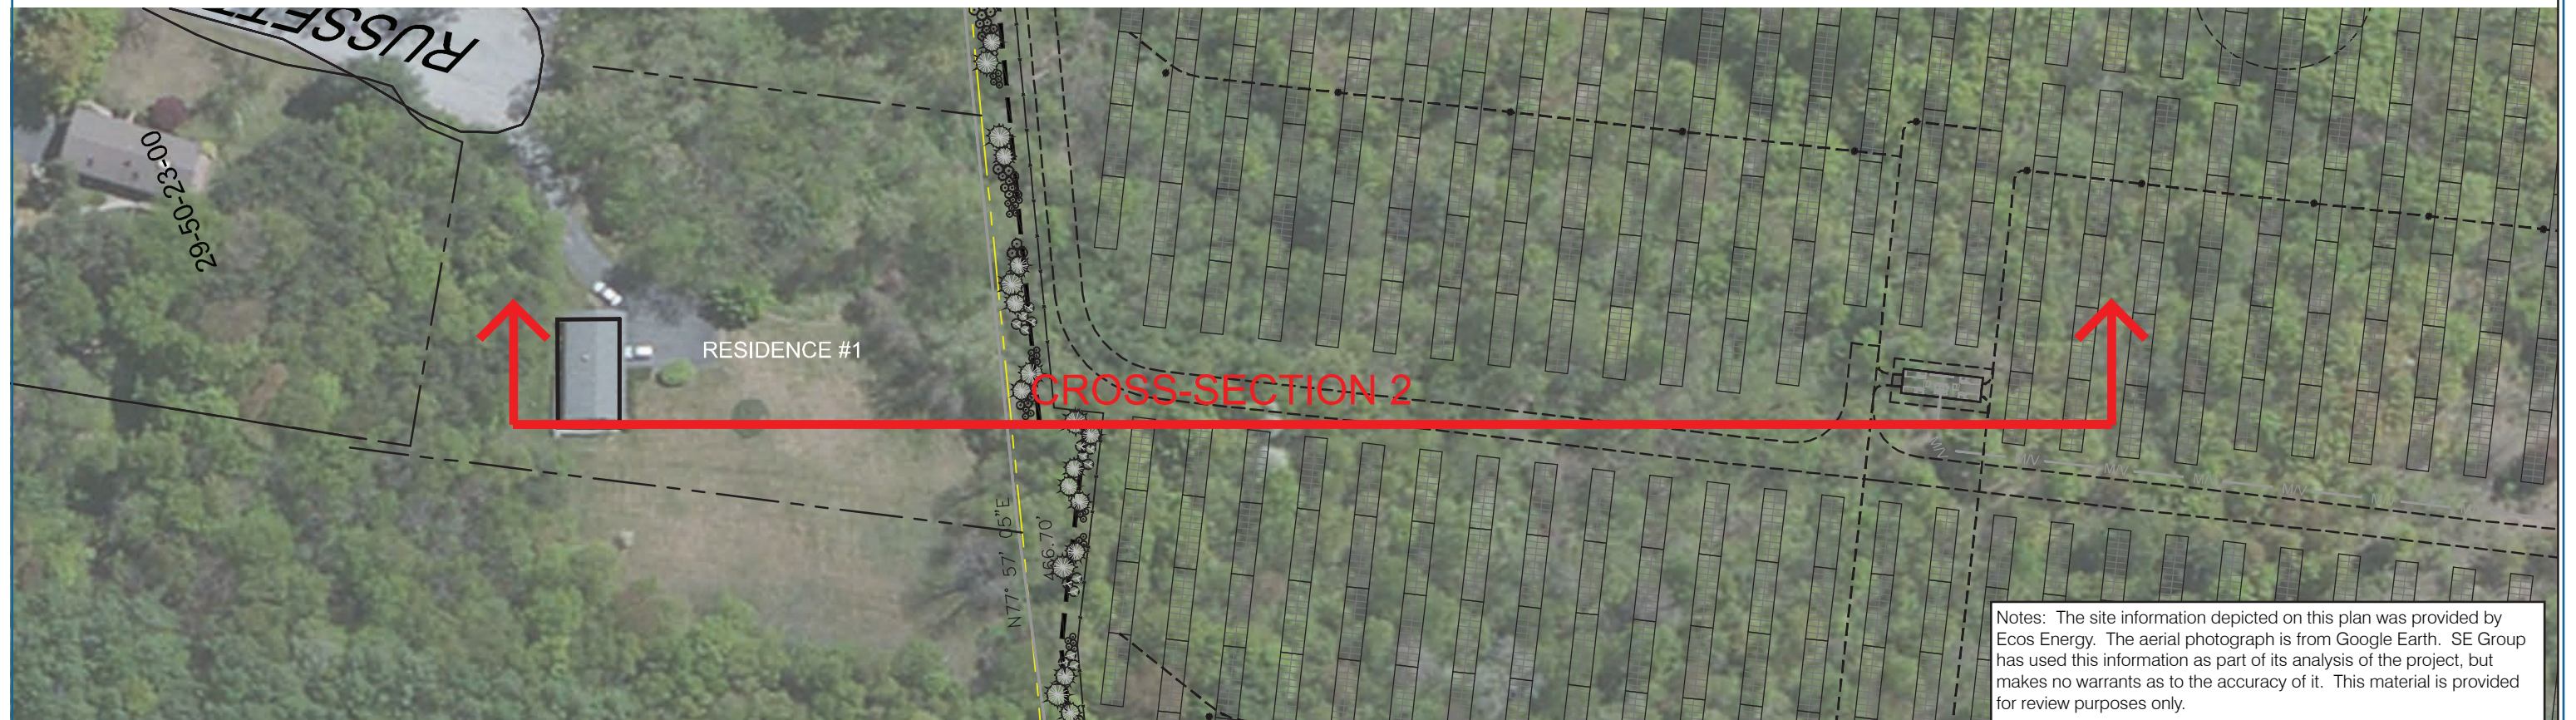
**SUPPLEMENTAL SITE SECTION 2 | Figure 5**

Cross Section 2 (Figure 5): This section is drawn from Apple Hill Road residence #1 and in a similar orientation to #1 (above). It also documents how the terrain drops away (nearly 20 feet) between the residential structure and the most proximal panel (which is about 255 feet away). This section also passes through the “notch”, an area where the Project fence line and clearing limits have been pushed southward. This notch allows an upwards of 30 feet of retained woodland to remain. Areas of potential supplemental landscape mitigation are also shown on the section line.
