## Memorandum

Re: Section 248 Natural Resources Assessment

Salisbury AD 1, LLC ("Salisbury AD 1") proposes to construct and operate an anaerobic digester ("AD") project at the Goodrich Farm in Salisbury, VT (see Natural Resource Map – Attachment 1). The Project received a Section 248 Certificate of Public Good ("CPG") from the Vermont Public Utility Commission ("PUC" or "Commission") on April 8, 2016 ("the As-Approved Project").<sup>[1]</sup> Lincoln RNG is no longer pursuing development of the project, and will transfer the CPG to Salisbury AD 1, subject to the Commission's prior approval. Salisbury AD 1 has revised the As-Approved Project's design in various respects ("the Proposed Modifications"). VHB has been retained to review any new or incremental environmental impacts of the Proposed Modifications, which have been incorporated into the final project design ("the Final Project").

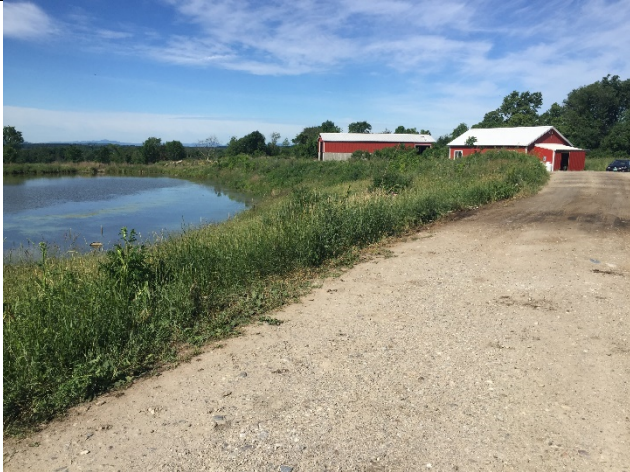
Photograph 1. Representative view looking west along the existing farm driveway, with the open water pond in wetland 2018-2 visible on the left

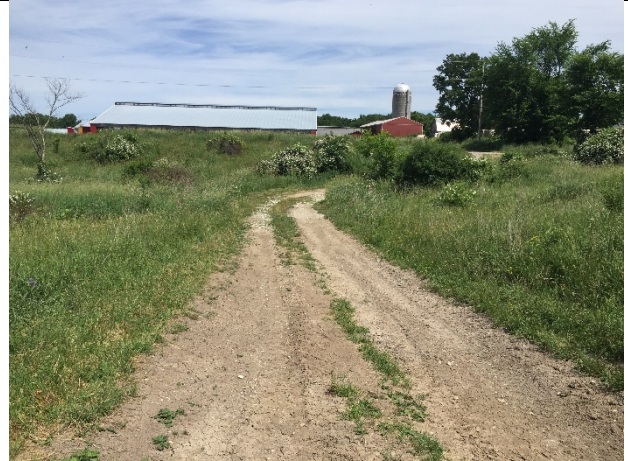
Photograph 2. Representative view of the existing agricultural access road that extends south from the driveway, in between wetland 2018-1 and 2018-2.

The Final Project has been designed to avoid impacts to wetlands and Class II buffers to the greatest extent practicable. The Final Project would use the existing agricultural access road which extends in between wetland 2018-1 and wetland 2018-2, within the buffer of each. The road may need to be maintained or improved, and is assumed to be within the VWR Allowed Use 6.12 for repair and maintenance of existing structures. Temporary trenching within a Class II wetland and buffer is anticipated to install a manure transfer pipe to the digestate tank along the alignment of the existing agricultural access road. No woody vegetation cutting or clearing is currently proposed within a Class II wetland or buffer. Pending the development of final EPSC site plans, minimal grading within the wetland buffer may be required. If necessary, the Project will consult with the DEC Wetlands Program and will acquire appropriate authorization from the DEC for any such activities that occur within a wetland buffer. Construction-phase soil disturbance will be addressed through EPSC measures through construction stormwater collateral permitting (Refer to VHB's Section 248 Water Supply & Conservation, Waste Disposal, and Soil Erosion Assessment). The Project will also consult with USACE and seek authorization under Section 404 of the Clean Water Act. It is anticipated that the work will qualify under the USACE General Permit.

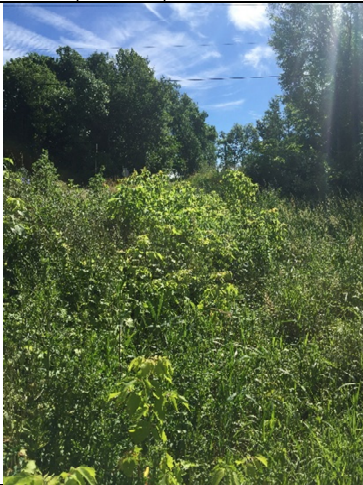
Photograph 3. Representative view of Class II wetland 2018-1, where low-lying topography defines the wetland boundary

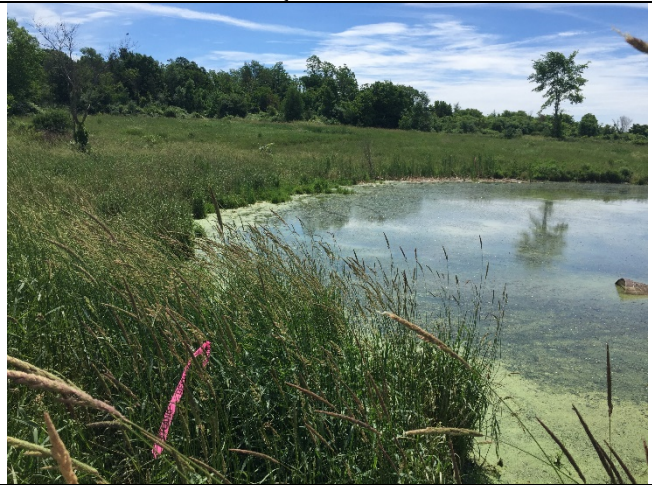
Photograph 4. Representative view of the northern edge of Class II wetland 2018-2, photo looking east

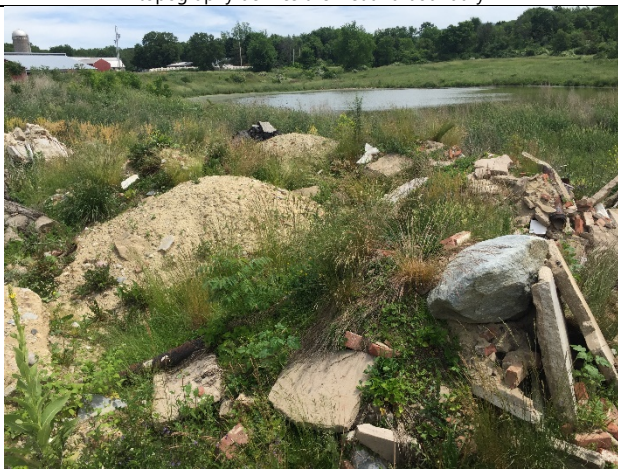
Photograph 5. A view of existing rock and debris piles in an upland area generally north of Wetland 2018-2 and south of an existing equipment shed and gravel parking area

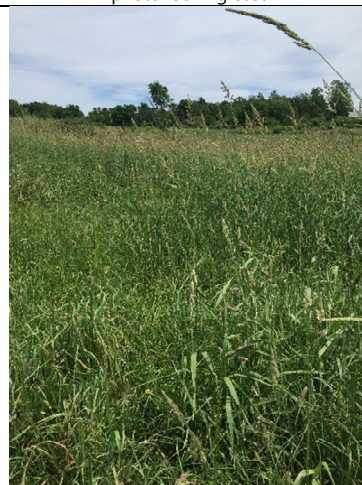
Photograph 6. Representative view of vegetative cover in Class II wetland 2018-2; photo view looking generally east from within the western portion of the wetland.

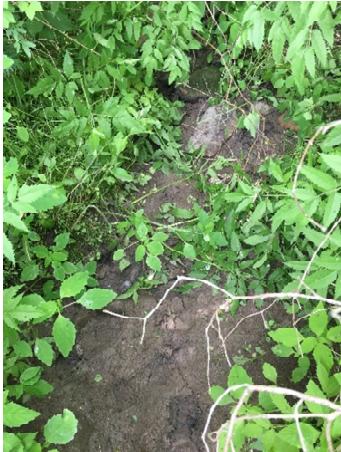
Photograph 7. An up-close view of the intermittent channel of Stream 2018-SC-1

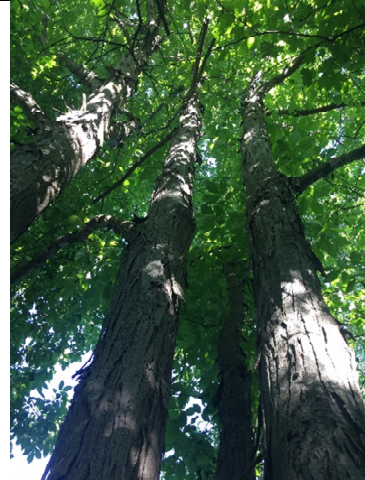
Photograph 8. A photograph of the potential roost trees, which may provide potential bat roosting habitat

identified PRTs would not be cut by the Project. Proposed Final Project tree clearing would be less than 1 percent of the available forest cover within a 1-mile radius of the Final Project. There are no documented hibernacula for RTE bats within 0.25 mile of the Final Project. Although the EO polygon for northern long-eared bats is mapped by ANR within approximately 0.25 mile of the Final Project, the EO record indicates that the actual known roosting habitat occurred at the covered bridge. As such, VHB finds that there is no known, ANR-documented roosting habitat within 1 mile of the Final Project, and so no specific conservation measures to avoid impacts to northern long-eared bats or other RTE bat species would be required per applicable agency guidance.

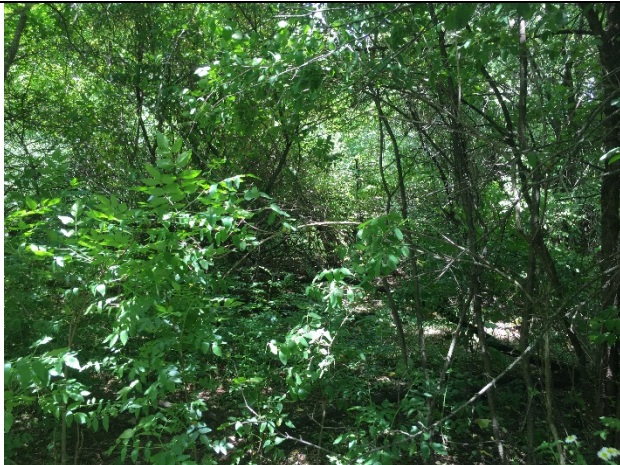
Photograph 9. Representative view of vegetative cover in the portion of currently forested area where the Project proposes to clear vegetation

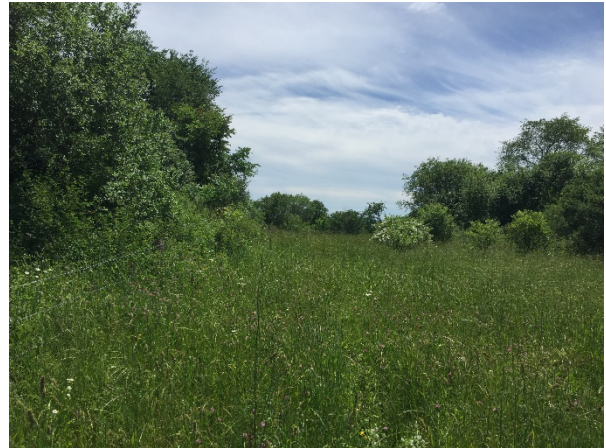
Photograph 10. Representative view of an upland area to the southwest of the existing bunker silos
