## **A Slippery Slope\***

# Exhibit MB-39 Part 1

## Site Plan Reference Page

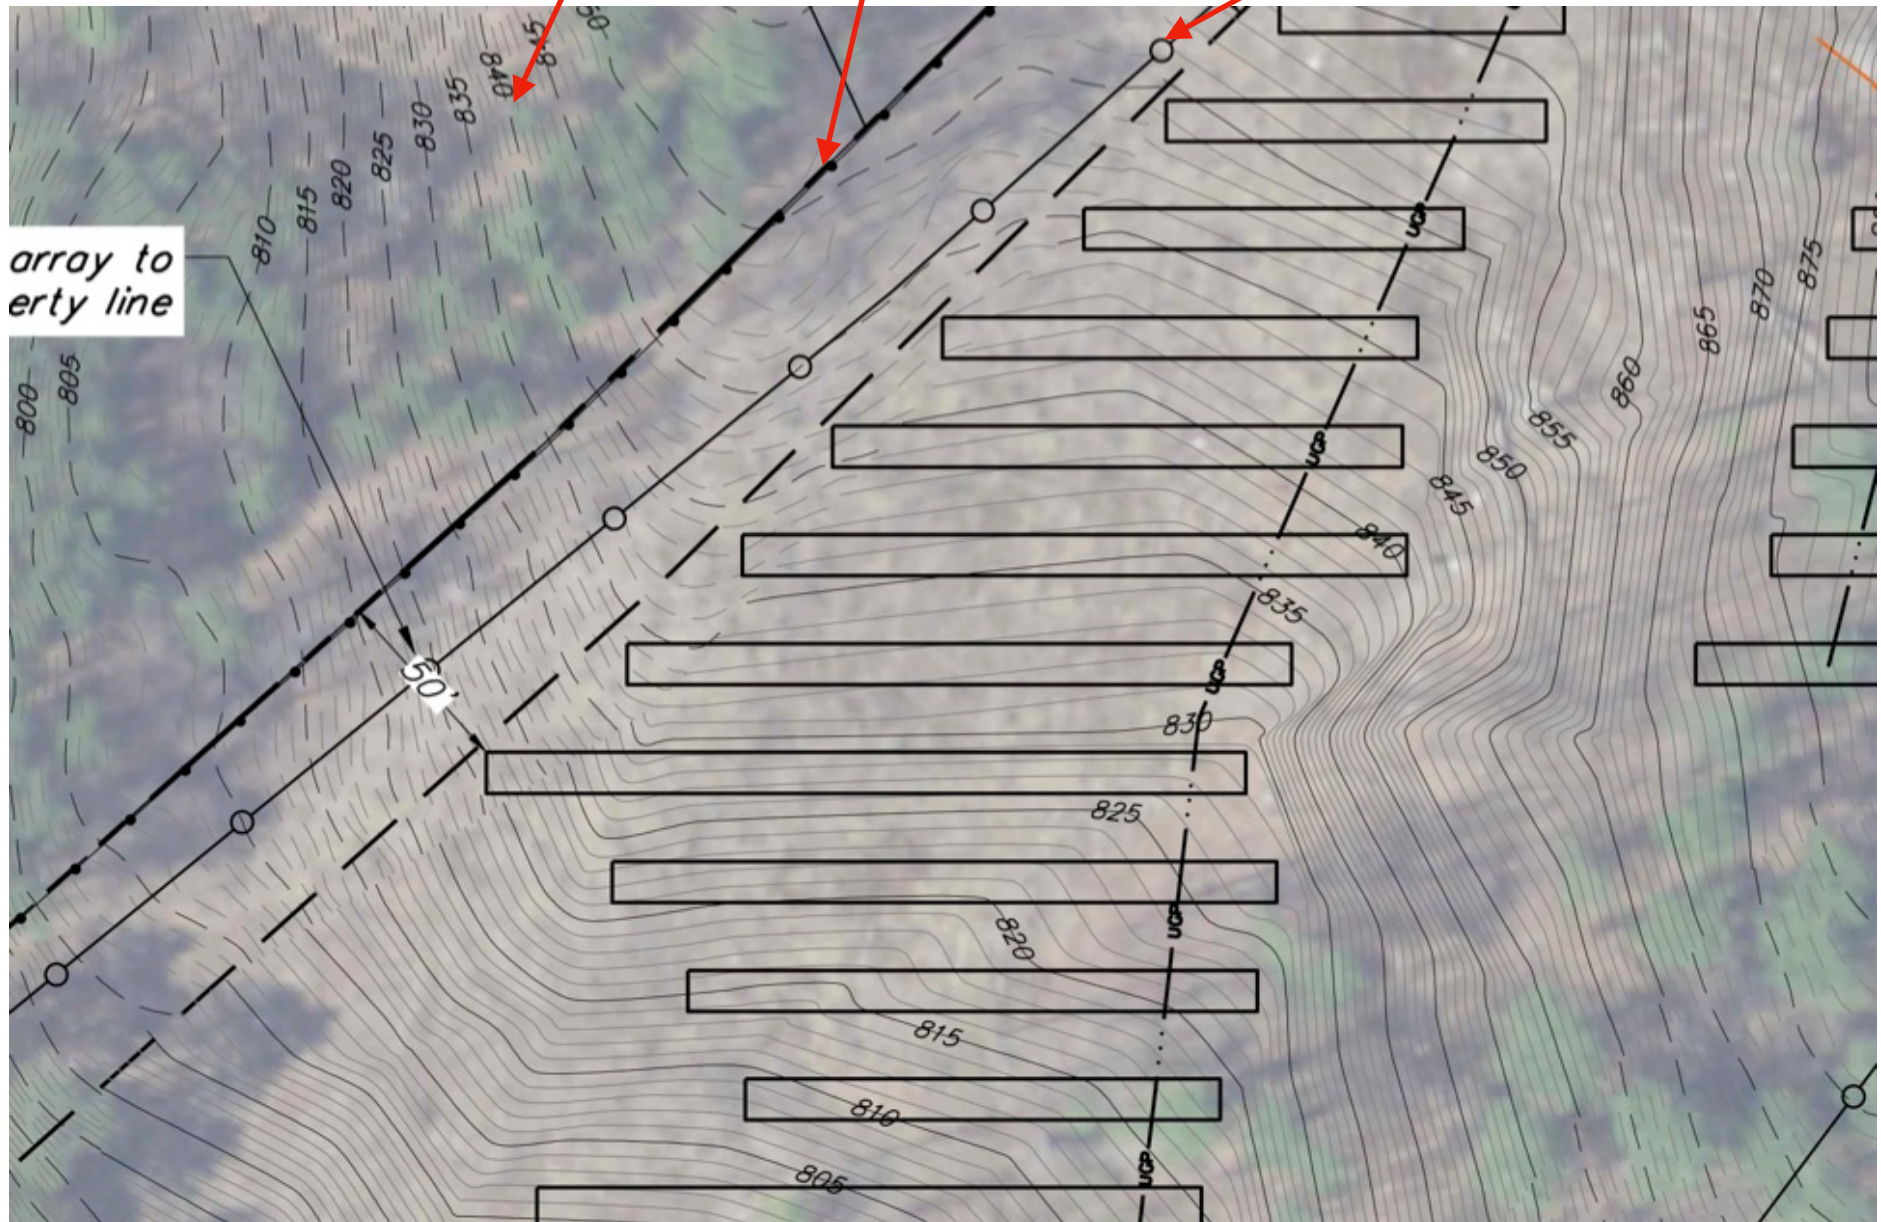
In the **Second Site Plan**, panels have been rearranged to be in two groups.

The contour lines under and around the array are derived from a ground based survey.

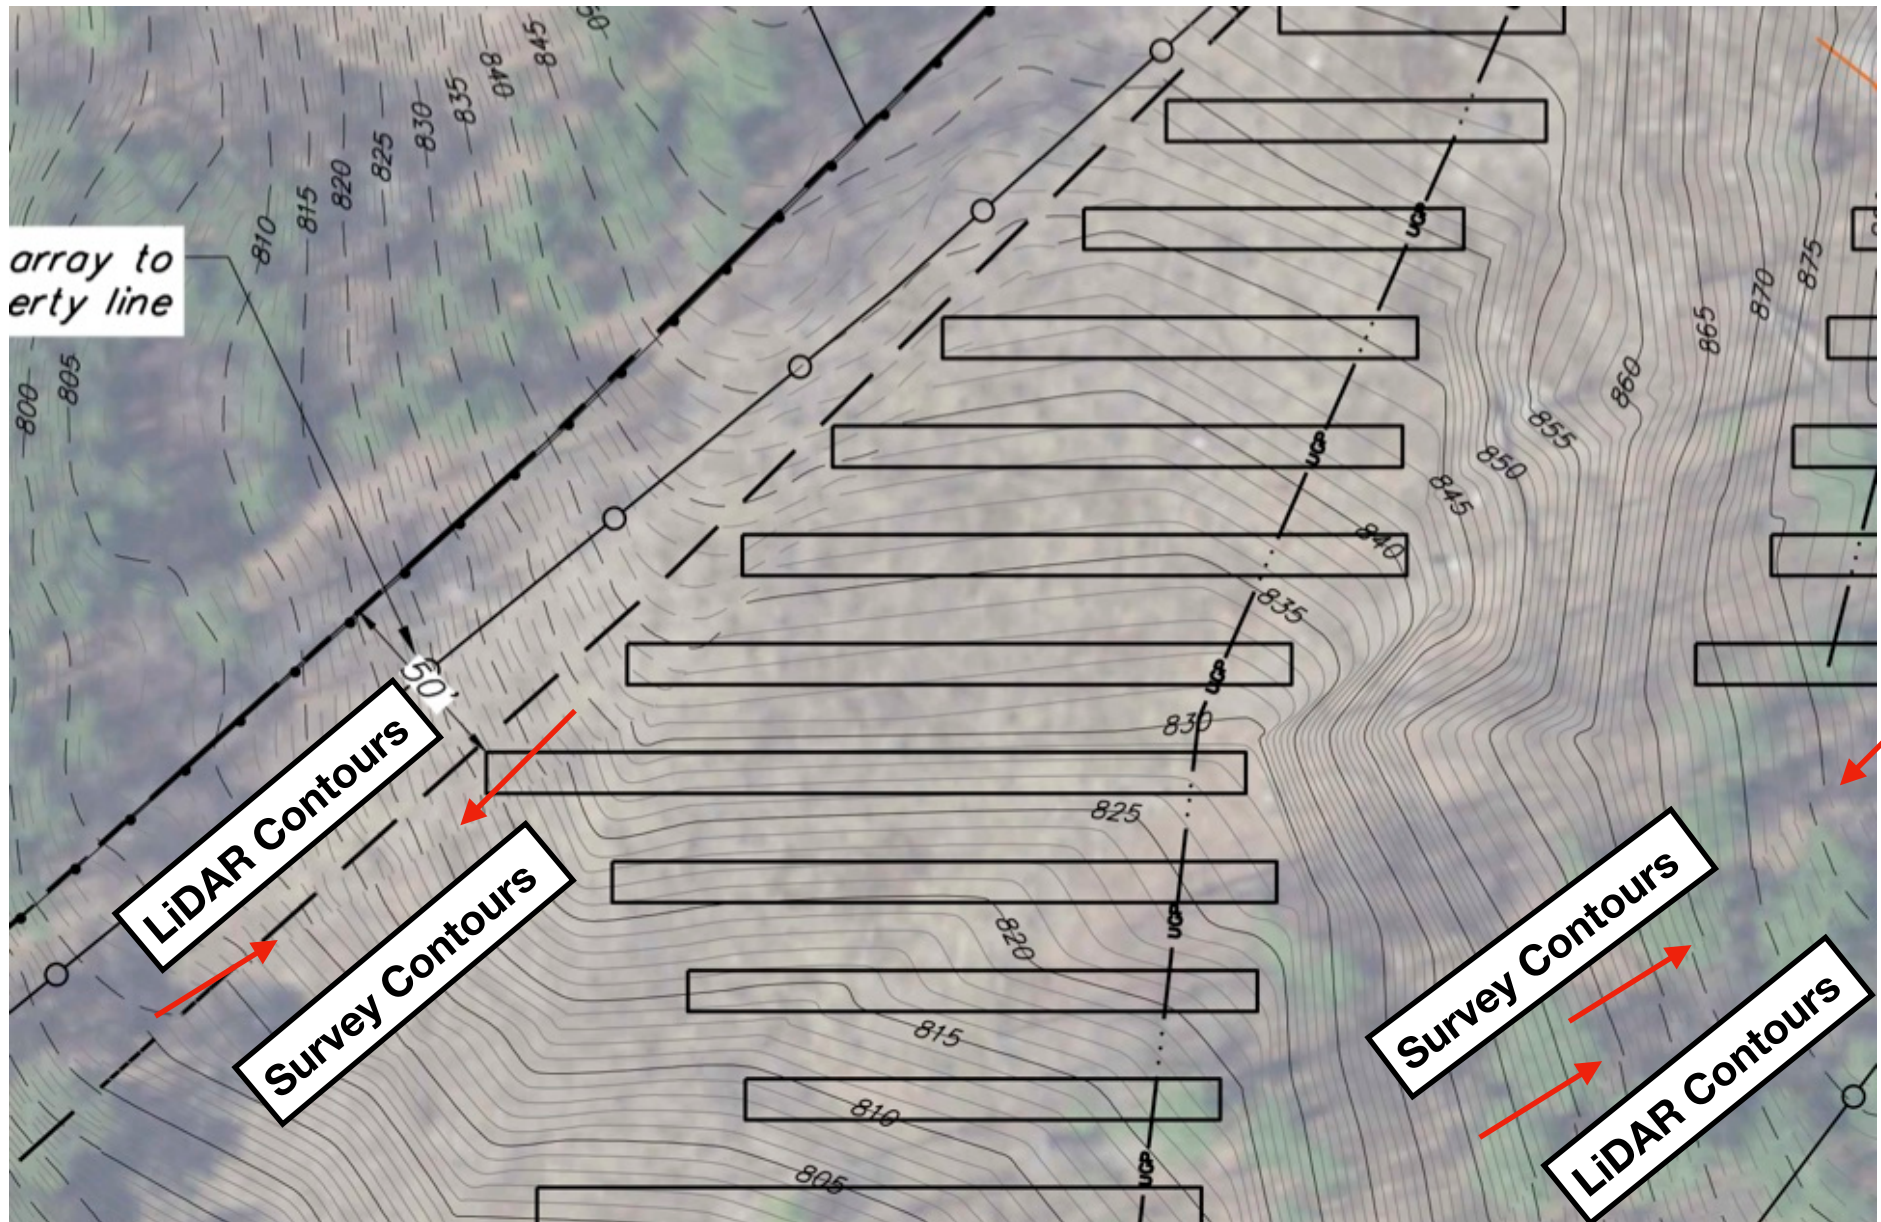
Discontinuities (Red Arrows) in the **Second Site Plan** are visible where the ground based survey is patched onto the LiDAR base layer

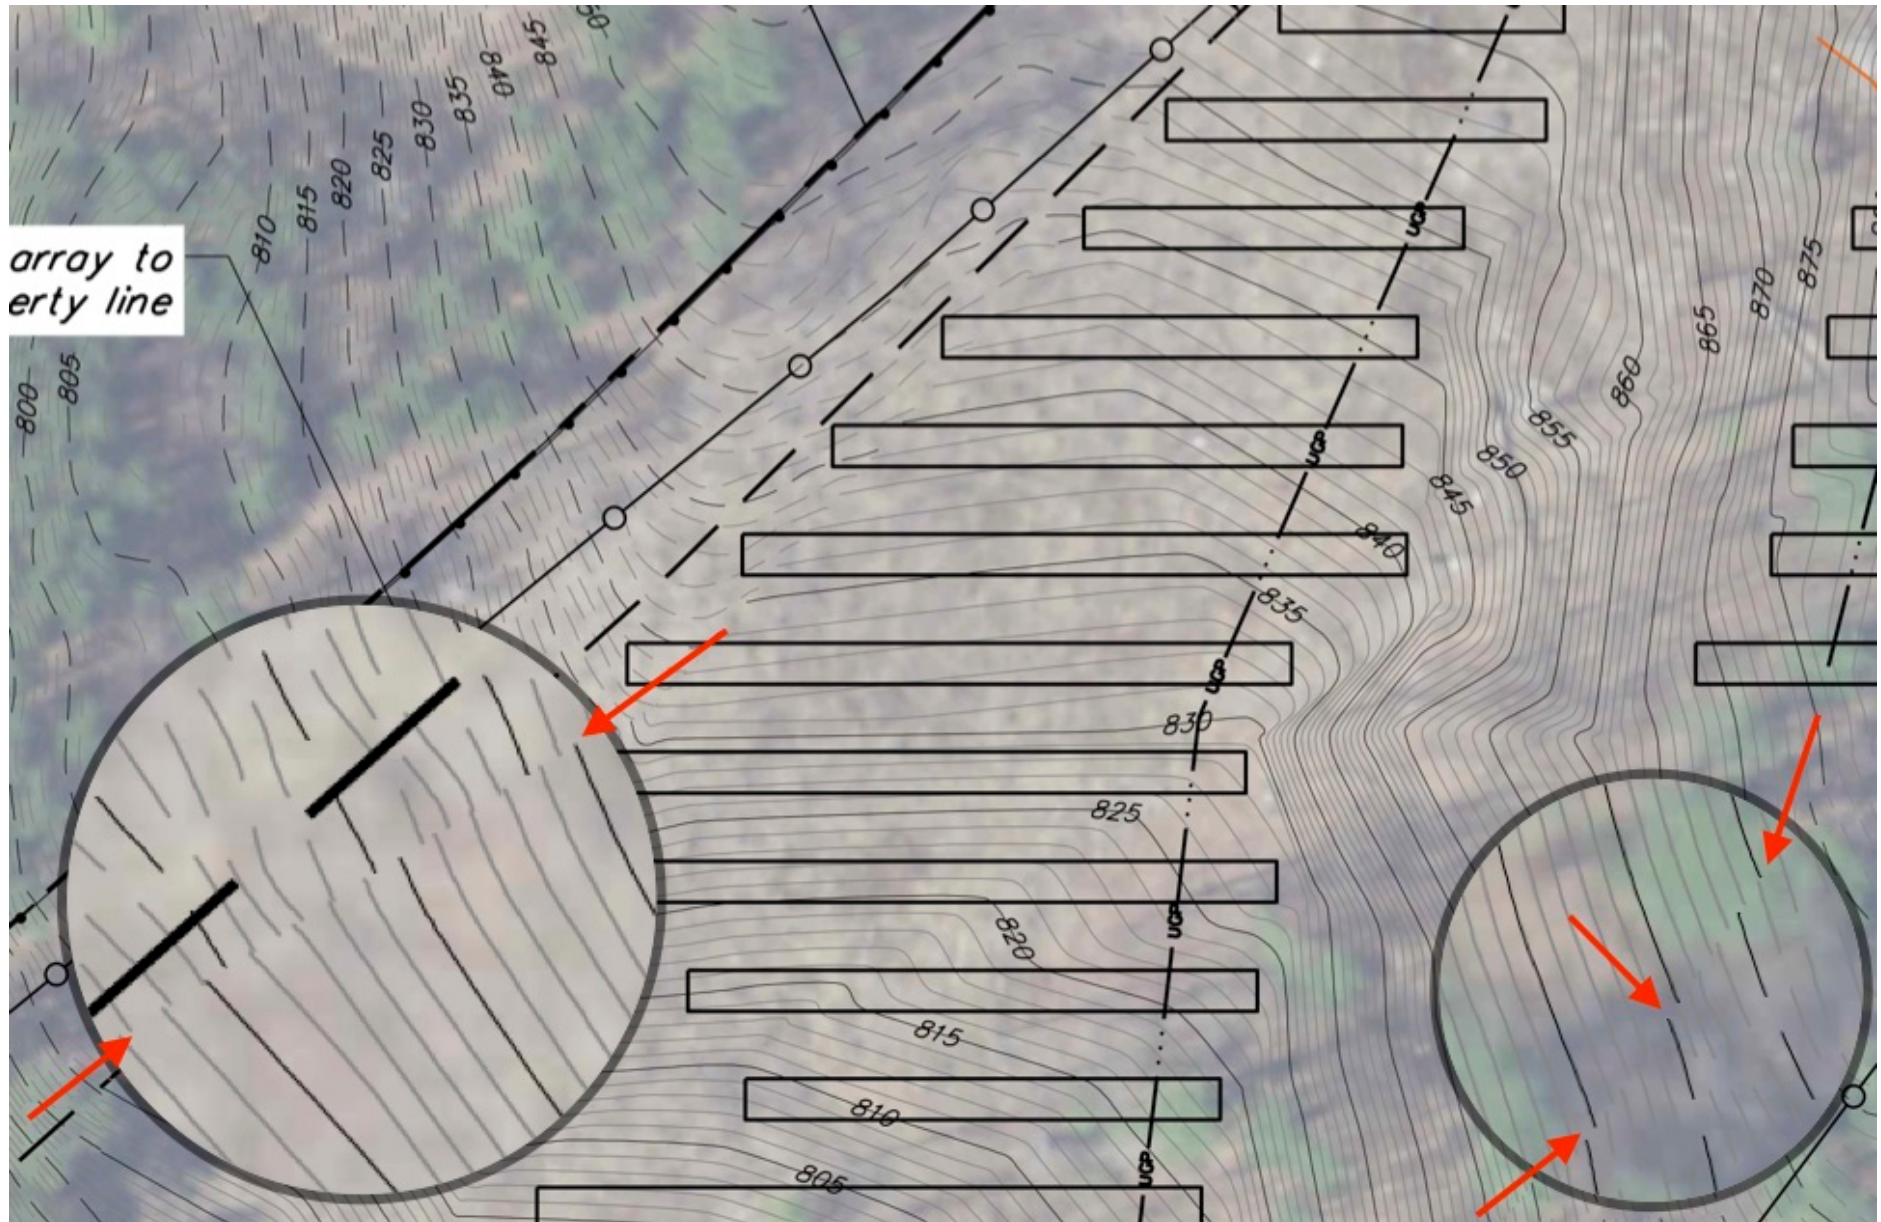
Northeast corner of the Site.  
**1st Site Plan**  
5 ft major, 1 ft minor contours

The local high point on the ridge is a 'double hump' at 905 and 906 ft elevation.

Northeast corner of the Site.  
**2nd Site Plan**  
5 ft major, 1 ft minor contours

Note the discontinuities where the ground based survey was patched onto the LiDAR base layer.

All Site Plans after the 2nd Plan have 10 ft major contours and the 'double hump' is not seen because there is no 905 ft contour

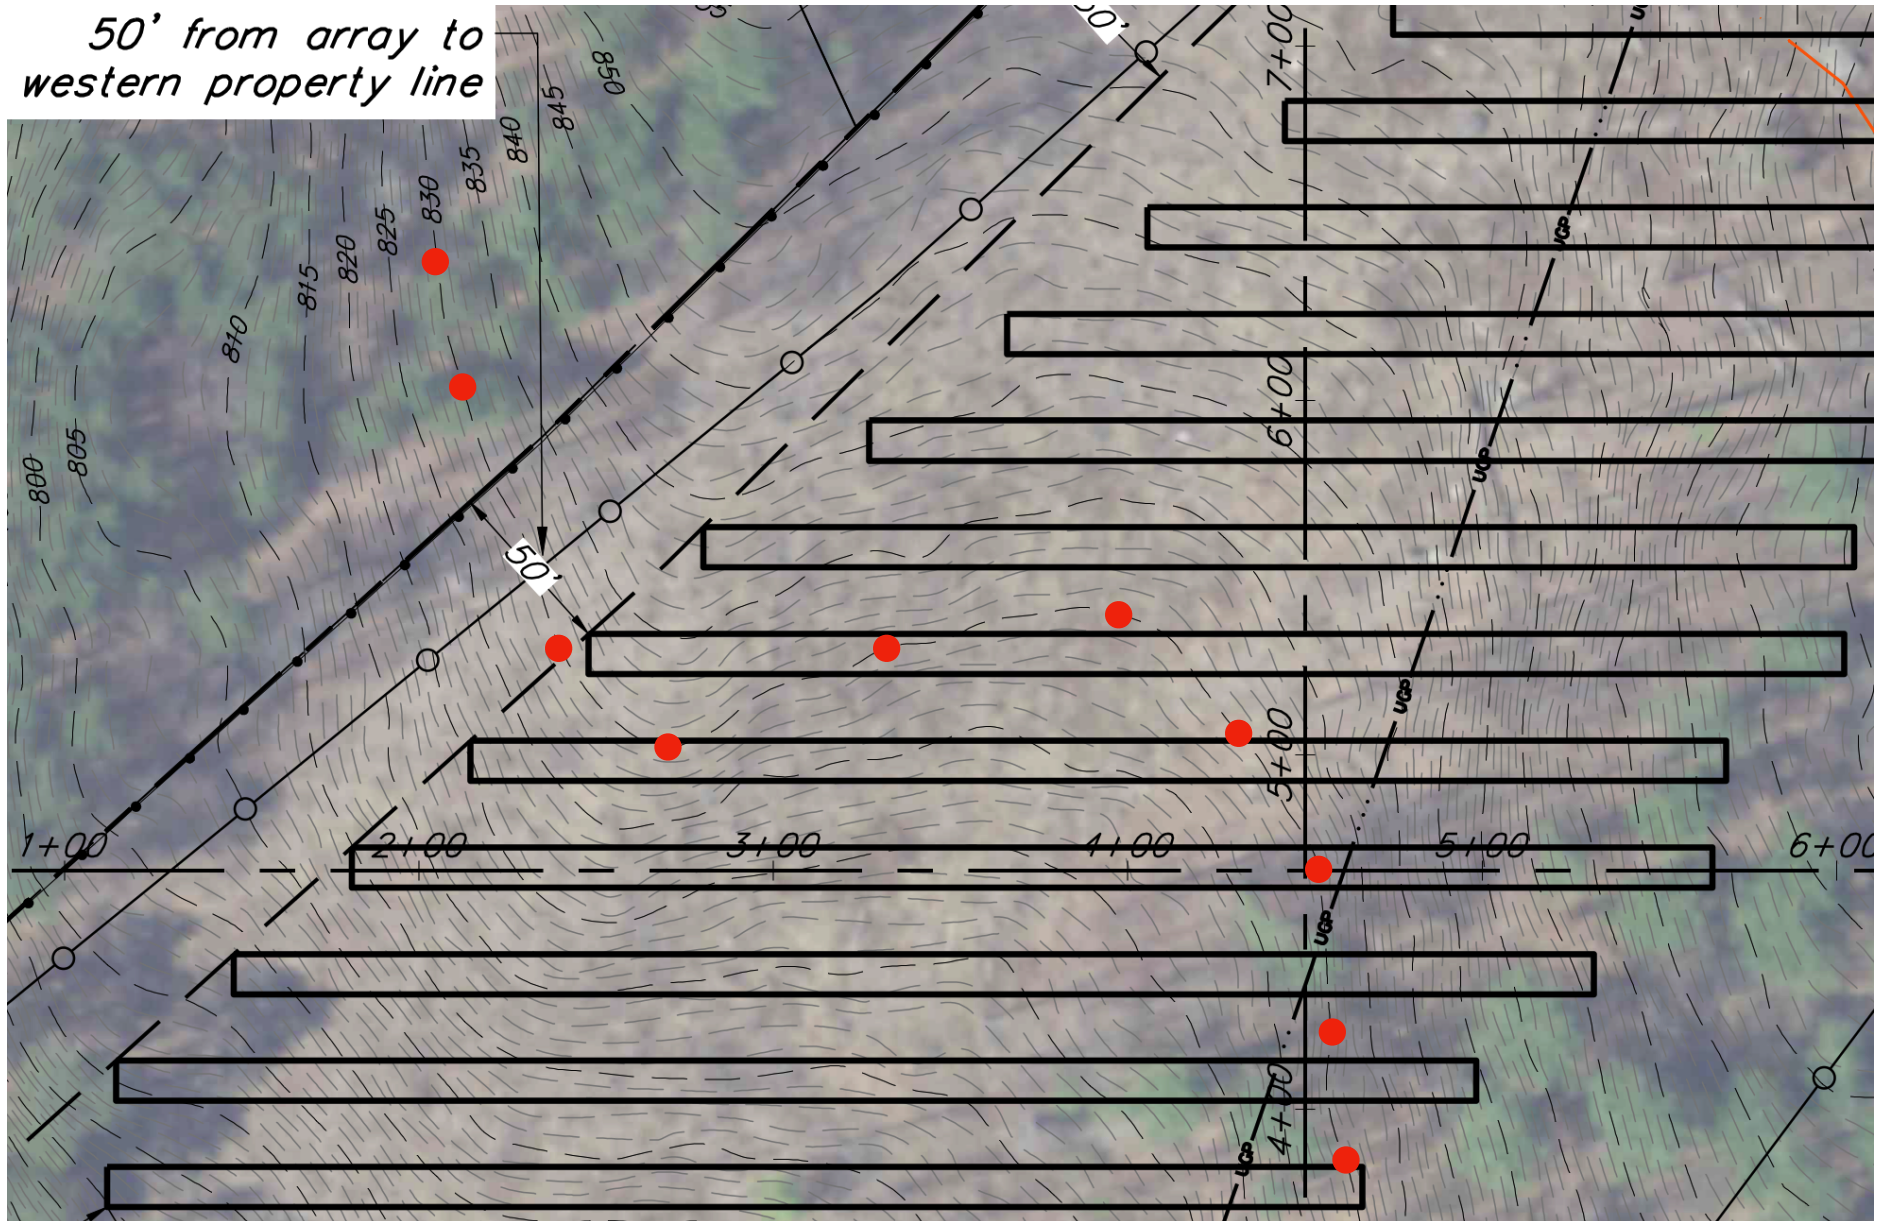
The **First Site Plan** has LiDAR contours throughout.

The 830 ft Elevation is marked with Red Dots.

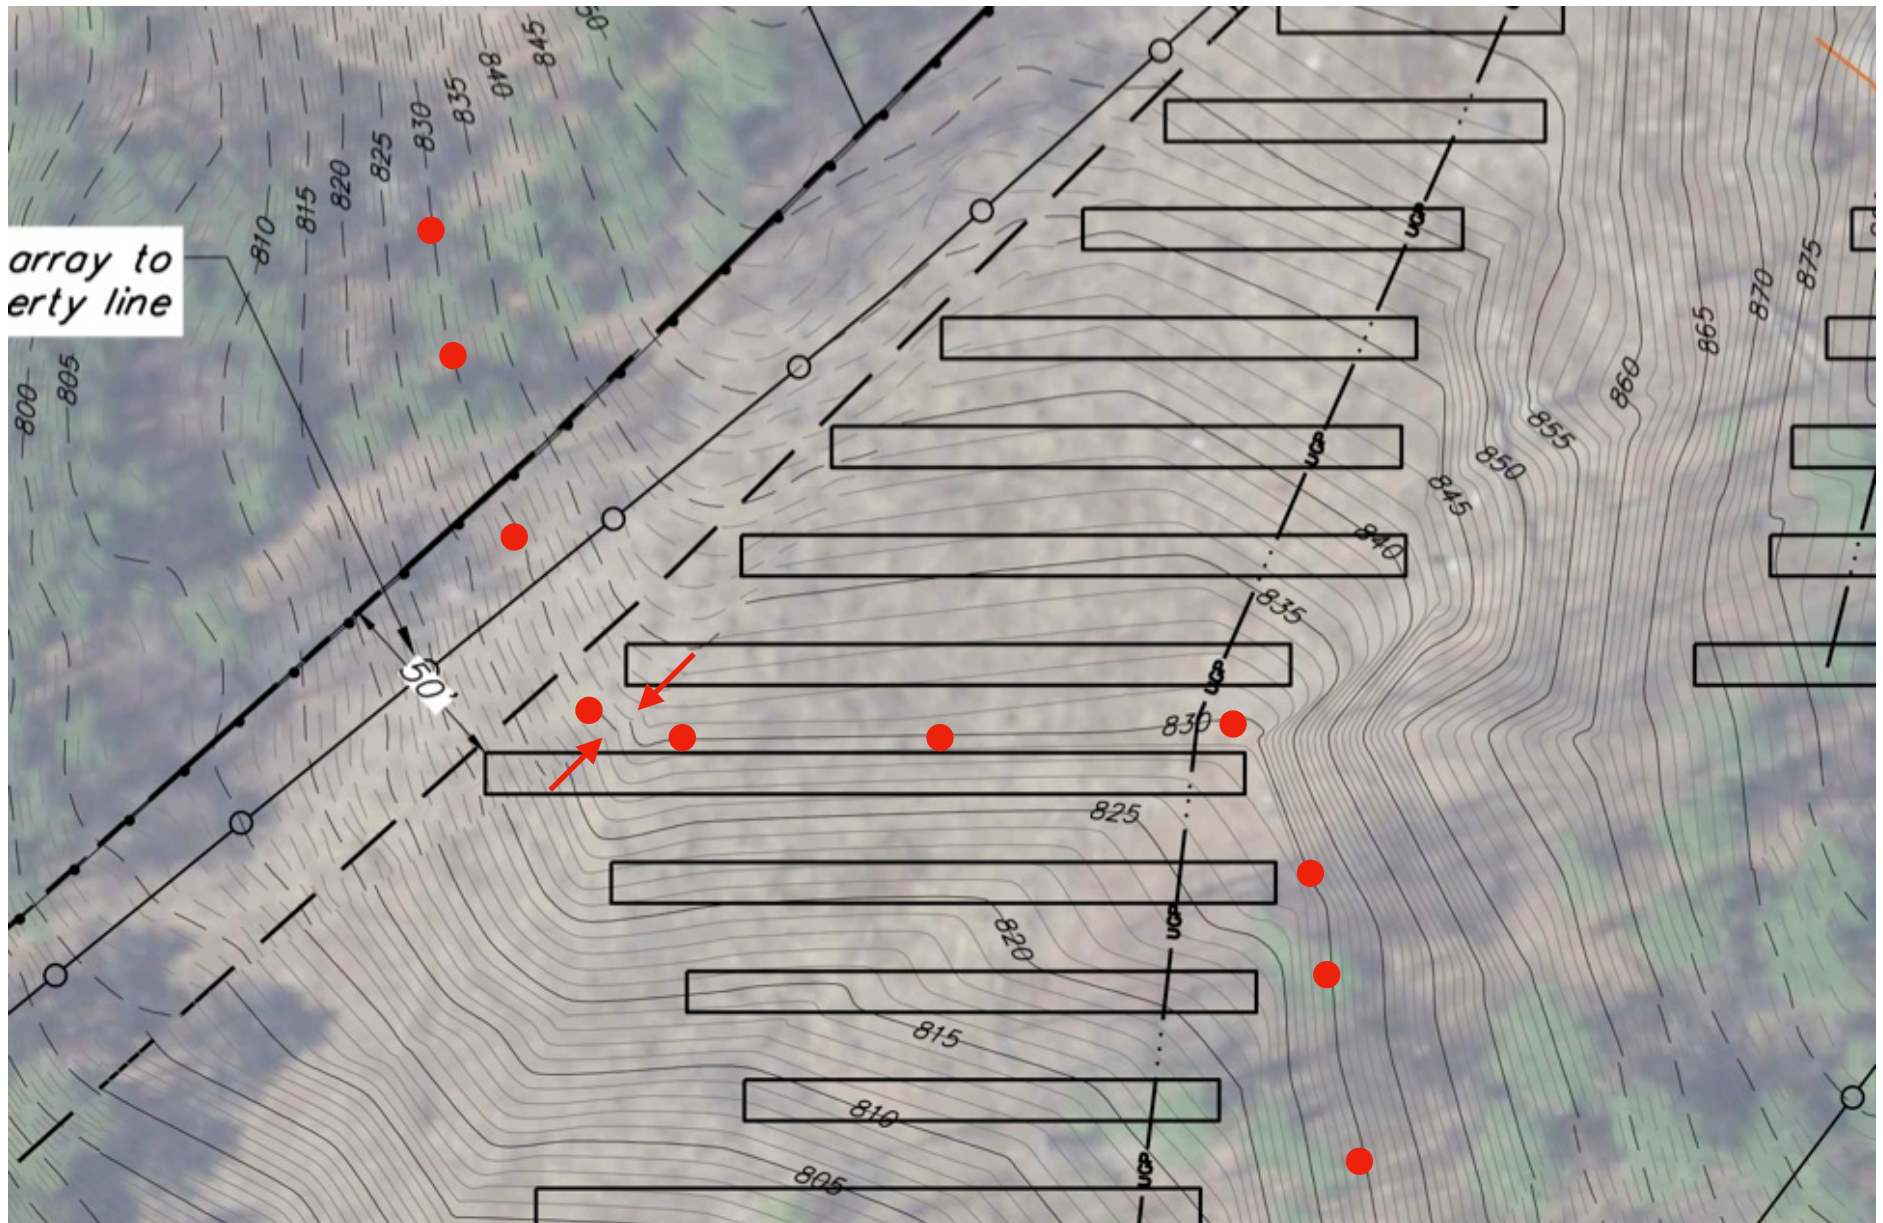
In the **Second Site Plan**, the 830 ft Elevation is marked with Red Dots.

The surveyor did not locate elevations at enough points to accurately draw the contours.

The discontinuity runs through the 830 ft contour line at the Red Arrows.

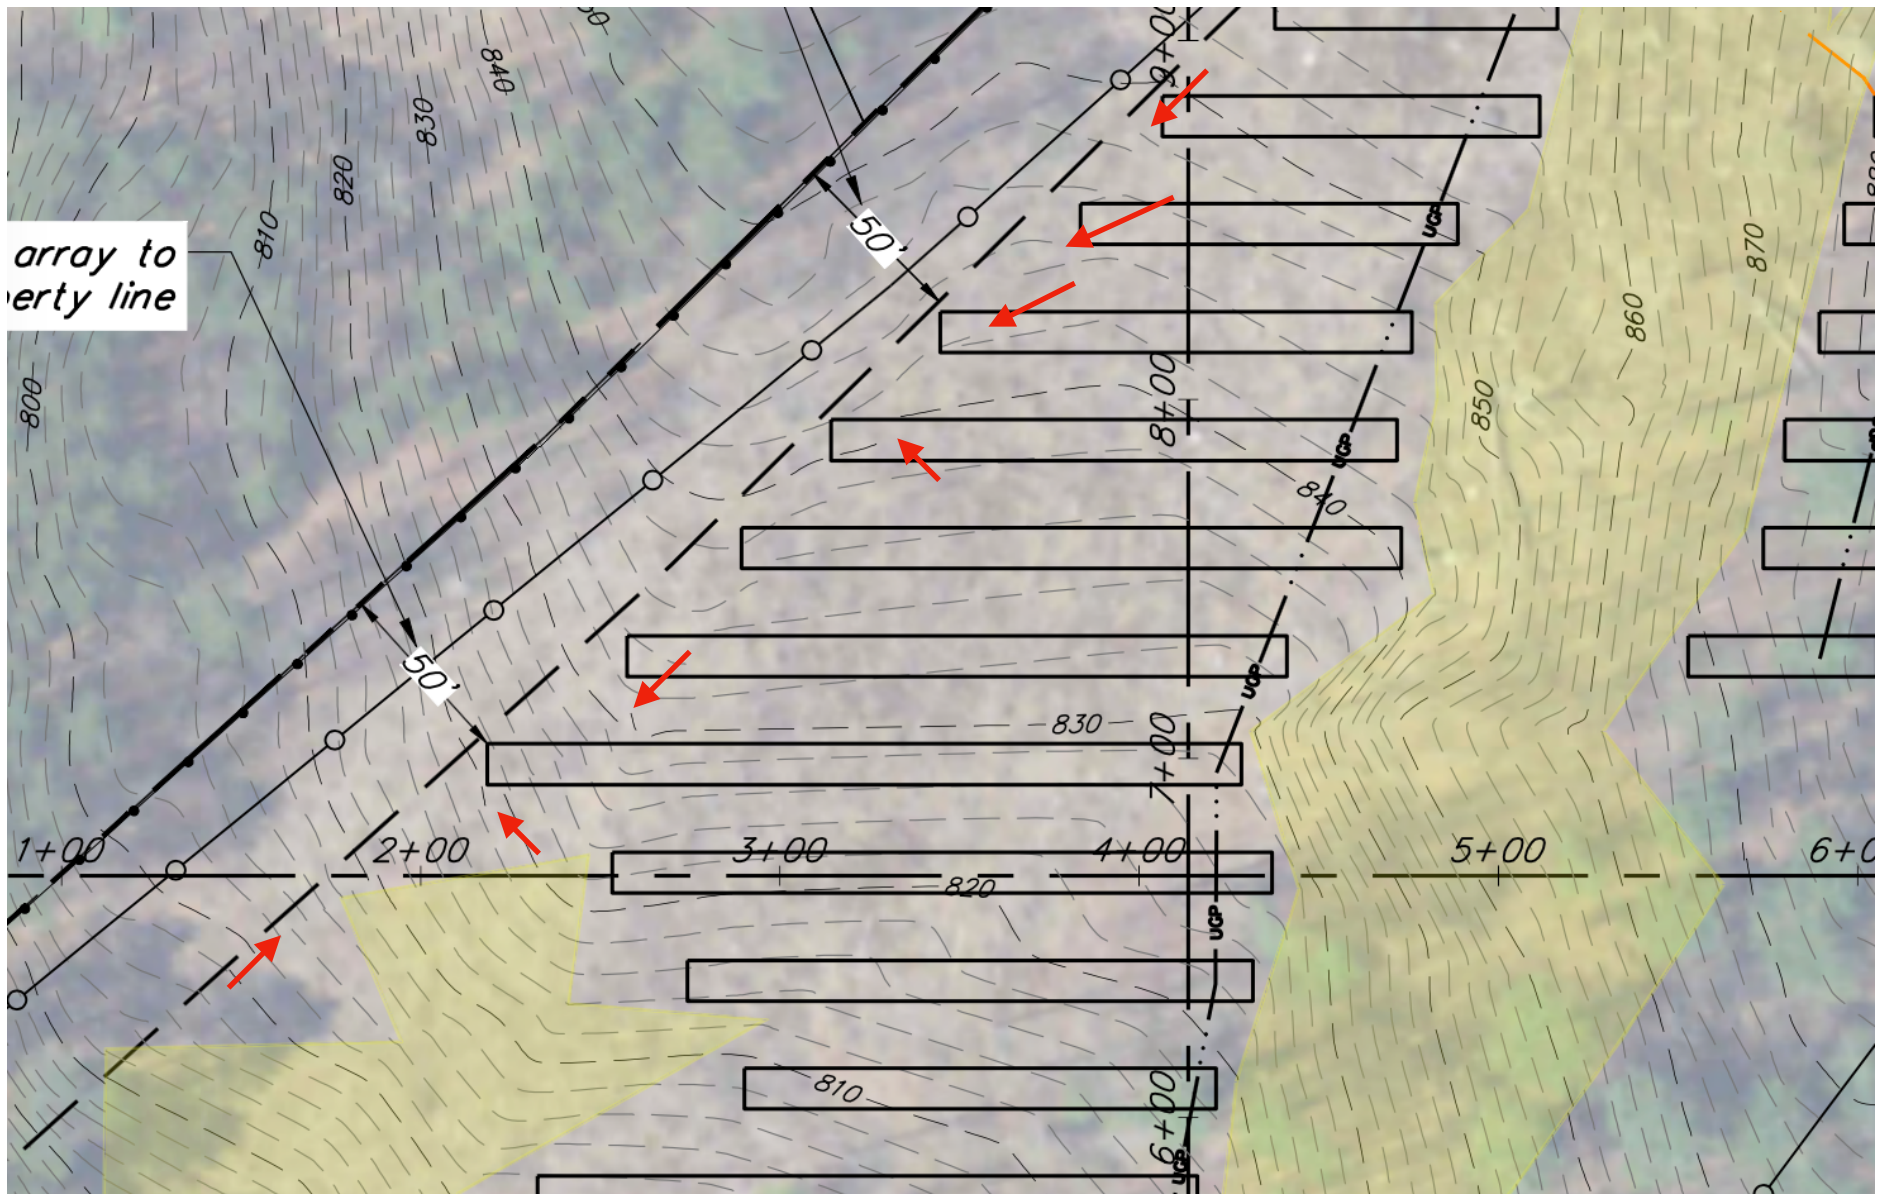
In the **Third Site Plan**, a greater-than-25% Slopes Layer (Yellow) was applied to the area of the ground based survey. The Major Contours are coarser (10 ft) and the discontinuities (red arrows) a bit less noticeable.

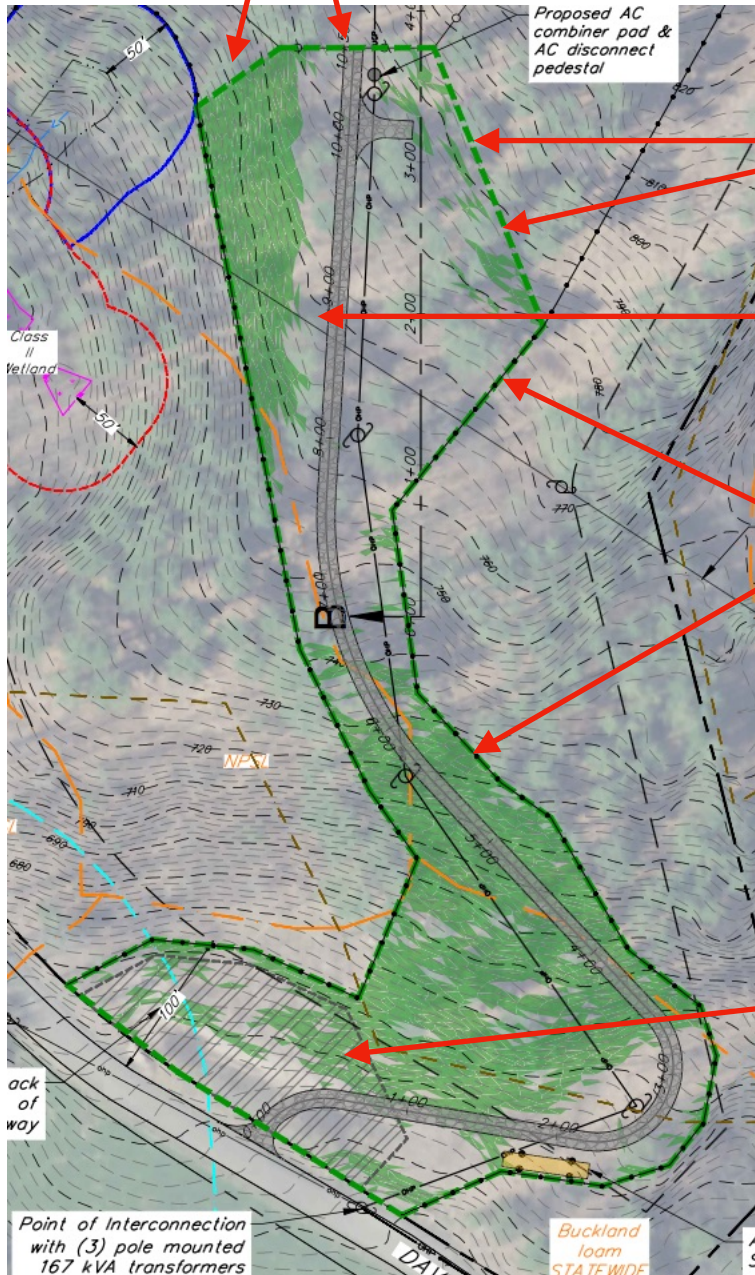
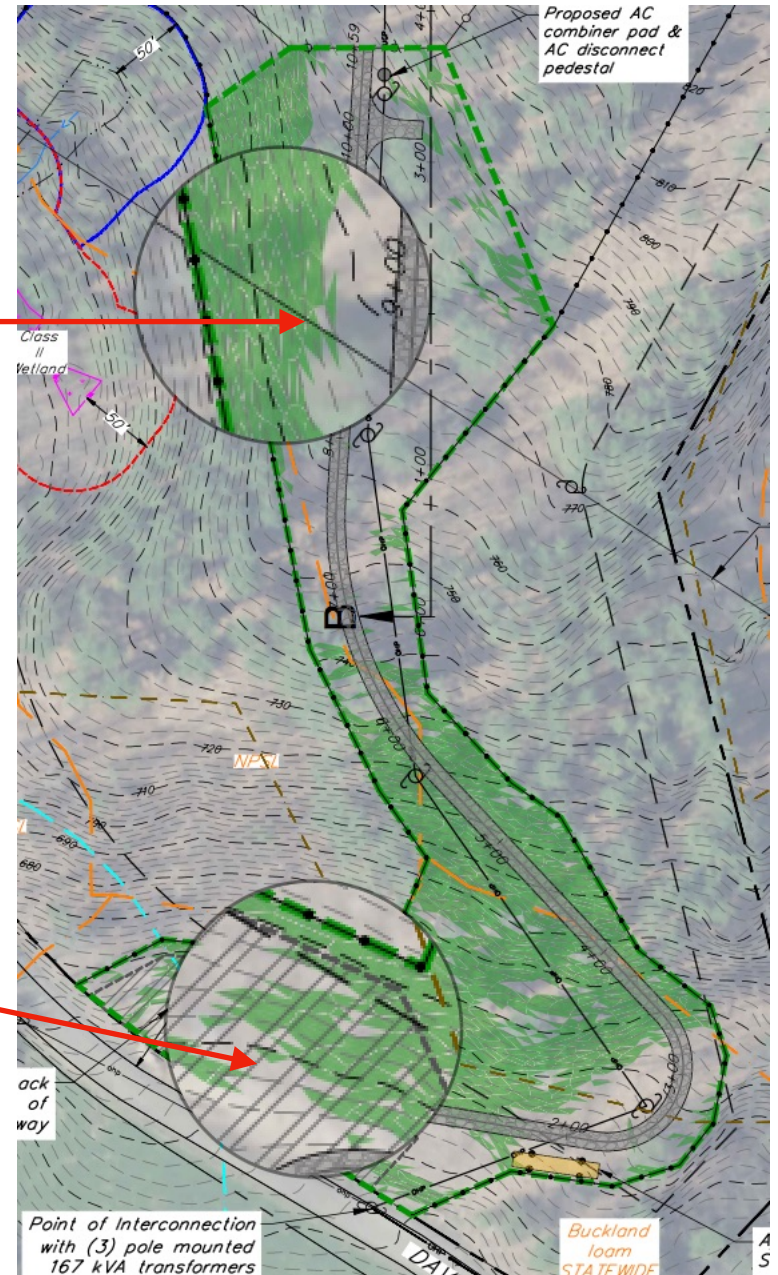
## Fourth Site Plan

In the **Fourth Site Plan**, a greater than 25% LiDAR Slope Layer (Green) was added around the Access Road.

Note the “frayed” edges of the slope layer. The Frayed Edges are typical of what a slopes layer on a natural landscape looks like.

Artificial Boundary  
of LiDAR Slope  
Layer

Frayed Edges

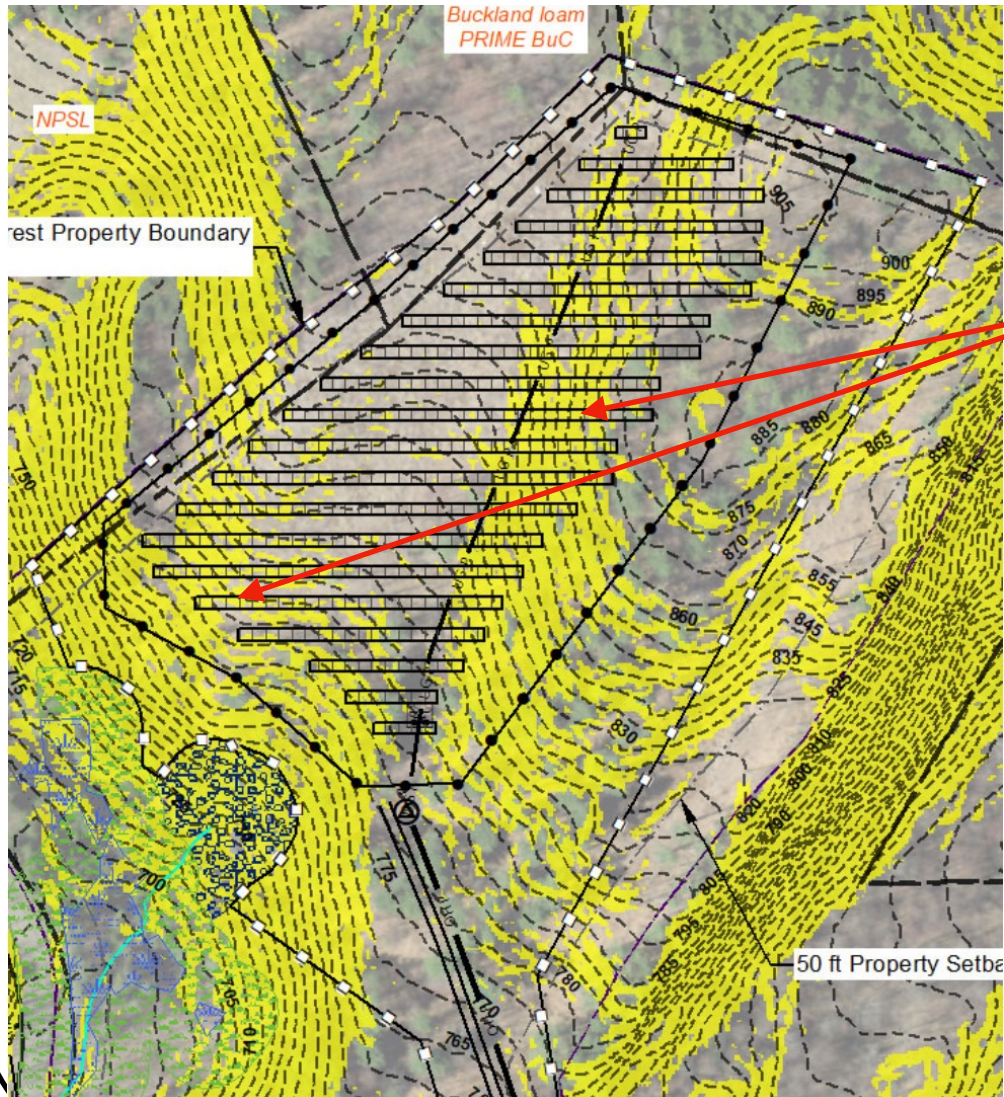
This is the Preliminary Site Plan that was sent in response to the Town's request (slopes over 25% in Yellow).

Steep slopes under the array

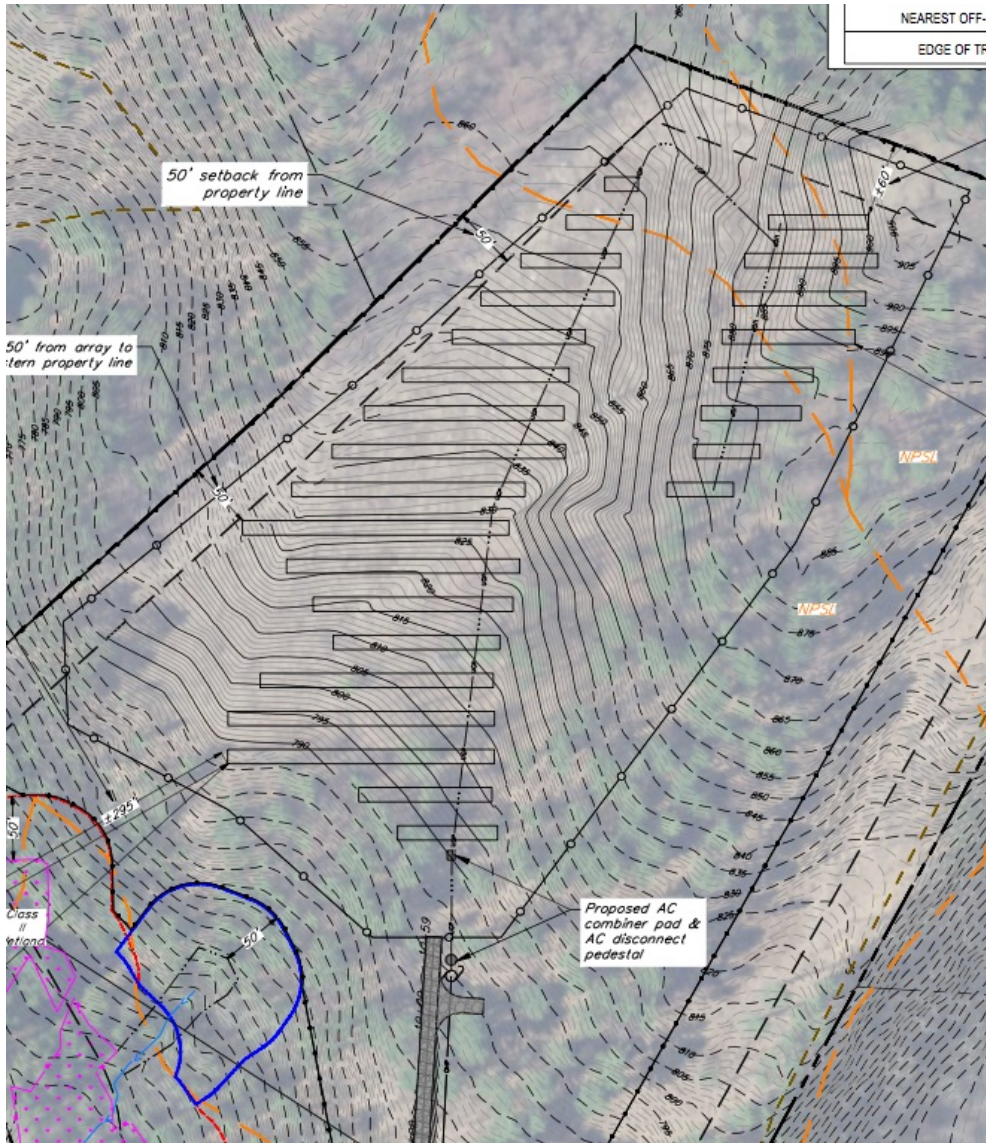
If the developer puts a LiDAR Slope Layer on the site plan, it will reveal that there is still yellow under the panels

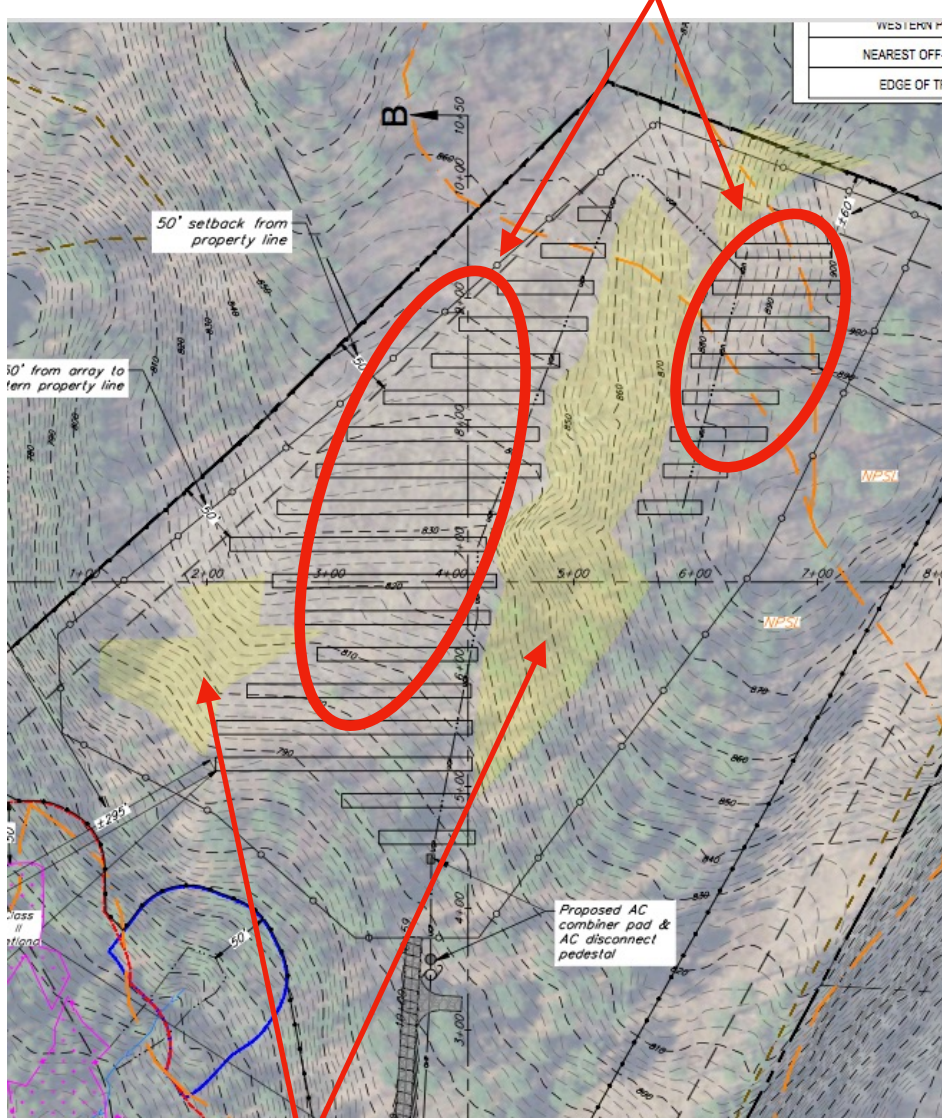
### Third Site Plan No Yellow Here!

When the computer determines the slope between two adjacent (but still far apart) survey points, the computer has to interpolate (guess) the elevations between the two points.

The result is that steep slopes are averaged with shallower slopes and the steep slopes just disappear from the Slope Layer.

**Contrived Slope Layer with unnatural shapes and smooth edges**

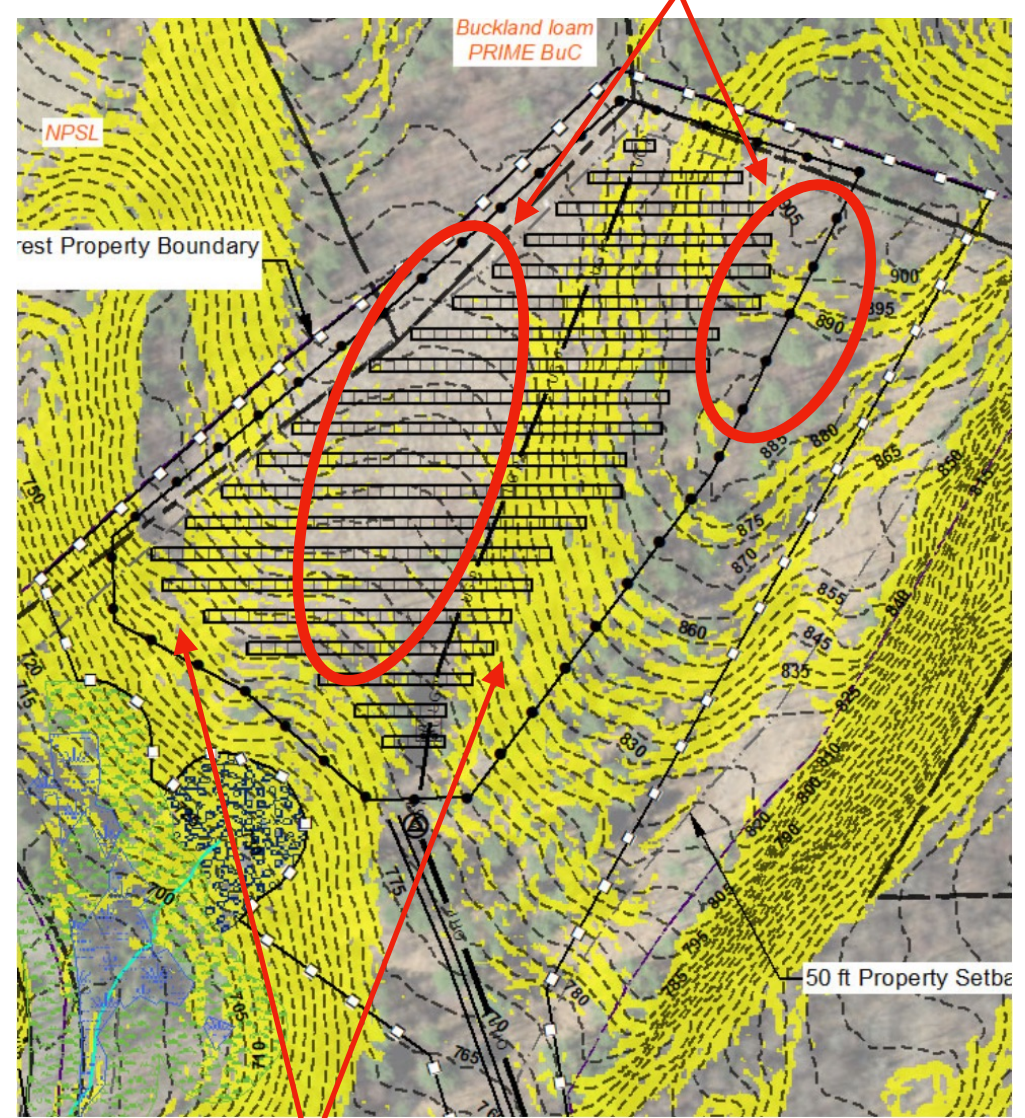
**LiDAR Slope Layer with natural shapes and frayed edges**

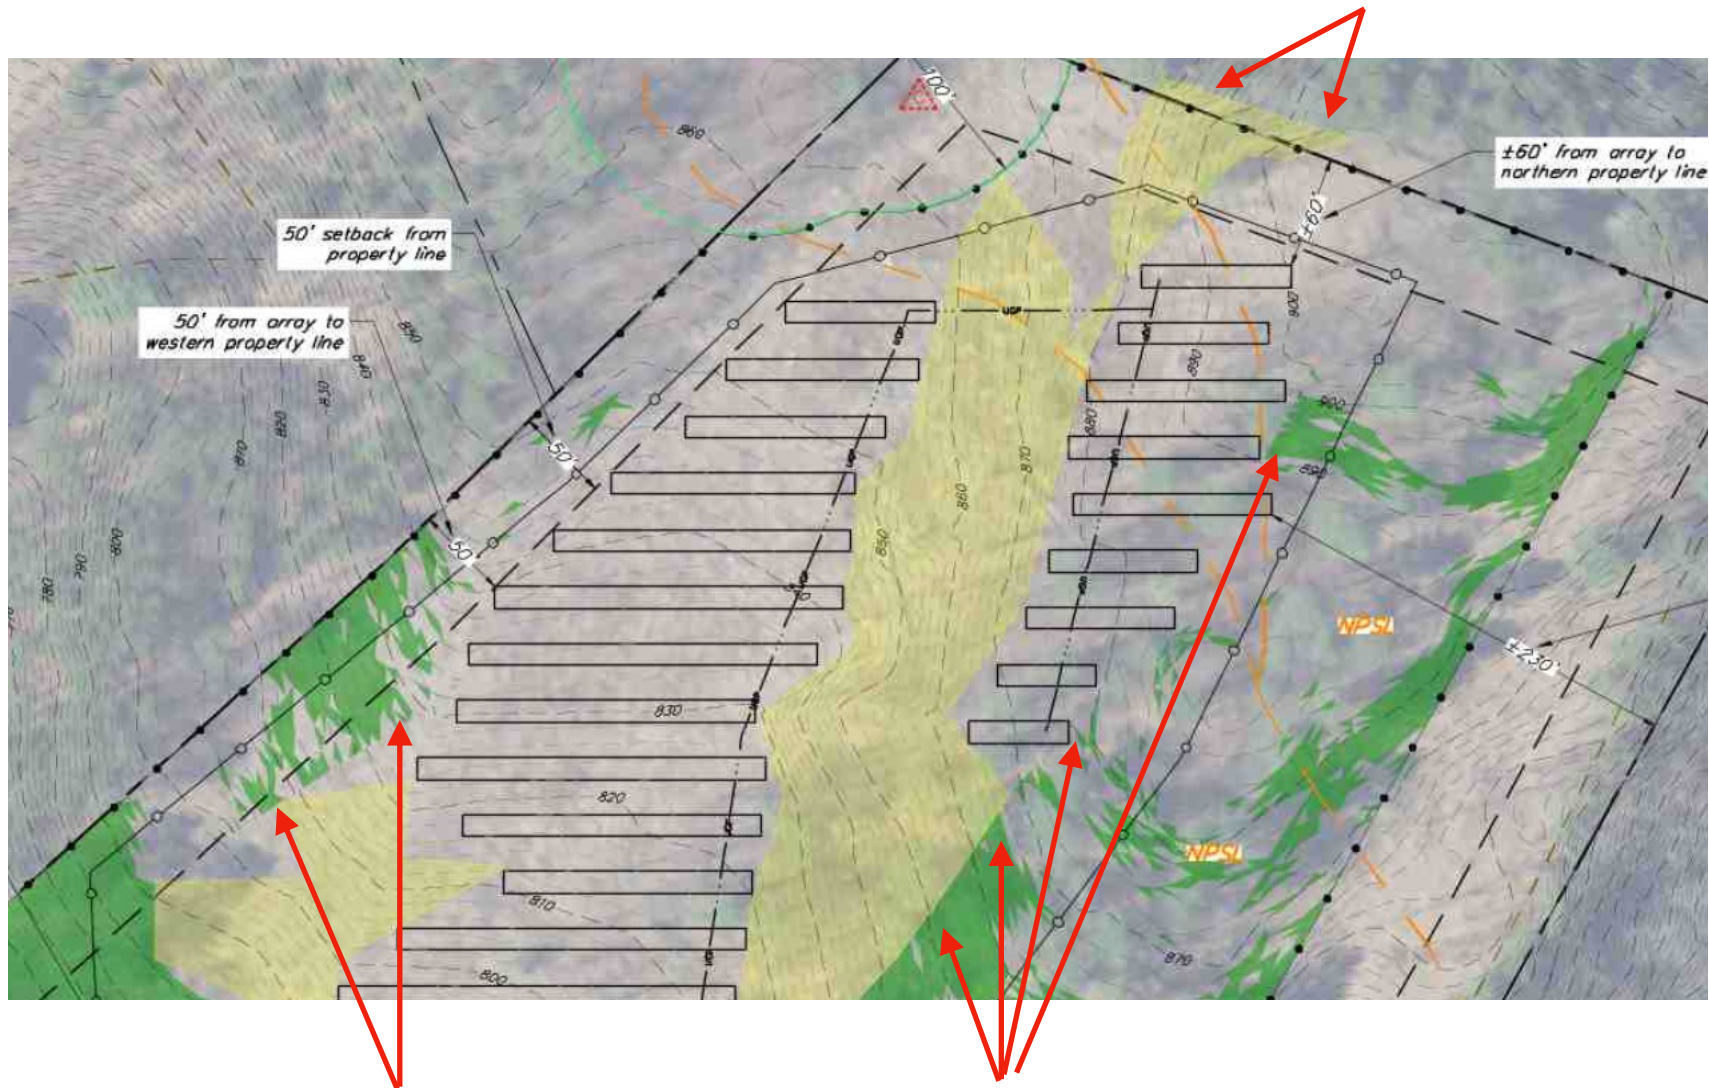
**In the Sixth Site Plan, a LiDAR derived Slope Layer (Green) is shown everywhere within the LoD, except where the Contrived Slope Layer persists under and around the Array.**

**The discontinuities where the Contrived, ground-based-survey Slope Layer meets the LiDAR Slope Layer are now glaringly obvious.**
