## **A Slippery Slope\***

# Exhibit MB-39 Part 1

## Site Plan Reference Page

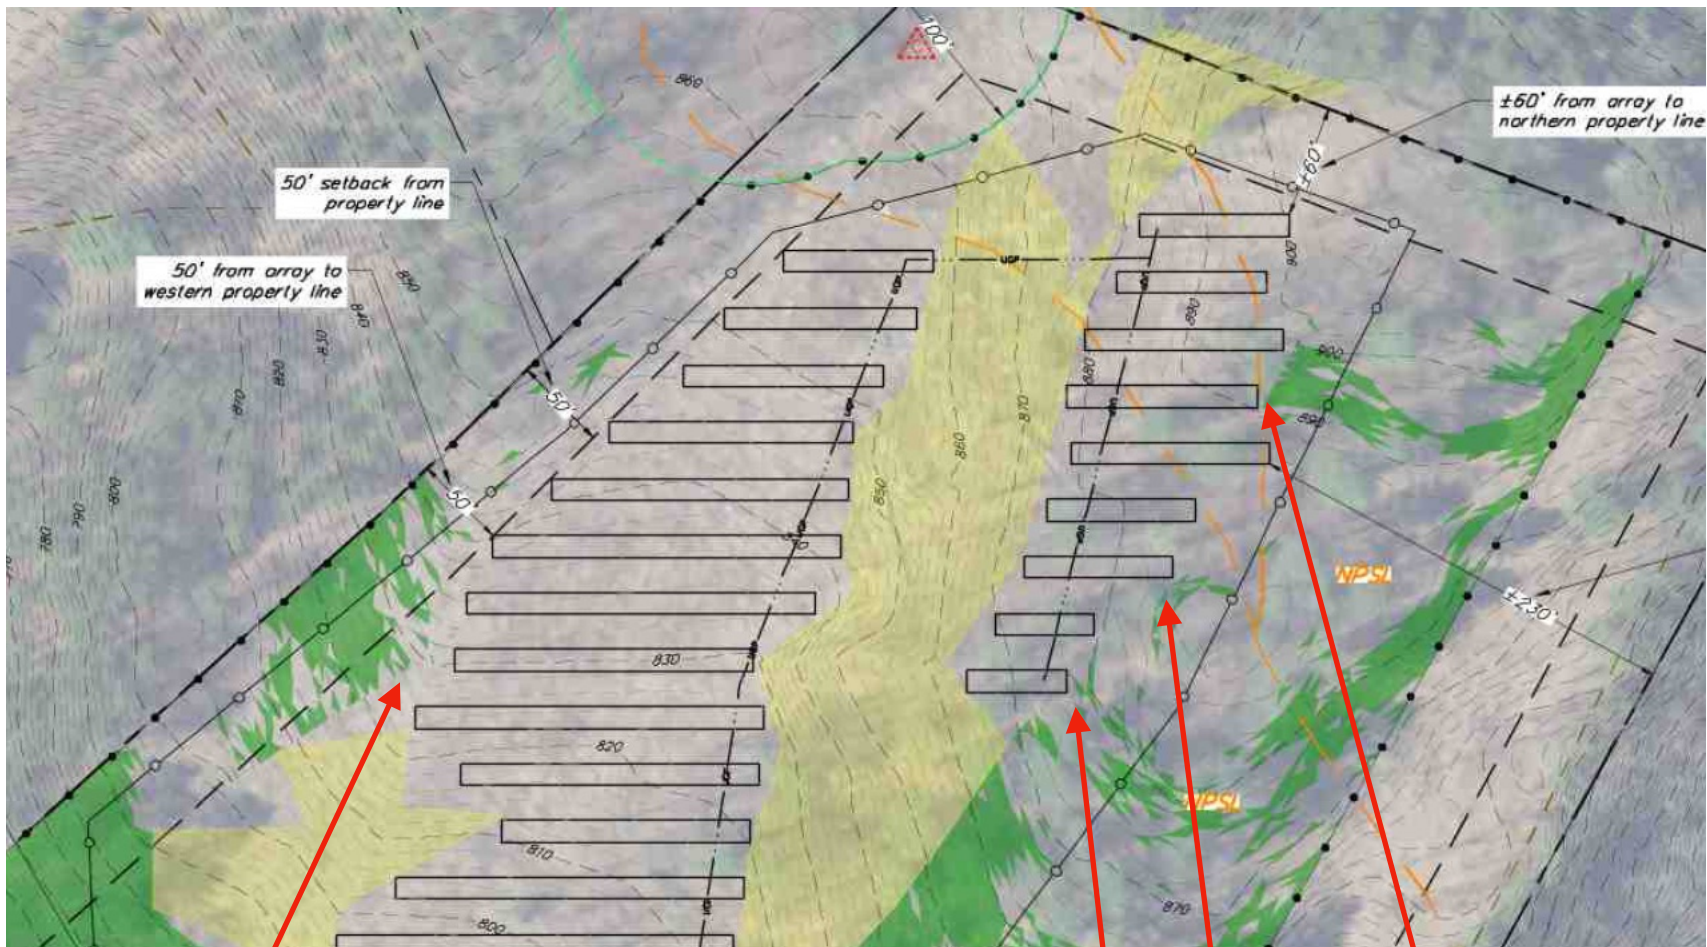
**The claim that the Array is entirely on Slopes less than 25% is not credible.**

**The Green LiDAR Slope Layer would extend under the Array if the contrived slope layer was not masking the actual steep slopes.**
