To: ER Reservoir Road Solar  
Project File

Project #: 58952.07

Re: Section 248 Natural Resources Assessment

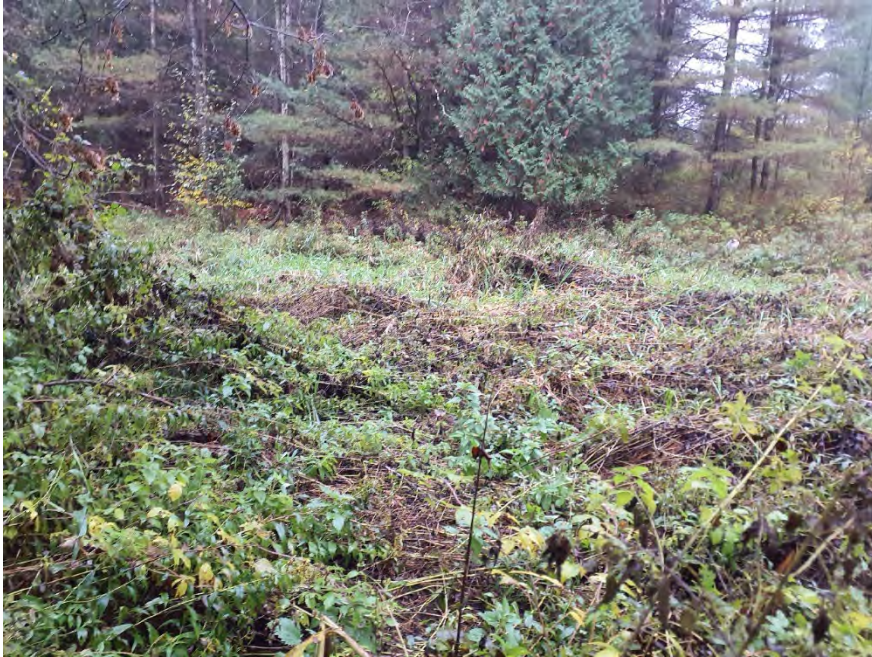
NO. 1 / 10.18.2022

Representative photograph of palustrine forested ("PFO") Wetland 2022-1(II), view is looking south to southwest.

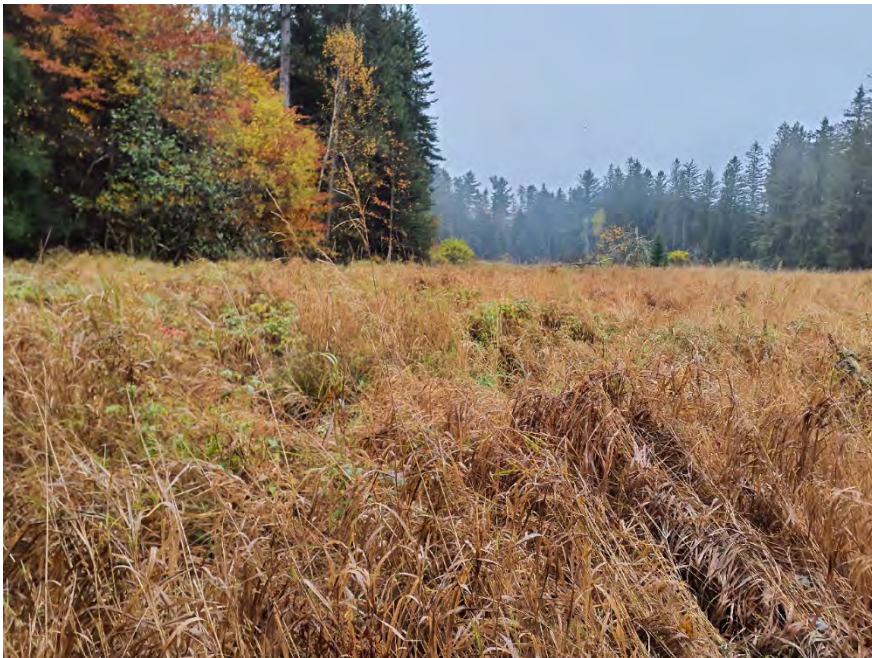
NO. 2 / 11.2.2022

Representative photograph of large palustrine emergent, palustrine scrub-shrub ("PEM/PSS") Wetland 2022-2(II) stretching north of reservoir, view is looking south to southeast.

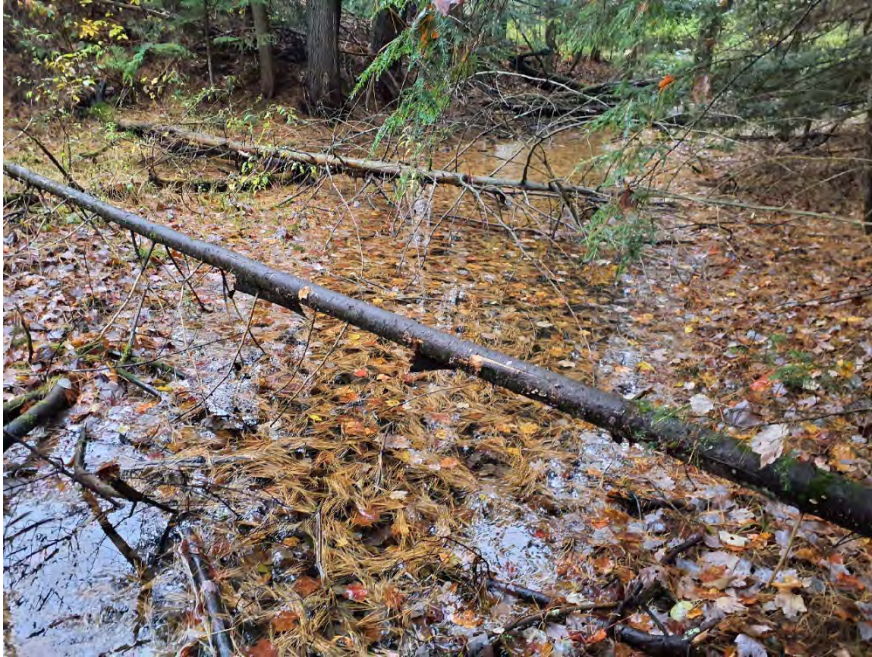
NO. 3 / 10.18.2022

Representative photograph of PFO Wetland 2022-3(II), depicting presence of potential vernal pool ("PVP") on eastern side of wetland. View is looking north.

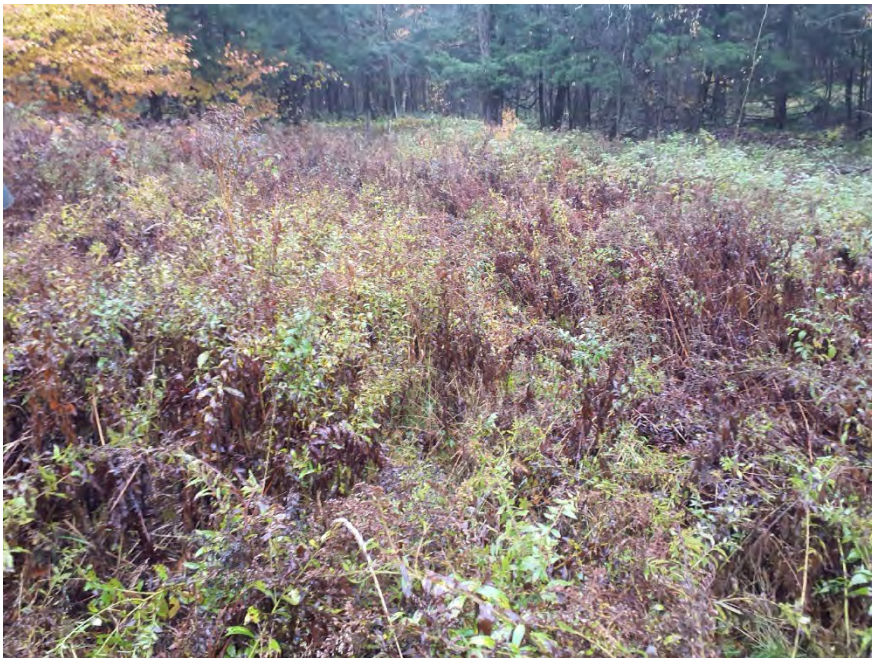
NO. 4 / 10.18.2022

Representative photograph palustrine emergent ("PEM") Wetland 2022-4(III); view is looking west.

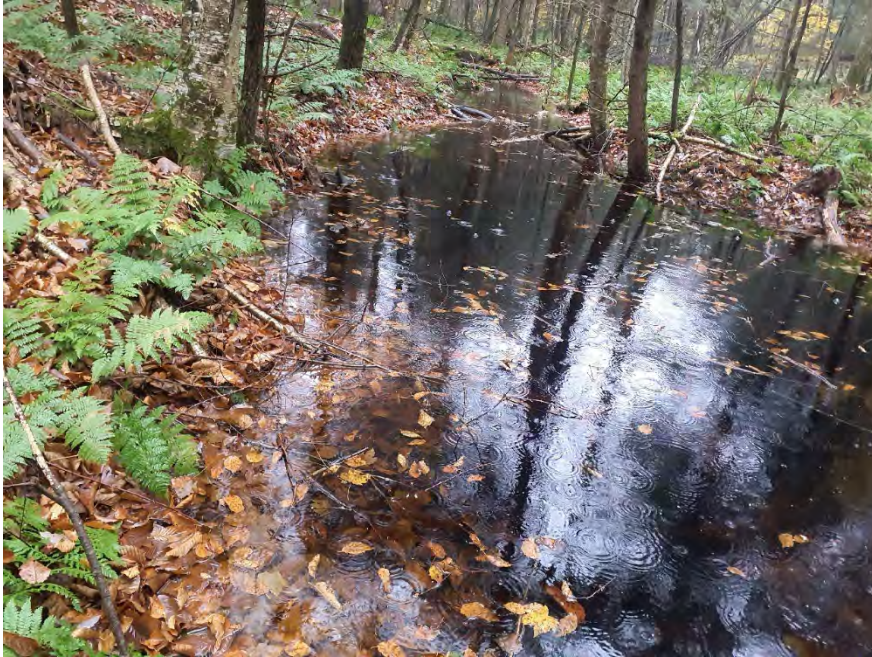
NO. 5 / 11.2.2022

Representative photograph PFO Wetland 2022-5(II); depicting PVP; view is looking north.

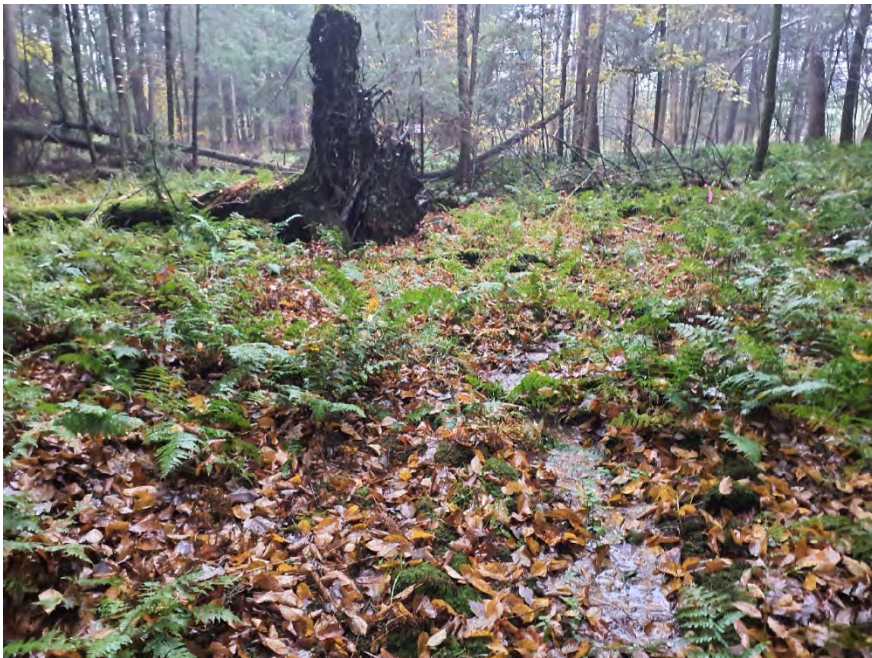
NO. 6 / 10.18.2022

Representative photograph PEM Wetland 2022-6(II); view is looking north to northeast.

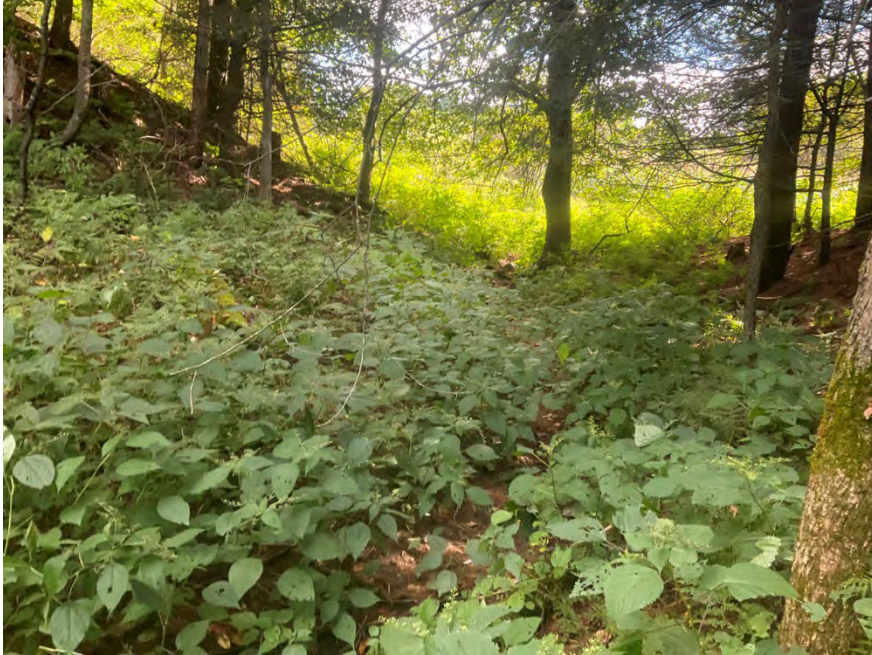
NO. 7 / 10.18.2022

Representative photograph of palustrine emergent ("PEM") Wetland 2022-300(II), view is looking west.

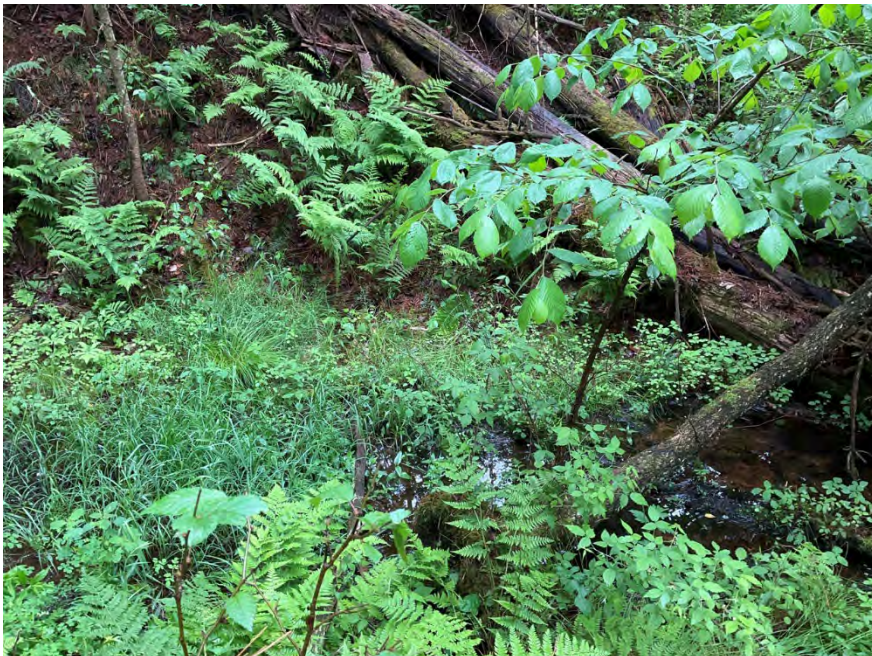
NO. 8 / 6.9.2023

Representative photograph of PFO Wetland 2023-300(II) in southwest corner of Study Area, view is looking south.

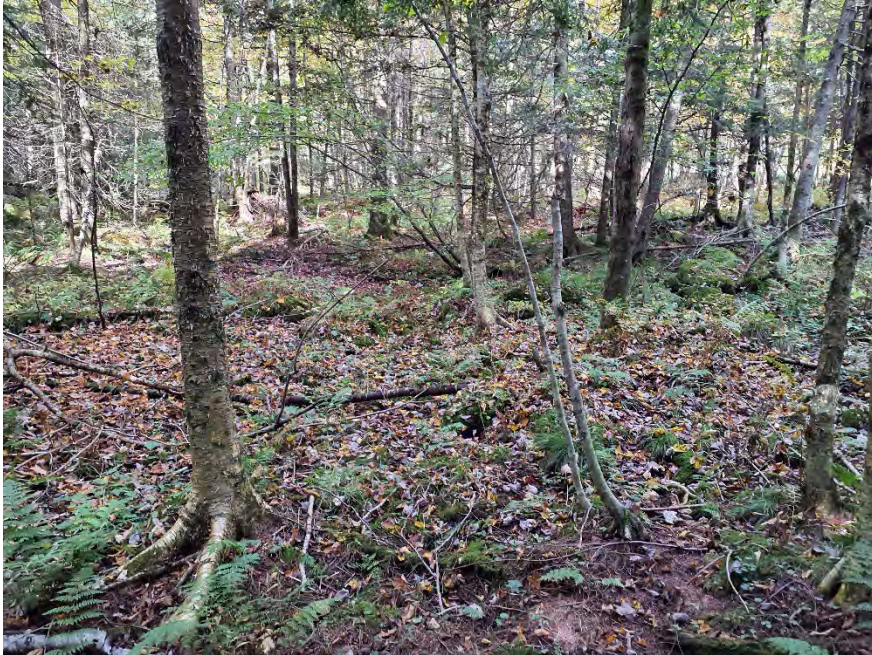
NO. 9 / 6.9.2023

Representative photograph of PFO Wetland 2023-301(II) in northwest corner of Study Area. View is looking north to northwest.

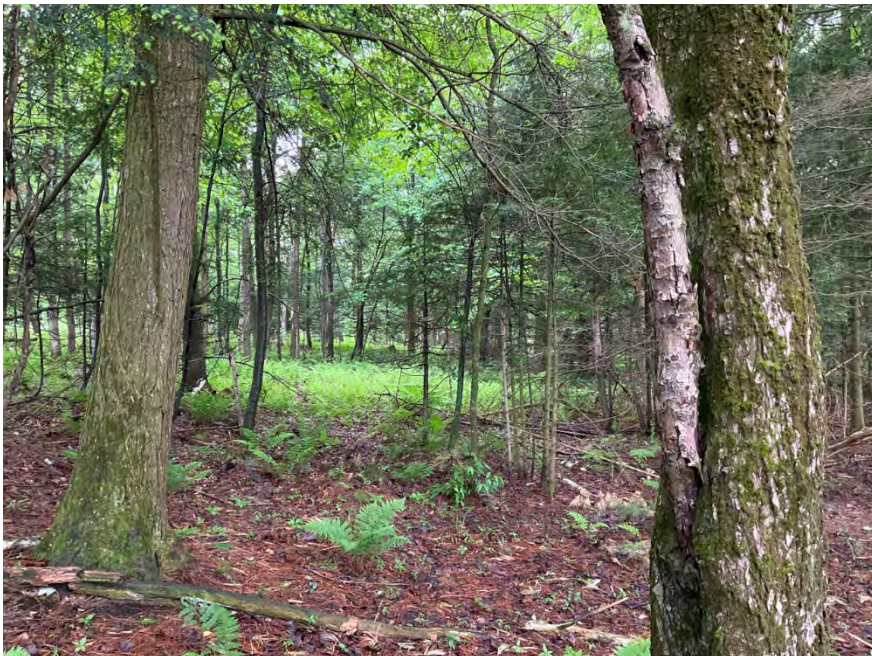
NO. 10 / 6.9.2023

Representative photograph of adjacent upland area east of PFO Wetland 2023-301(II). View is looking south to southwest.

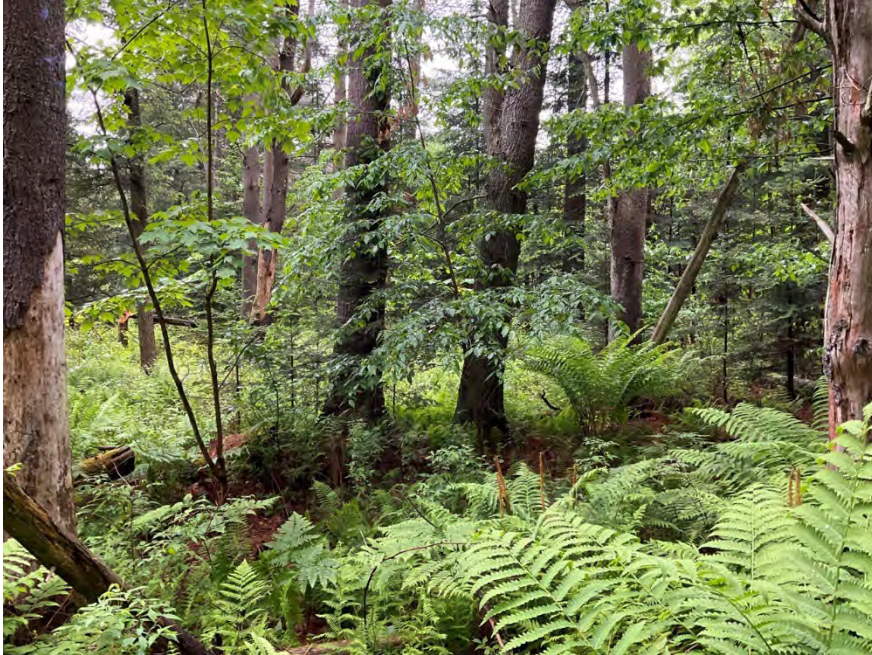
NO. 11 / 6.9.2023

Representative photograph of upland area northeast from PFO Wetland 2023-301(II), view is looking north to northeast.

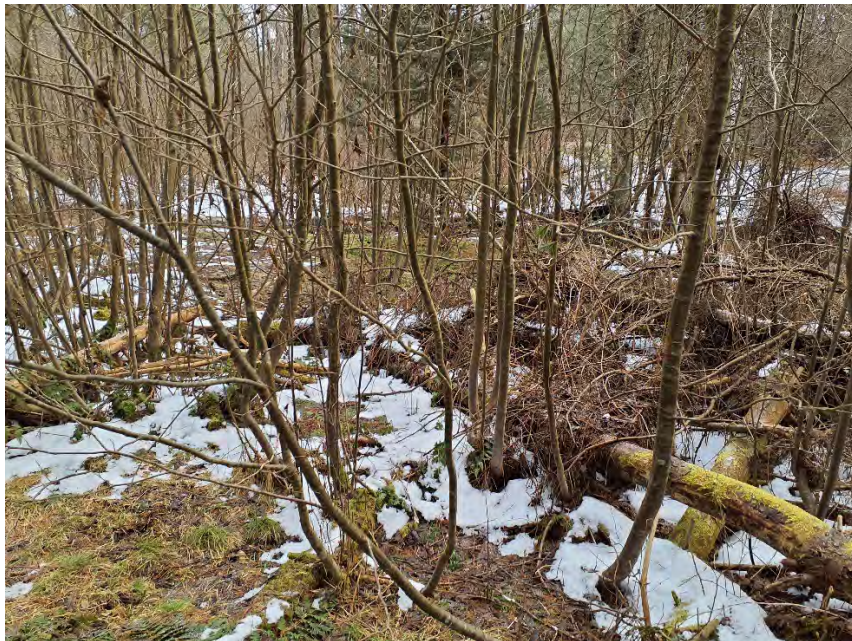
NO. 12 / 2.3.2024

Representative photograph of upland area northeast from PFO Wetland 2024-1(II), view is looking west to southwest.

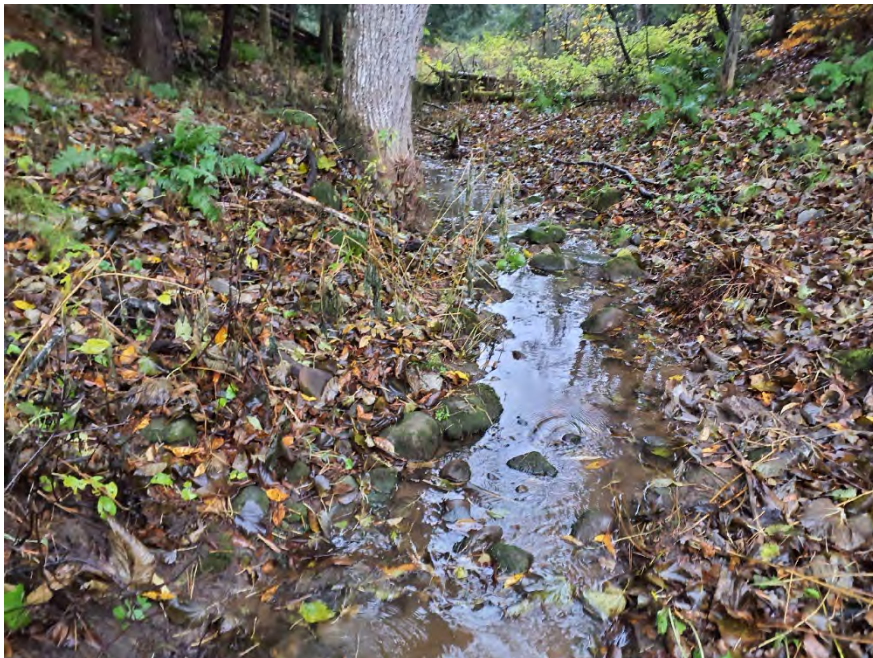
NO. 14 / 10.18.2022

Representative photograph of intermittent stream channel 2022-SC-1; a tributary to Trout Brook, which generally flows north to south, through PEM Wetland 2022-4(III).

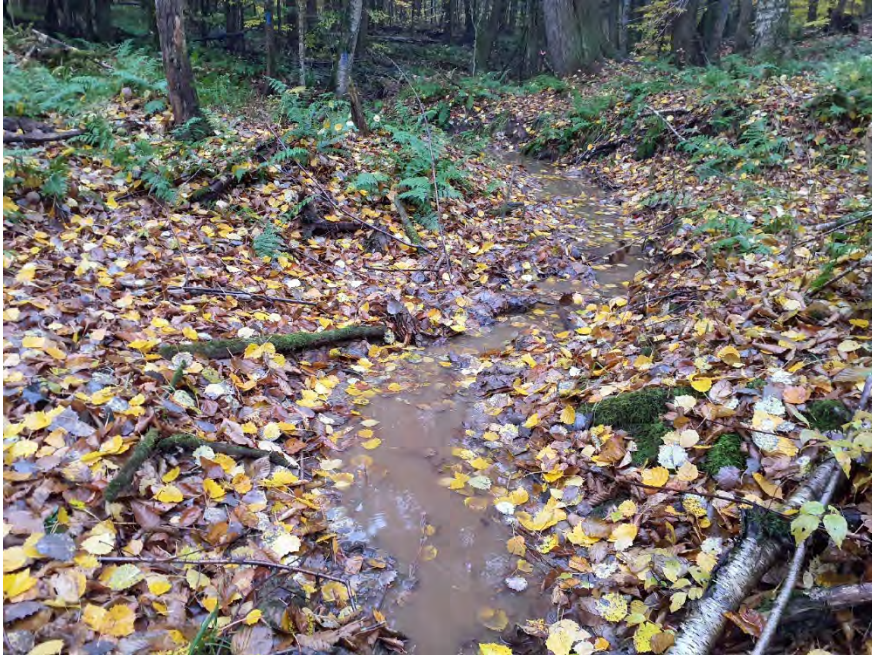
NO. 15 / 10.18.2022

Representative photograph of intermittent stream 2022-SC-2; a tributary to Trout Brook, which flows generally northeast to southwest and outlets into Wetland 2022-2(II). View is looking southwest.

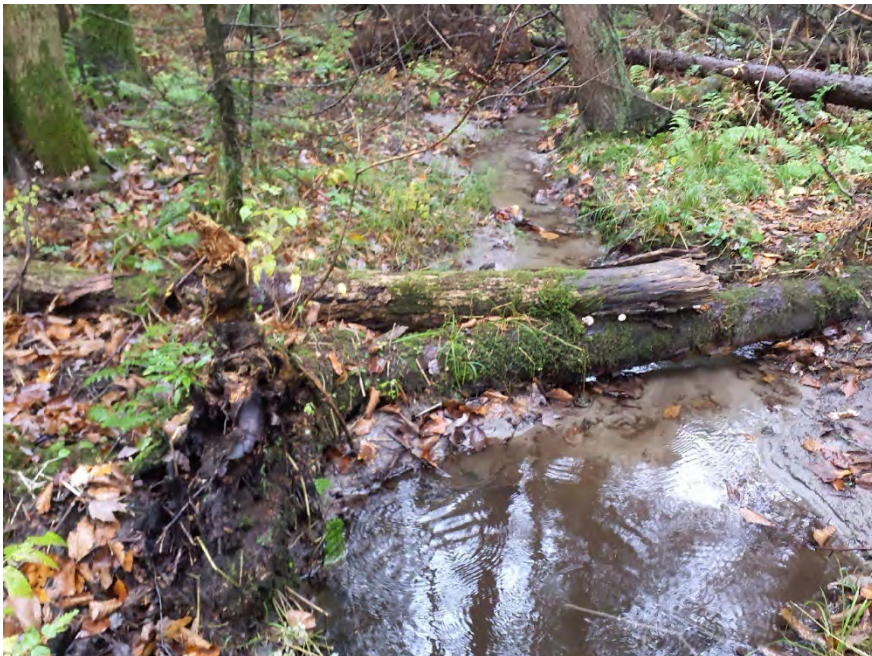
NO. 16 / 10.18.2022

Representative photograph of intermittent stream 2022-SC-3; a tributary to Trout Brook, which flows generally west to east and outlets into Wetland 2022-2(II). View is looking west.

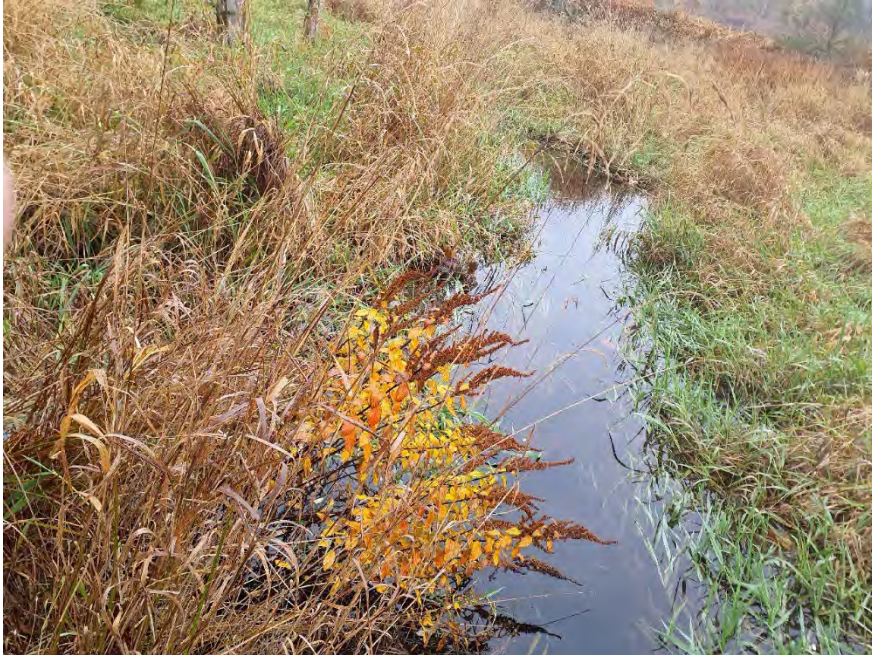
NO. 17 / 10.18.2022

Representative photograph of intermittent stream 2022-SC-4; a tributary to Trout Brook, which flows generally north to south through Wetland 2022-2(II). View is looking south to southwest.

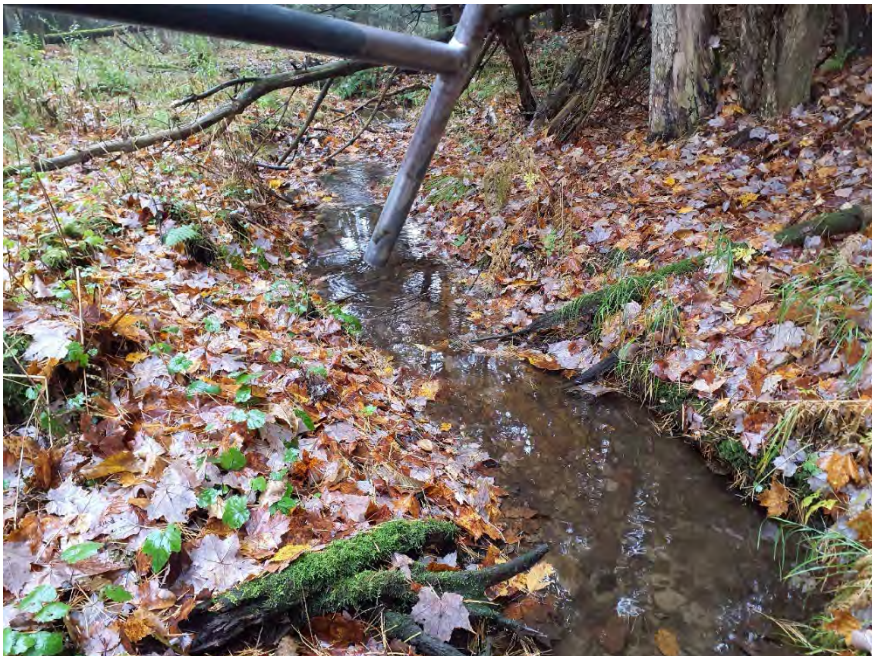
NO. 18 / 10.18.2022

Representative photograph of intermittent stream 2022-SC-5; a tributary to Trout Brook, which flows generally west to east and outlets into Wetland 2022-2(II). View is looking east to southeast.

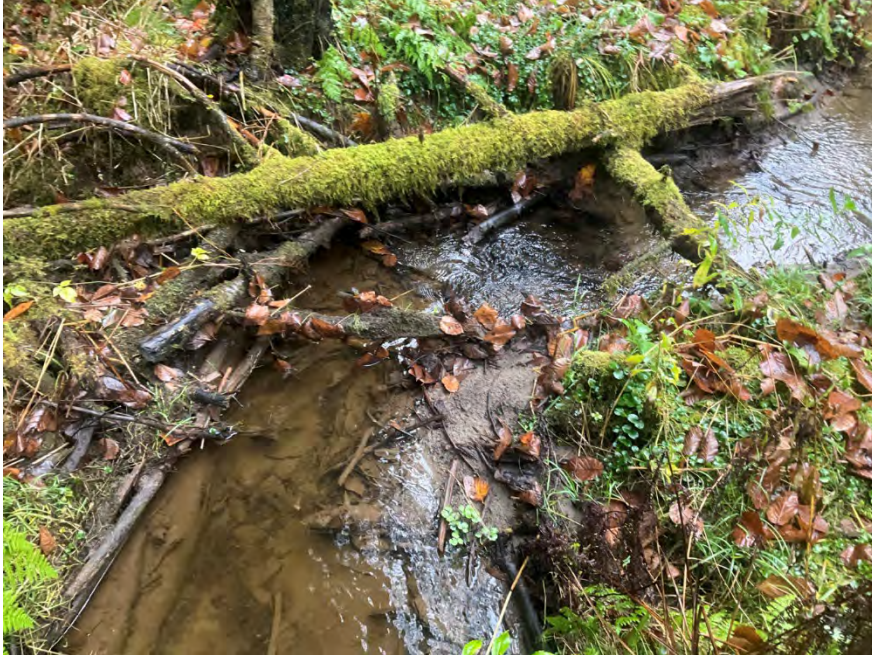
NO. 19 / 10.18.2022

Representative photograph of perennial stream 2022-SC-102; a tributary to Trout Brook, which flows generally northeast to southwest and outlets into Wetland 2022-2(II). View is looking southwest.

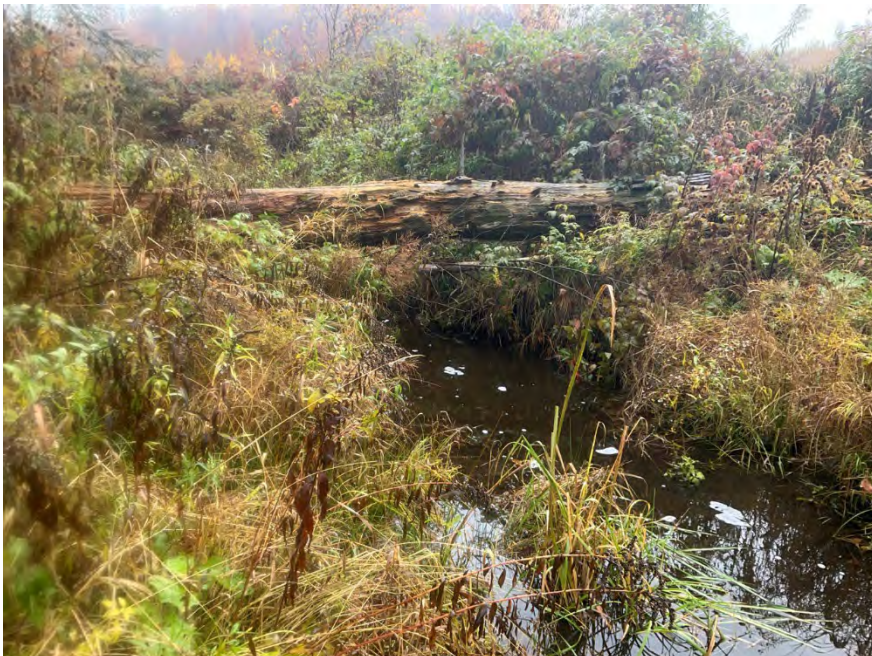
NO. 20 / 10.18.2022

Representative photograph of perennial stream 2022-SC-103; a tributary to Trout Brook, which flows generally west to east and outlets into Wetland 2022-2(II). View is looking east to southeast.

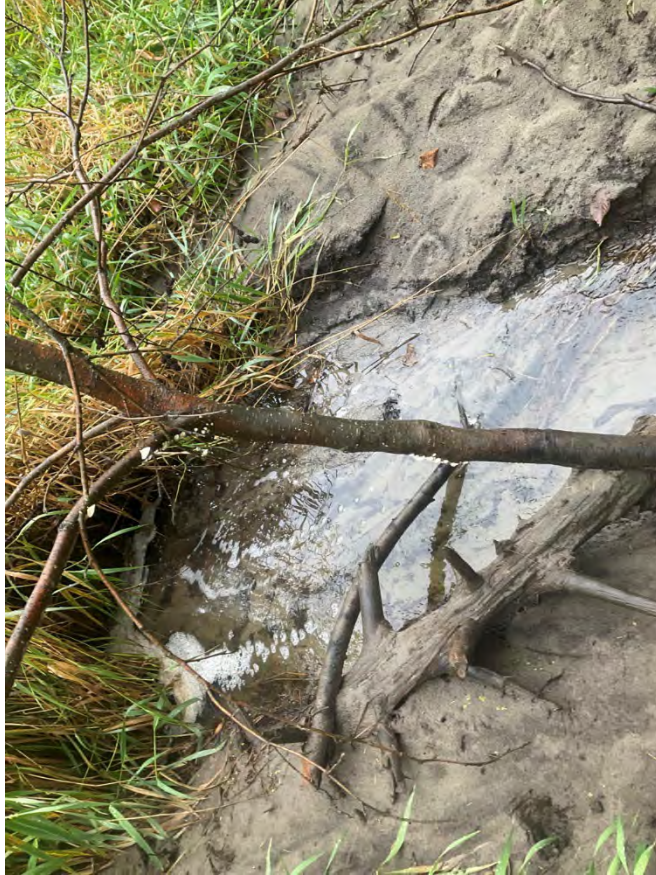
NO. 21 / 10.18.2022

Representative photograph of perennial stream 2022-SC-105; a tributary to Trout Brook, which flows generally north to south. View is looking south.

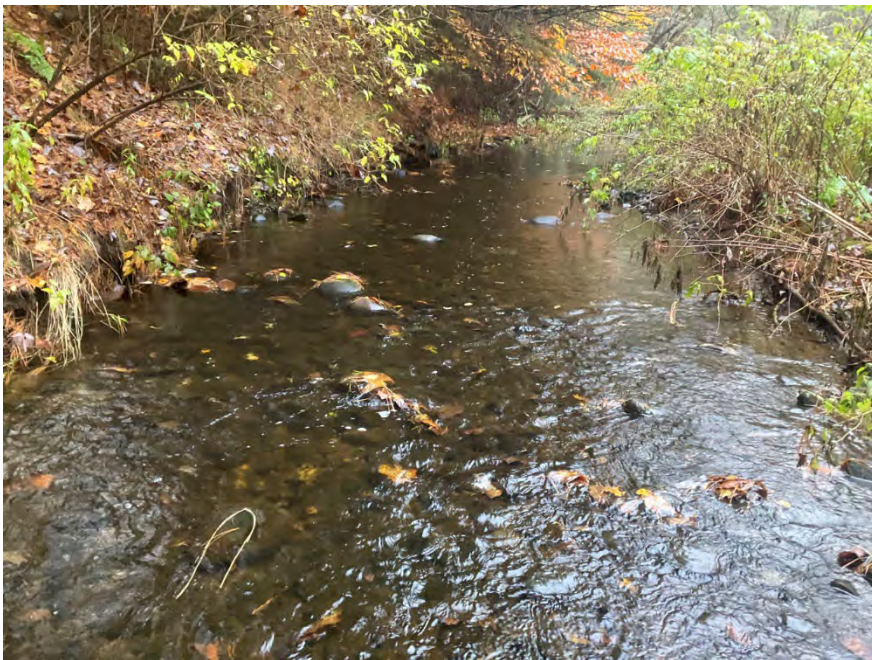
NO. 22 / 10.18.2022

Representative photograph of perennial stream 2022-TOB-100; a tributary to Trout Brook, associated with PFO Wetlands 2022-1(III) and 2022-3(II).

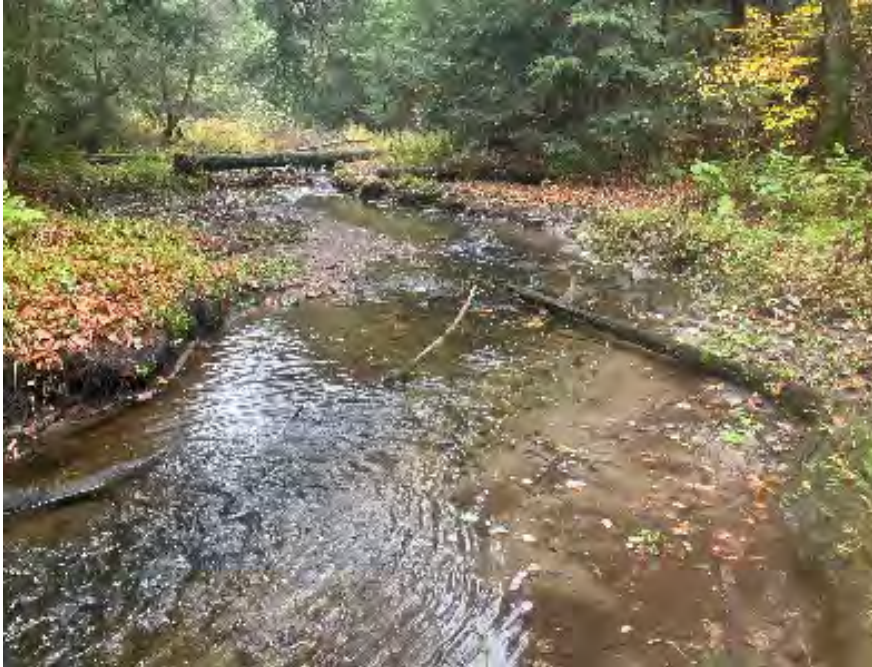
NO. 23 / 10.18.2022

Representative photograph of perennial stream 2022-TOB/OHW-101; a tributary to Trout Brook, which flows generally north to south through Wetland 2022-2(II) and outlets into the Enosburg Falls Reservoir. View is looking north.

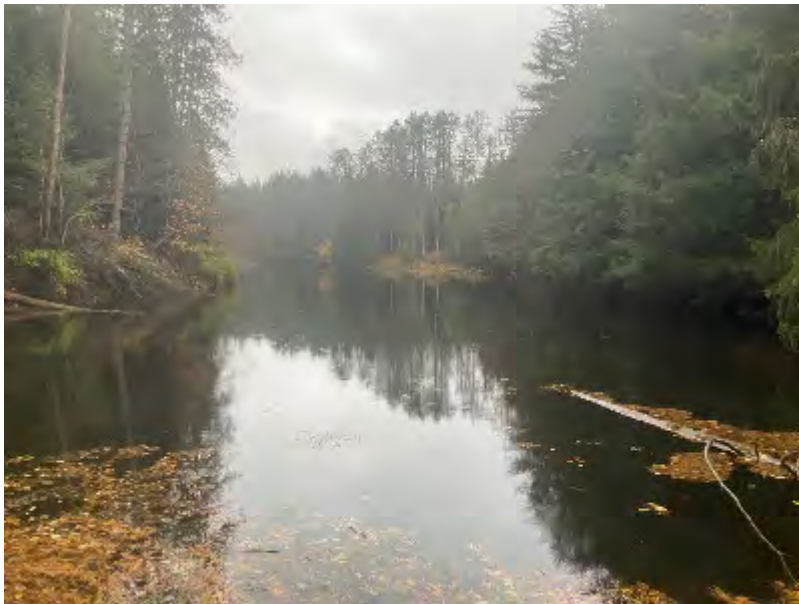
NO. 24 / 10.18.2022

Representative photograph of Enosburg Falls Reservoir (2022-TOB/OHW-R) from the southern edge, view is looking northwest.

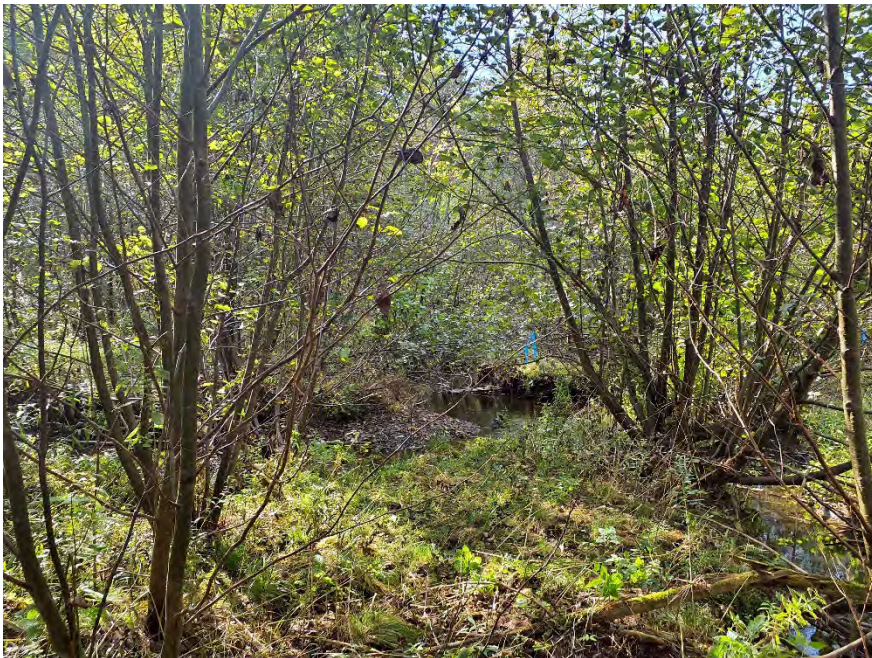
NO. 26 / 10.3.2023

Representative photograph of perennial stream 2023-TOB-300; a tributary to Trout Brook, associated with PFO Wetland 2023-300(II). View is looking south to southeast.

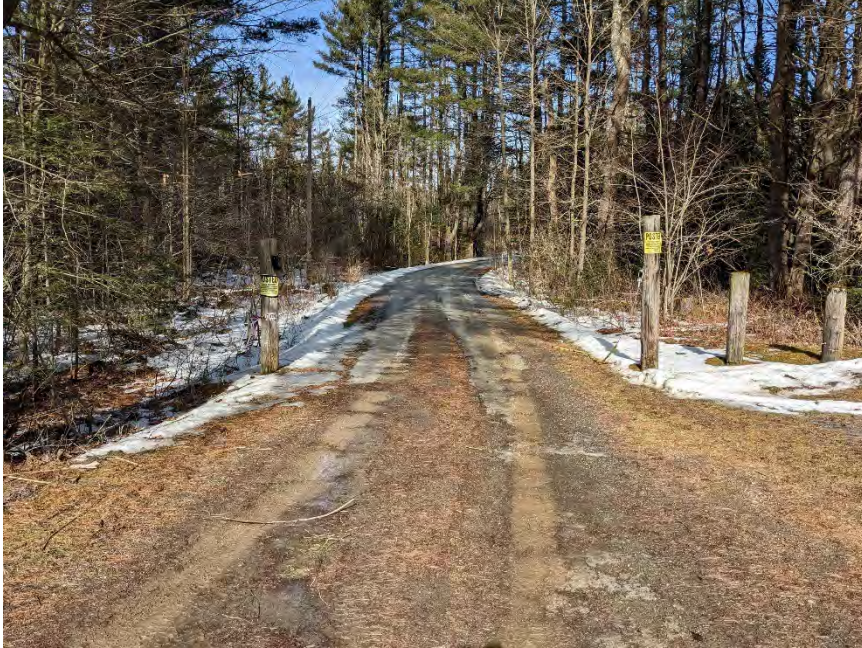
NO. 27 / 2.21.2023

Representative photograph of access road from Reservoir Road, view is looking north.

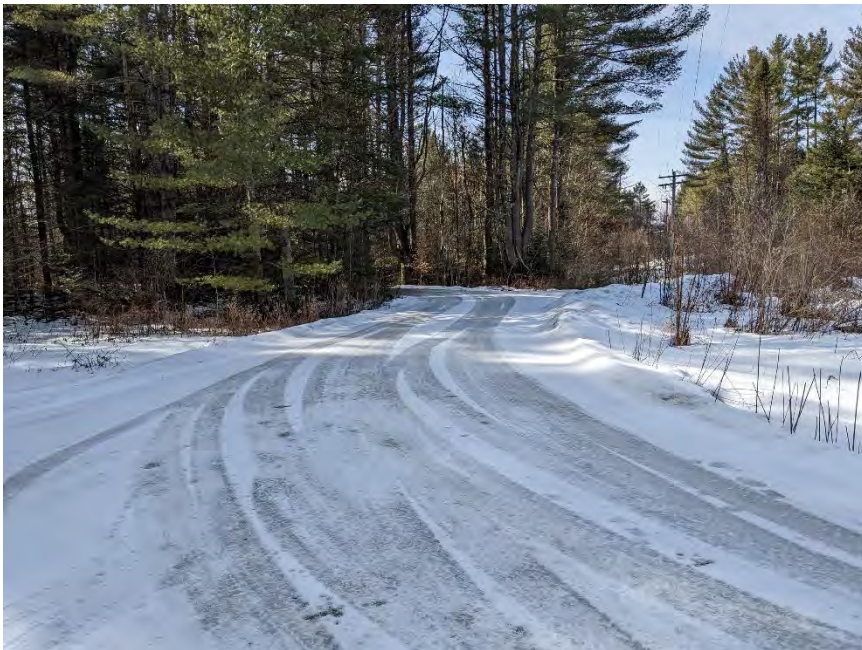
NO. 28 / 2.21.2023

Representative photograph of access road, looking southwest from Enosburg Falls Reservoir.

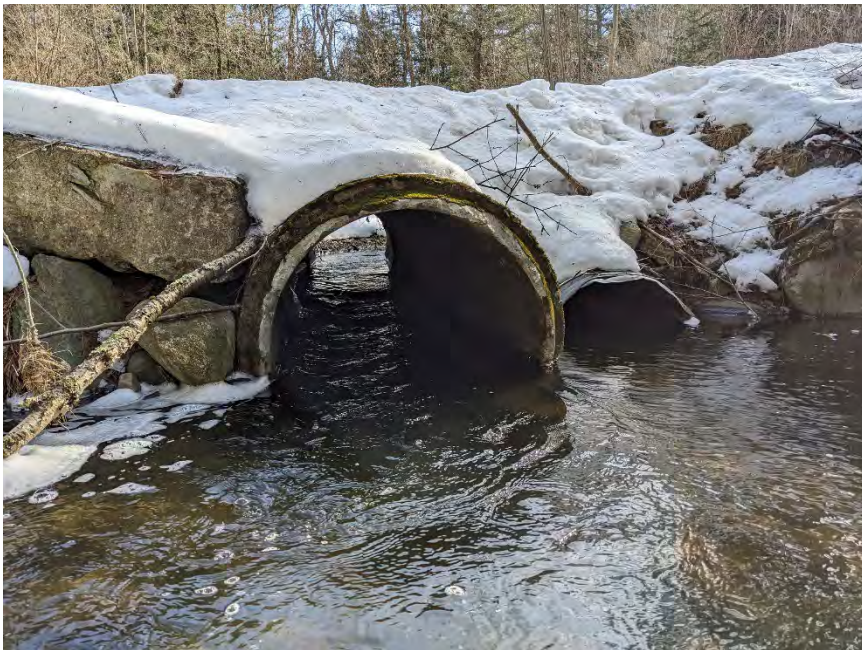
NO. 30 / 2.21.2023

Representative photograph of culvert under access road; view is looking east to southeast, downstream.

- Replacing two existing culverts (24-inch reinforced concrete pipe and 38-inch corrugated metal pipe) at the crossing of Trout Brook with a 15-foot x 6.5-foot aluminum box culvert and associated road reconstruction within the existing footprint;

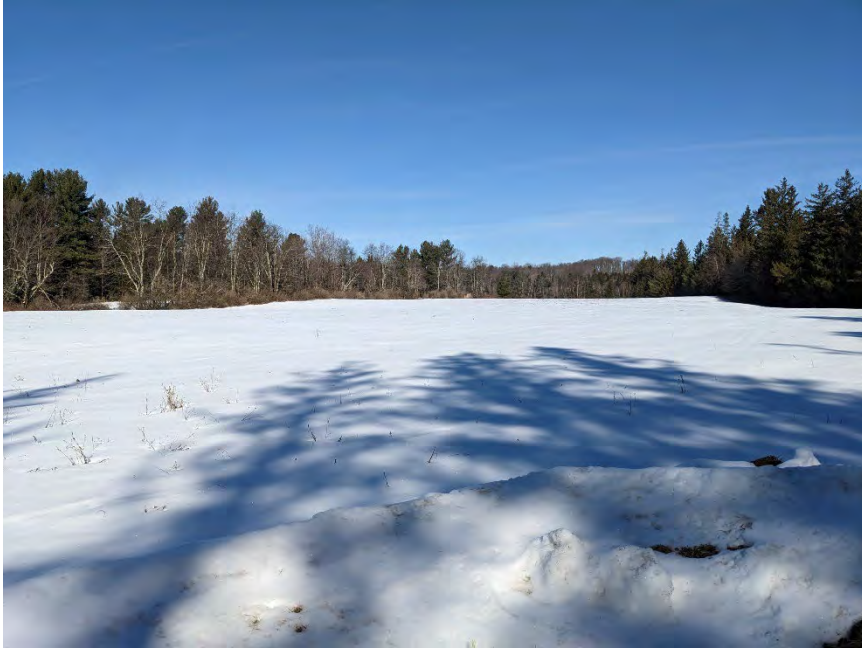
NO. 31 / 2.21.2023

Representative photograph of southern portion of Study Area, looking north across proposed array area.

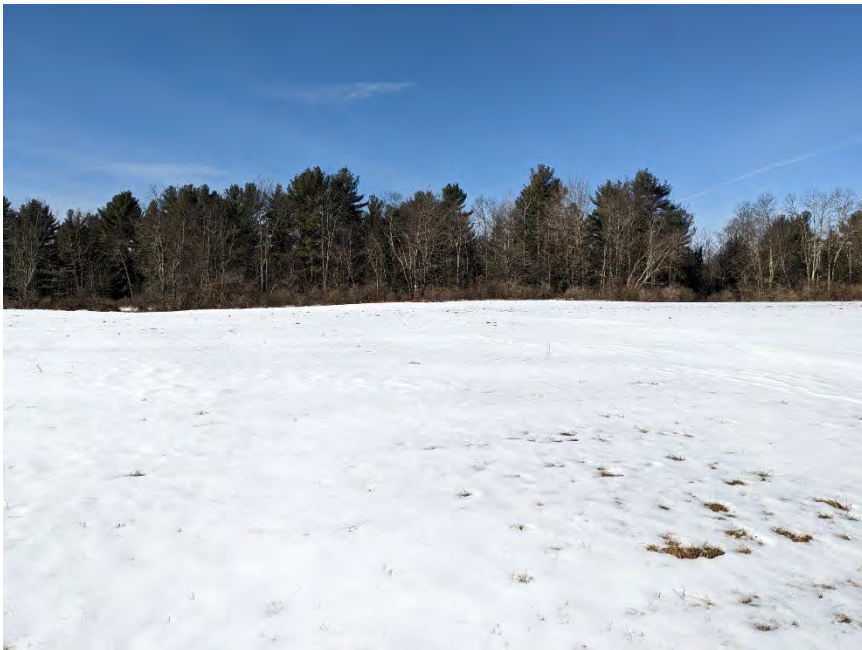
NO. 32 / 2.21.2023

Representative photograph of east-central portion of Study Area, looking west in proposed array area.

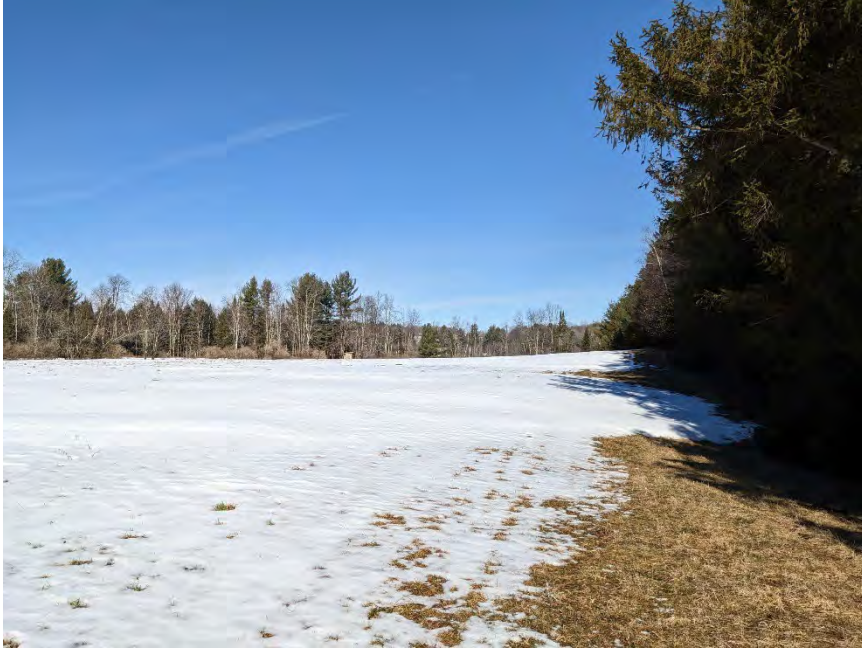
NO. 33 / 2.21.2023

Representative photograph of east-central portion of Study Area, looking north to northwest in proposed array area.

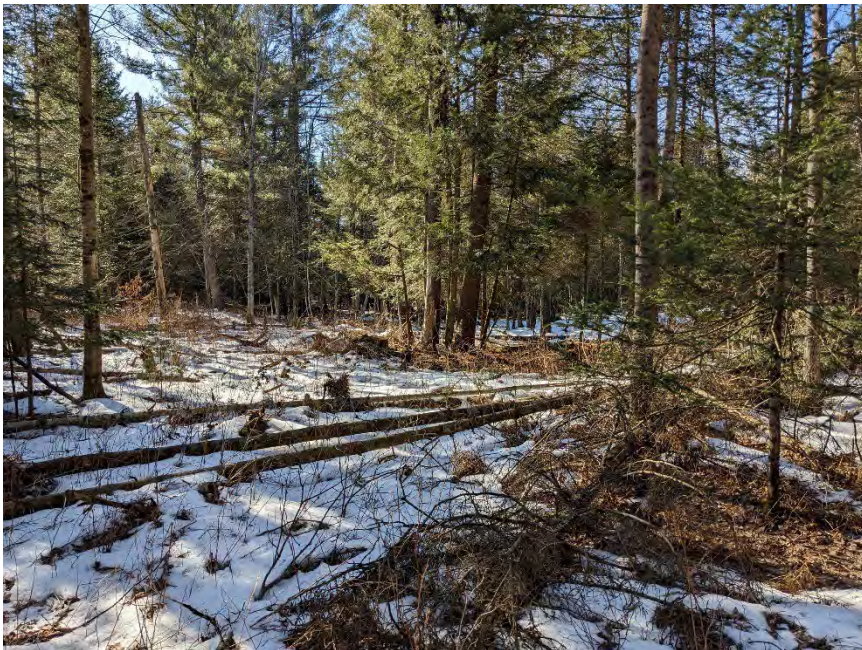
NO. 34 / 2.21.2023

Representative photograph of western forested portion of Study Area.

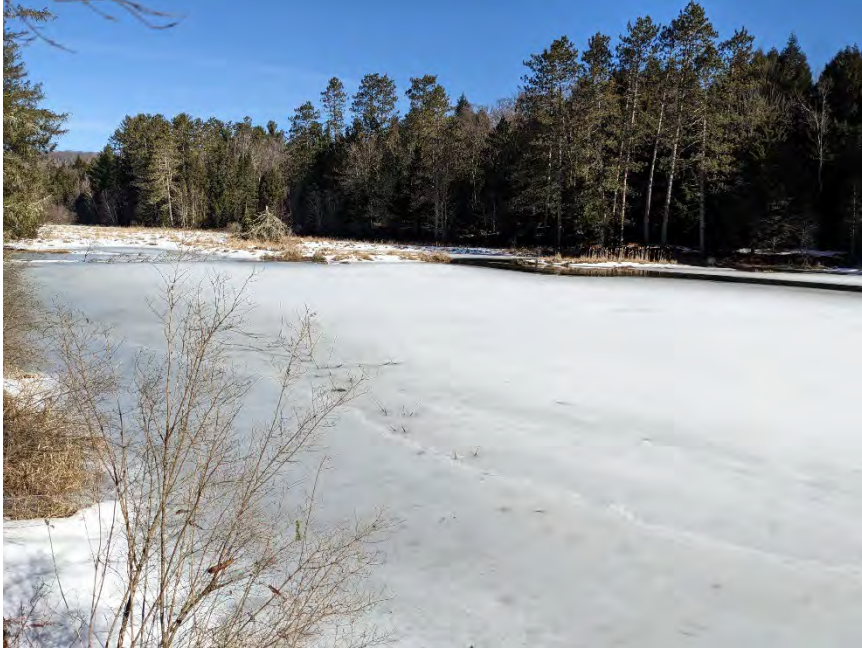
NO. 35 / 2.21.2023

Representative photograph of the northern portion of Enosburg Falls Reservoir, within the eastern portion of Study Area.

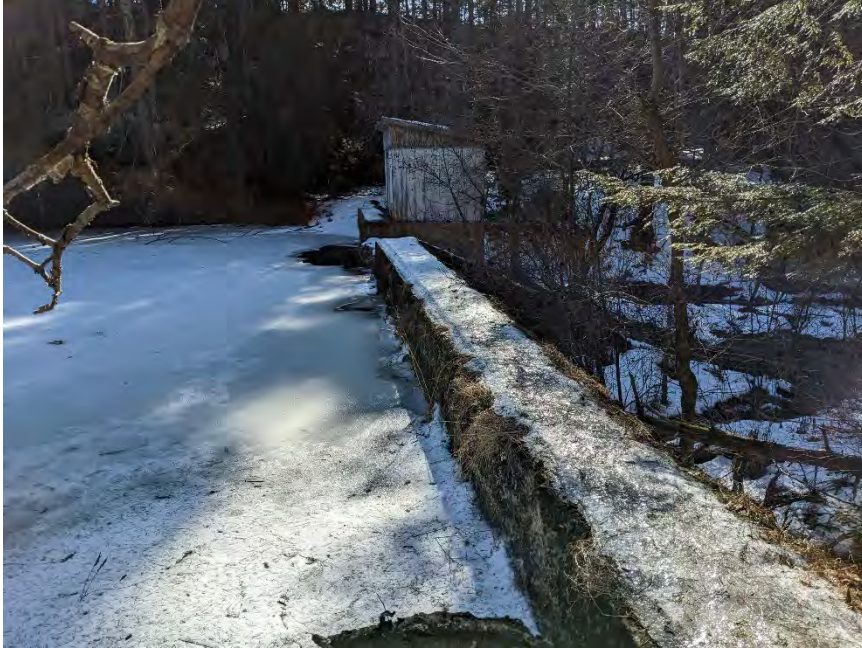
NO. 37 / 2.21.2023

Representative photograph of Enosburg Falls Reservoir dam.

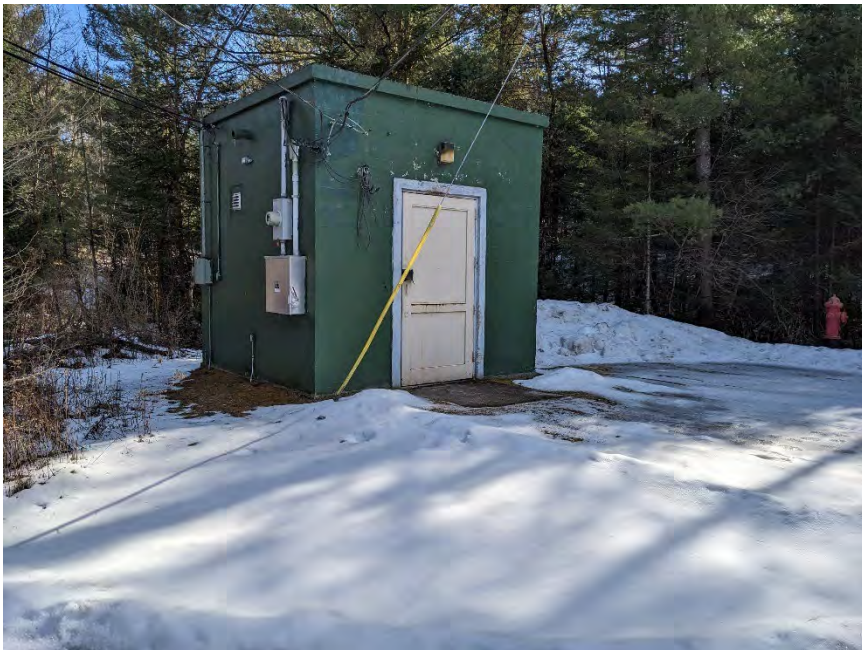
NO. 38 / 2.21.2023

Representative photograph of Well pumphouse exterior, southwest of Enosburg Falls Reservoir.
