## Memorandum

From: Britta Tonn and Kaitlin O'Shea, Preservation Planners    Re: ER Dunsmore Solar Historic Resources Assessment

ER Dunsmore Solar | St. Albans, Vermont

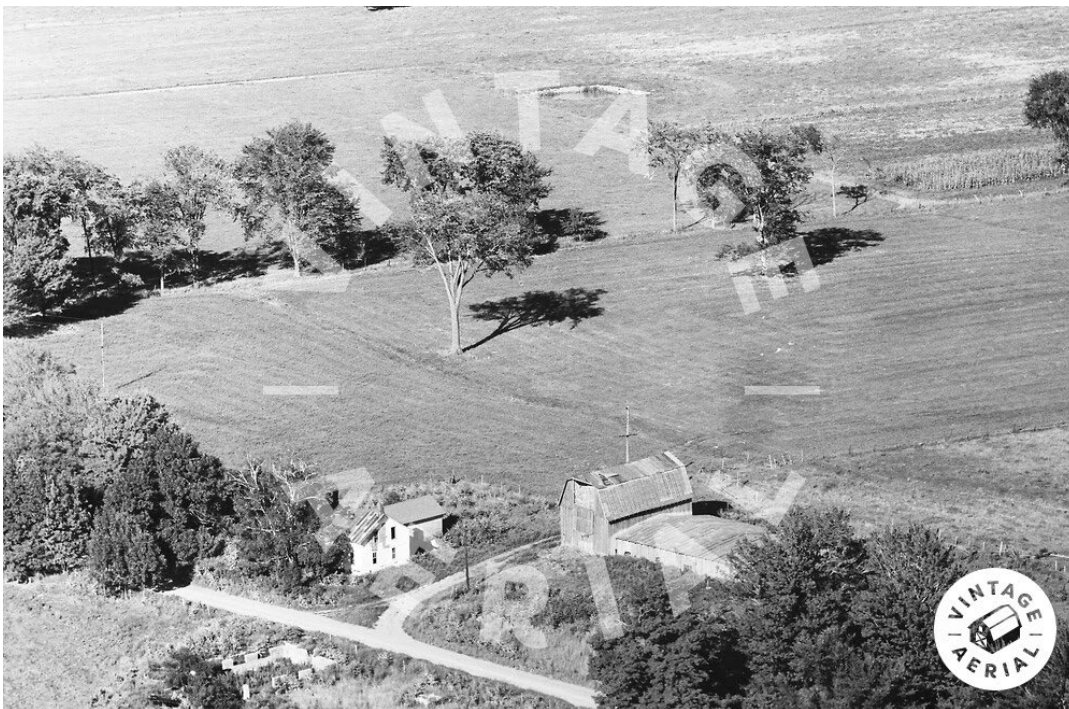
**Figure 1:** 2296 Dunsmore Road, 1966 aerial photograph. Note the former gambrel roof barn attached to the existing barn, since removed. Source: Vintage Aerial, <https://vintageaerial.com/photos/vermont/franklin/1966/QFR/22/11>.

2296 Dunsmore Road is a 1.5 story, gable roof, eaves front, wood-frame, 4x2 bay house with a 1.5 story gable roof and wood-frame rear ell. Details include overhanging eaves, cornerboards, wood siding, one remaining kneewall window on the façade which is a non-historic single-light fixed wood window, exterior end chimney, and stone foundation. Windows throughout are replacement 6/6 vinyl sash, and the primary entrance is a vertical wood plank door with decorative iron strapping. A secondary entrance with a projecting gable roof portico constructed of heavy timbers, added sometime after 2012, has been added to the southern elevation of the ell, along with a non-historic bay window. A large, 1-story, shallow gable roof barn with sliding paired doors and wood board and batten siding sits to the southeast of the house. The date of construction of this barn is unknown, although based on a historic aerial photograph, it was built sometime before 1962 as an addition to an older, gambrel roof barn that has since been removed (see Figure 1).

This small, vernacular Greek Revival house was built prior to 1857 (ca. 1850). The existing barn is the shallow gable roof addition to an older, gambrel roof barn that was removed sometime after 1966. On the 1857 Walling Map and 1871 Beers Map, the house was occupied by members of the Skinner family, who also occupied the property slightly north at 2551 Dunsmore Road. In the mid- to late-19<sup>th</sup> century, the area was sparsely populated presumably with farms, with several families owning more than one property along Dunsmore and Lower Newton Roads. The rural and agricultural nature of the area persisted into the 1970s, when some of the large farms were subdivided to support increased residential development.

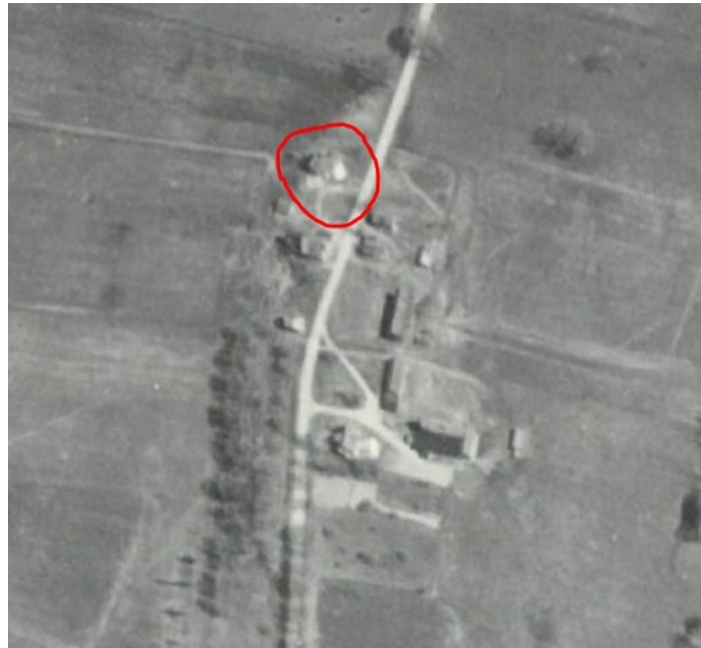
**Figure 2:** 1962 aerial photograph with 2789 Dunsmore Road circled in red. Note that the two barns across the street have not yet been built. Source: VCGI

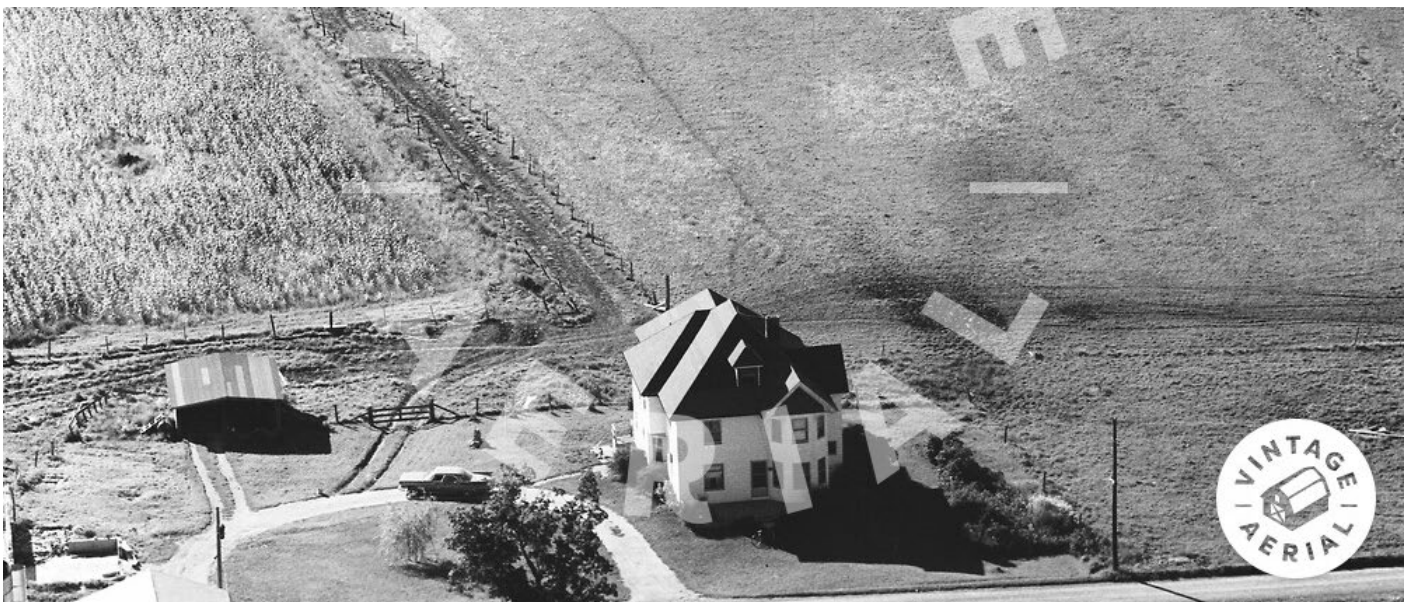
**Figure 3:** 2789 Dunsmore Road, 1966 aerial photograph. Note the lack of a front porch on the house. Source: Vintage Aerial <https://vintageaerial.com/photos/vermont/franklin/1966/QFR/22/5>.

Alterations to the 1927 house include changes in materials (siding and windows), addition of the front porch after 1966 (see Figure 3), and subsequent replacement of the Tuscan columns with the current pressure treated lumber. While some character defining features of a Colonial Revival style house remain (such as the Colonial Revival/Queen Anne style windows) and the clipped window hood, other details have been lost due to alterations. The current front door cannot be identified through the storm door, although 2012 Google Street View shows an incompatible fiberglass replacement door. These alterations have resulted in a loss of integrity of design, materials, workmanship, and feeling.

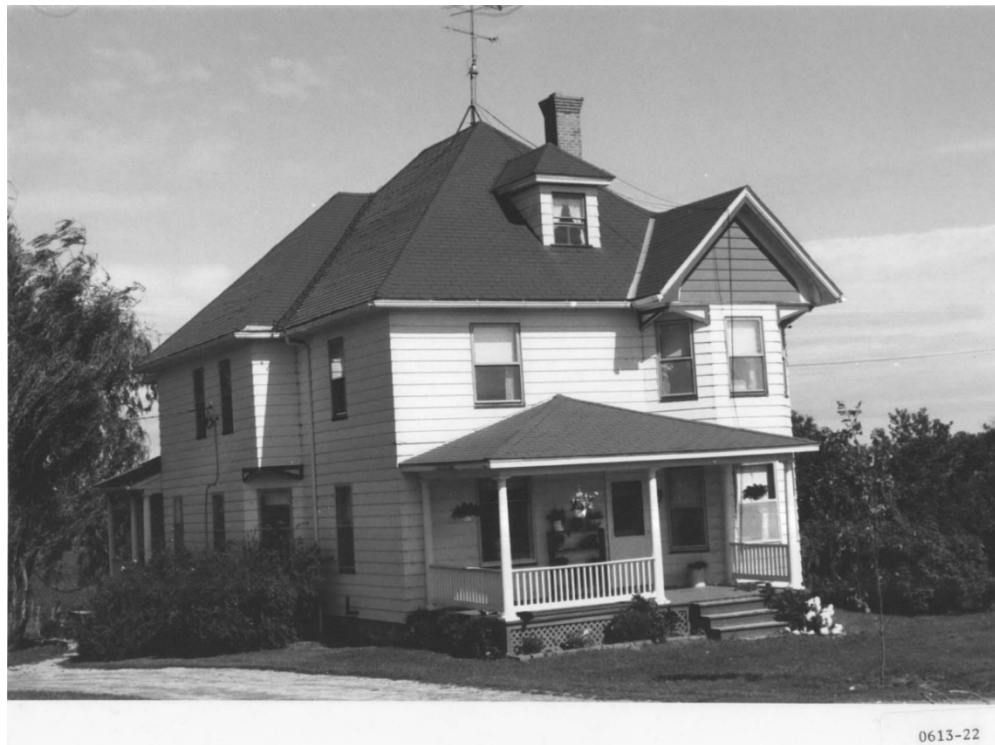
**Figure 5:** 2789 Dunsmore Road in 1985 from the VHSSS form. Note the porch with Tuscan columns that was built sometime after 1966; the porch posts have been replaced.

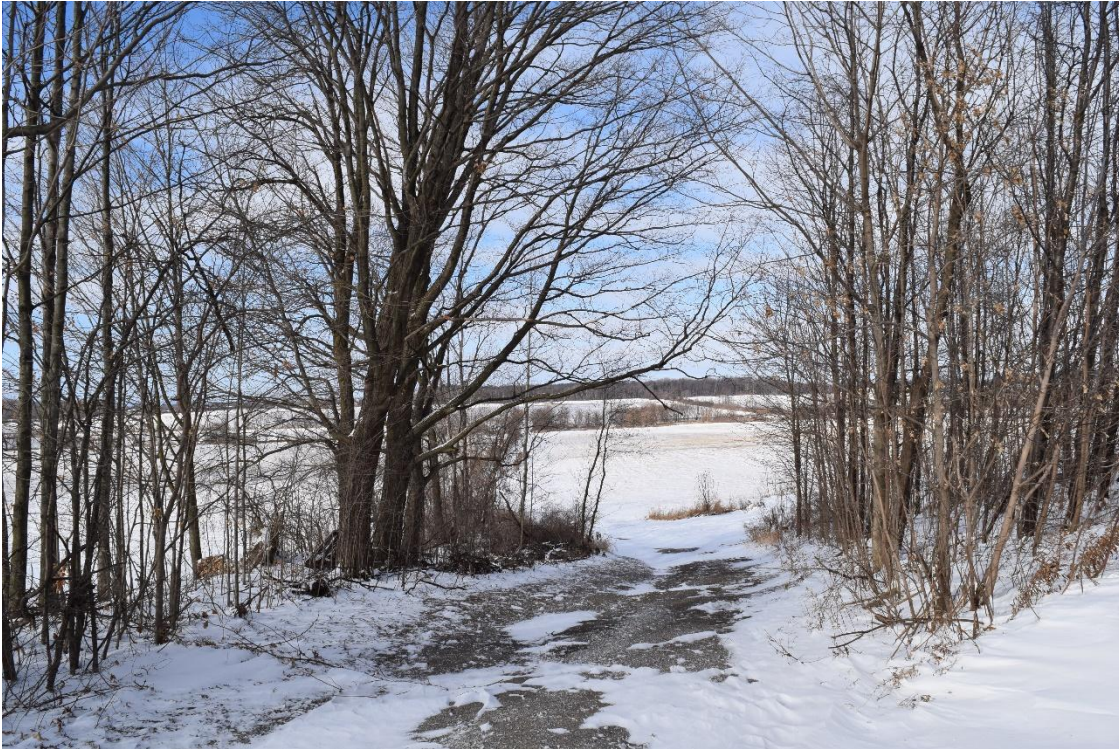
**Photograph 1:** Access road viewed from Dunsmore Road, looking east. The Project will occupy the back field in the center of the photograph.

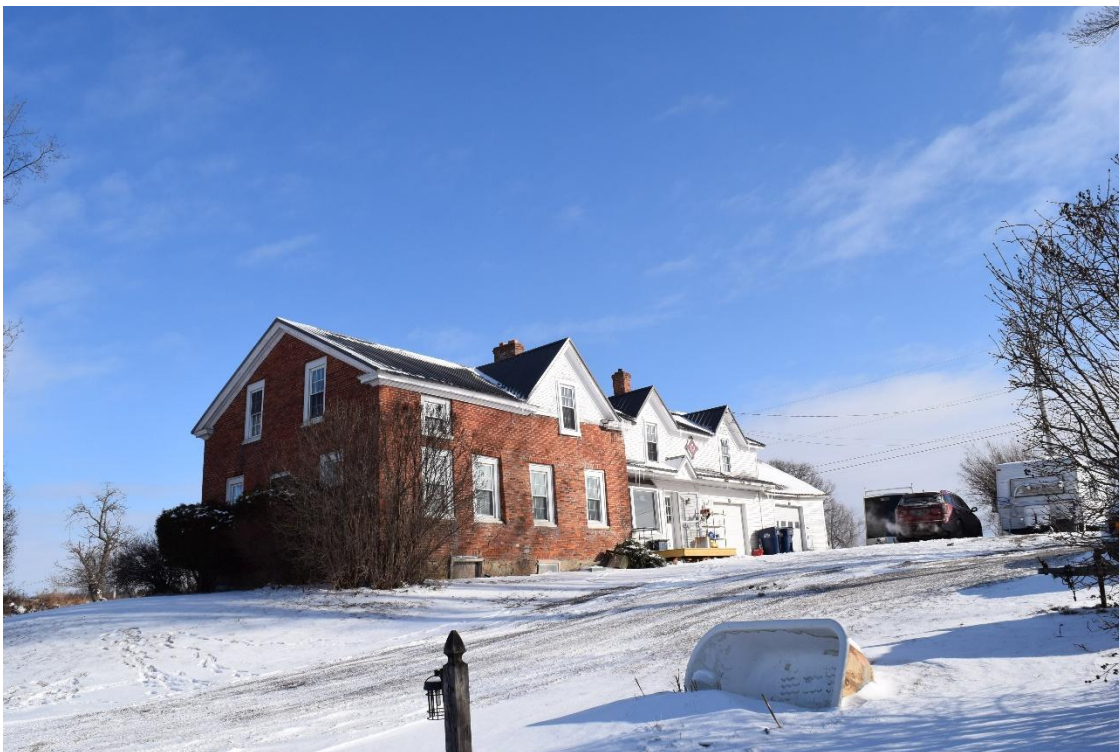
**Photograph 2:** 2162 Dunsmore Road, listed in the State Register (0613-5). Looking northeast.

At its nearest point, 2162 Dunsmore Road is approximately 0.75 miles southeast of the proposed array and is separated from the Project by a treeline on Dunsmore Road and several deciduous hedgerows delineating several agricultural fields. The Project may be slightly visible from the main house during leaf-off conditions, but at a substantial distance which would render it a very minor alteration to the property's setting. Due to its location on the east side of Dunsmore Road, the property and the Project will not be visible within the same field of view when seen from Dunsmore Road. Based on the above facts, the Project will not adversely impact the agricultural setting and character-defining features of the property that render it State Register eligible, as described in the VHSS form.

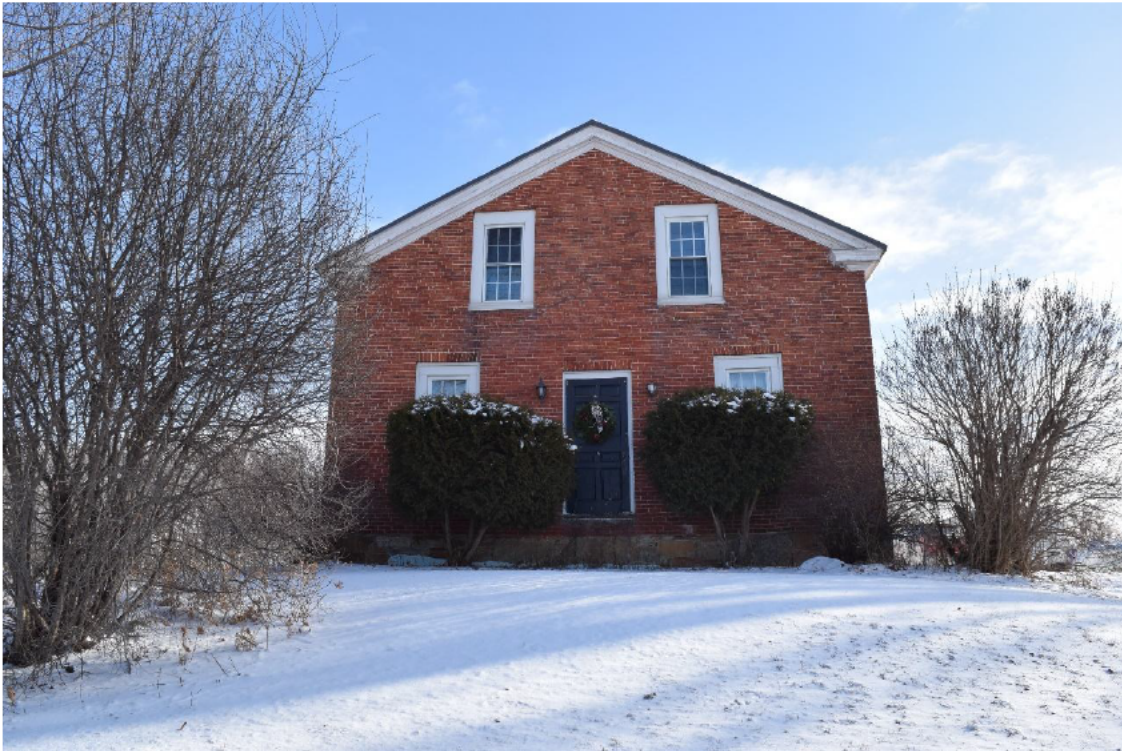
**Photograph 3:** 2162 Dunsmore Road, listed in the State Register (0613-5). Looking east.

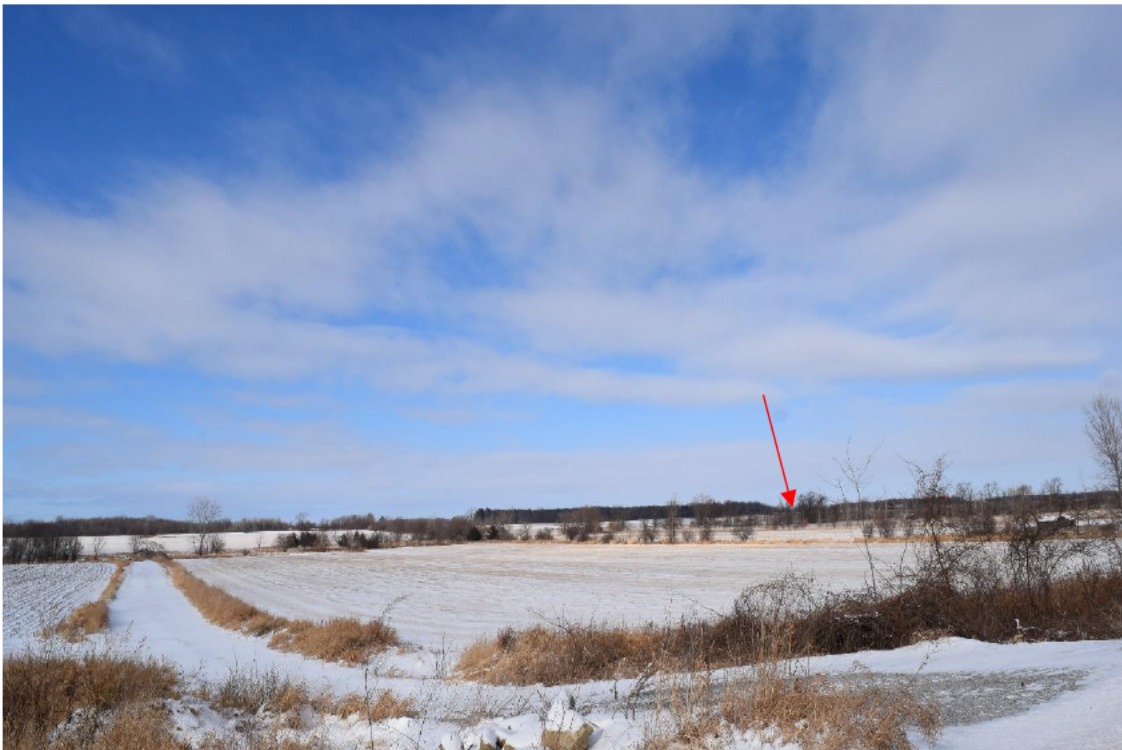
**Photograph 4:** Looking northeast from 2162 Dunsmore Road toward the Project, approximate location indicated by the red arrow.

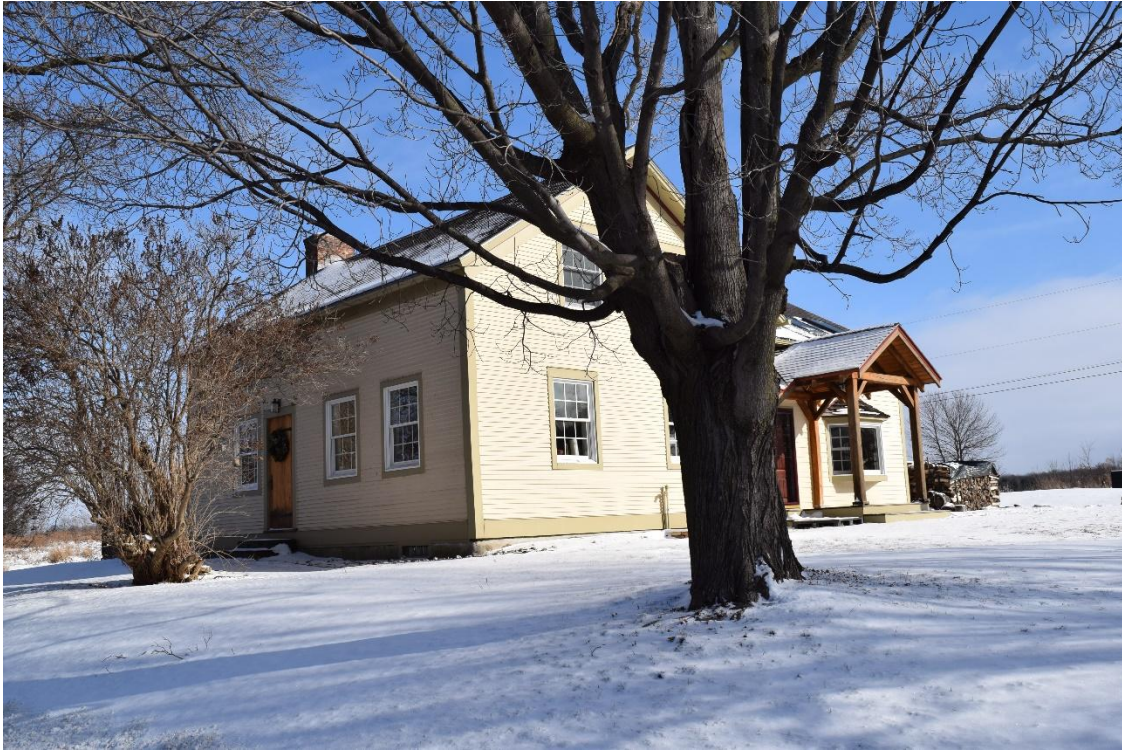
**Photograph 5:** 2296 Dunsmore Road, looking northeast.

2296 Dunsmore Road is an example of a farmhouse that was built during the first wave of 19<sup>th</sup> century agricultural development on Dunsmore Road. Its Greek Revival design is slightly visible with the presence of one kneewall window on the façade and the eaves-front form evoking a Classic Cape typology. However, numerous alterations have resulted in a loss of integrity of the house's character-defining features. Alterations include possible removal of kneewall windows on the façade; replacement of the one kneewall window with a single-light fixed wood window; vinyl replacement windows; alterations to the roofline; replacement wood trim; and a large, incompatible, heavy timber frame portico sheltering the secondary entrance on the south elevation of the ell (it was added sometime after 2012). These alterations have resulted in a loss of integrity of design, materials, workmanship, and feeling. The gambrel roof main barn has been removed, leaving only the one-story large, shed addition; as a result, the property's association with 19<sup>th</sup> century and early 20<sup>th</sup> century agriculture has been erased. Due to a loss of integrity resulting in the property's inability to convey its feeling and association as a mid-19<sup>th</sup> century Greek Revival house and farmstead, the property is recommended ineligible for listing in the State Register.

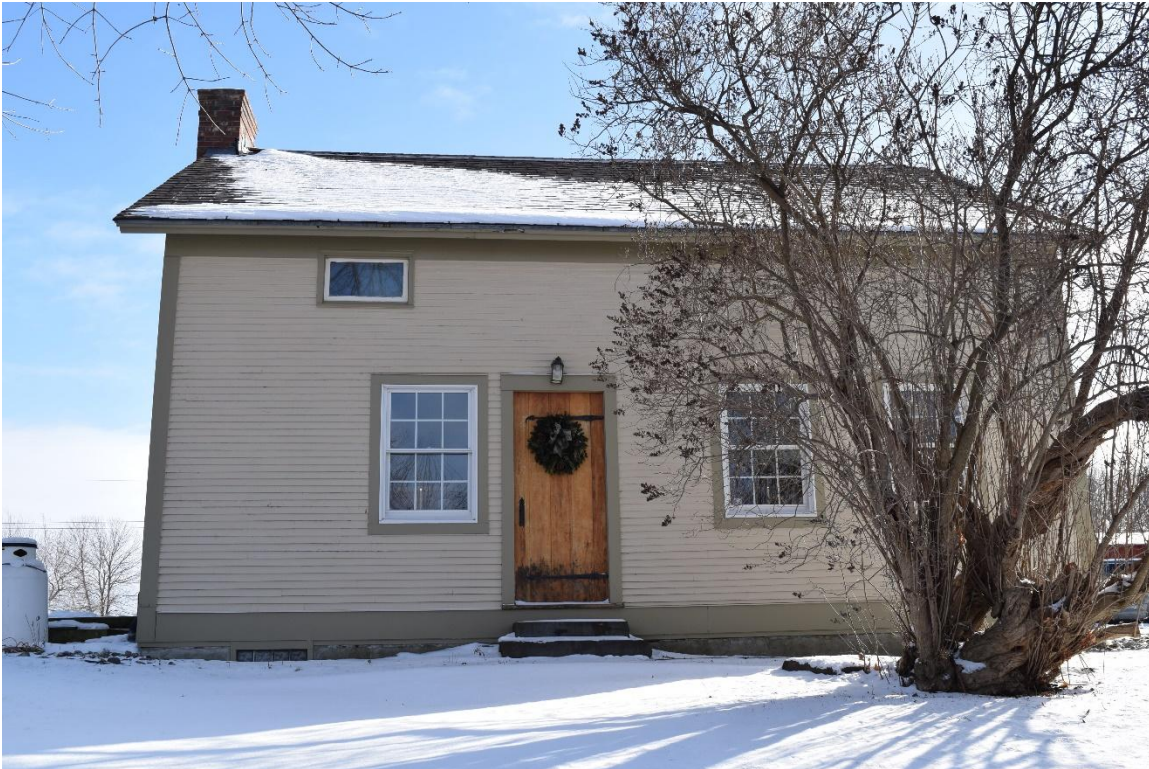
**Photograph 6:** 2296 Dunsmore Road, looking east.

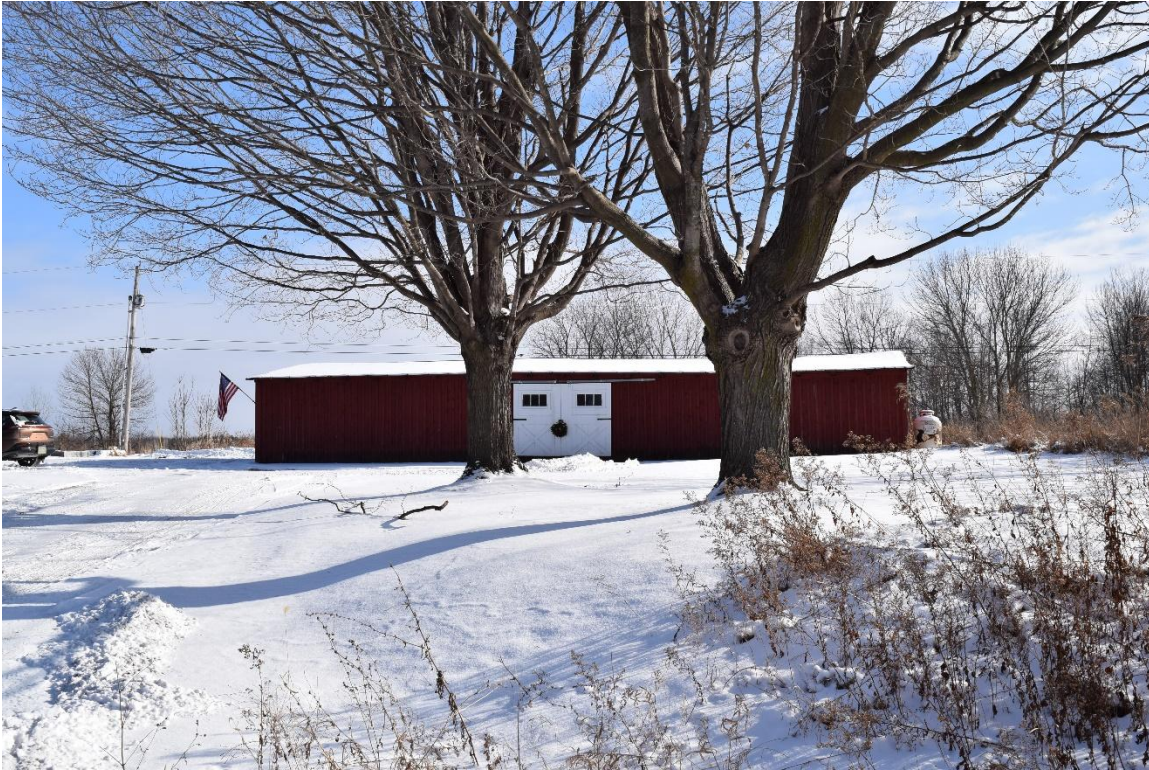
**Photograph 7:** Barn at 2296 Dunsmore Road, looking east.

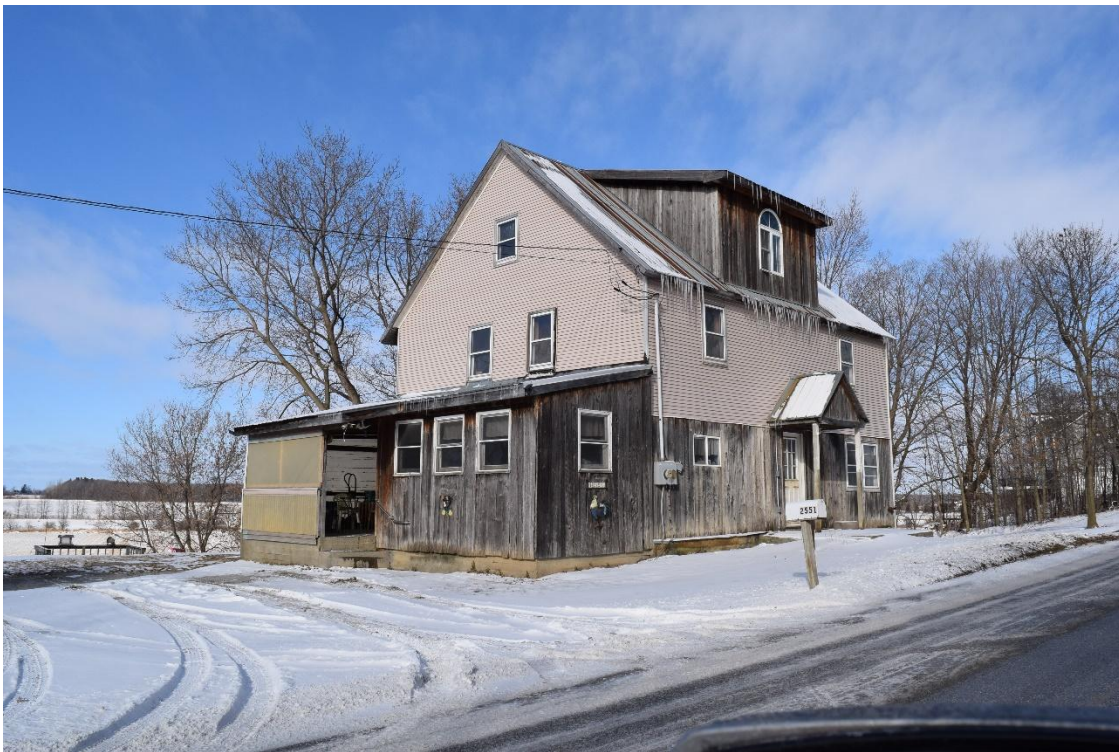
**Photograph 8:** 2551 Dunsmore Road, looking northwest.

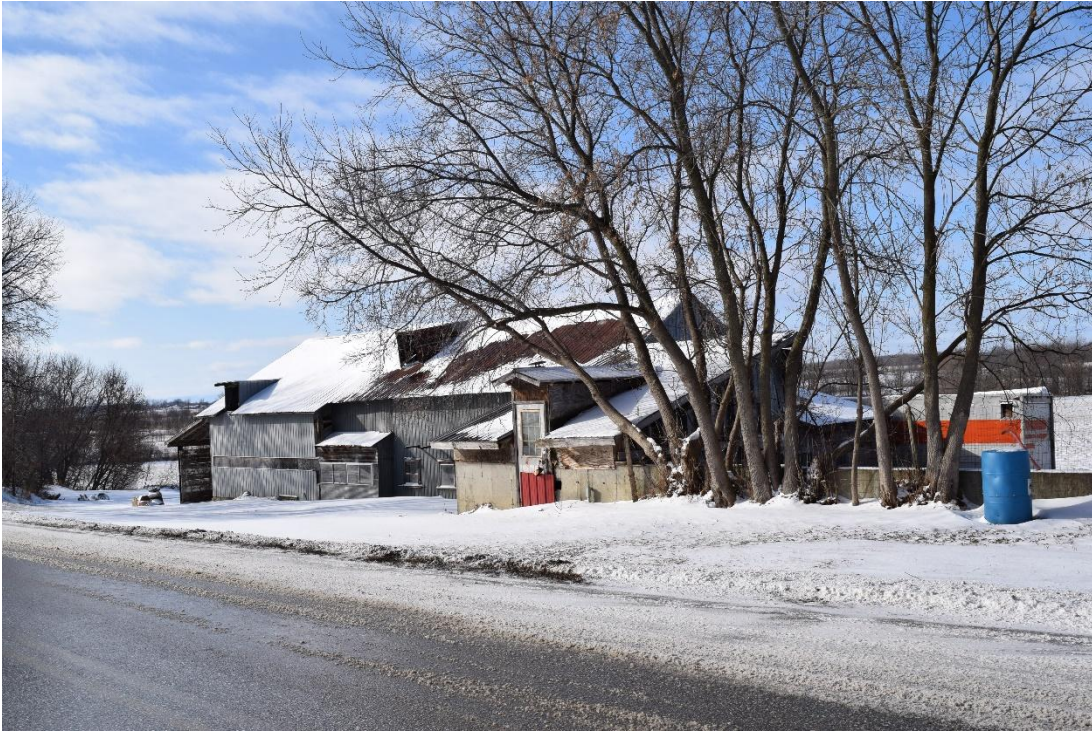
**Photograph 9:** Barn associated with 2551 Dunsmore Road (addressed as 2519 Dunsmore Road), looking southwest.

| Map ID | Address | Photo(s) | Date of Construction | State Register Listing | State Register Eligibility Notes |
|---|---|---|---|---|---|
| 3 | 2551 Dunsmore Rd | 8-9 | ca. 1850 (house)<br>Late 19 <sup>th</sup> century (barn) | N/A | 2.5 story, gable roof, eaves front, wood-frame residence that is heavily altered by materials and fenestration. The associated barn is heavily altered as well, with many additions and modifications. house with barn. Barn is addressed as 2519 Dunsmore Rd.<br><br>Recommended ineligible due to loss of integrity. |

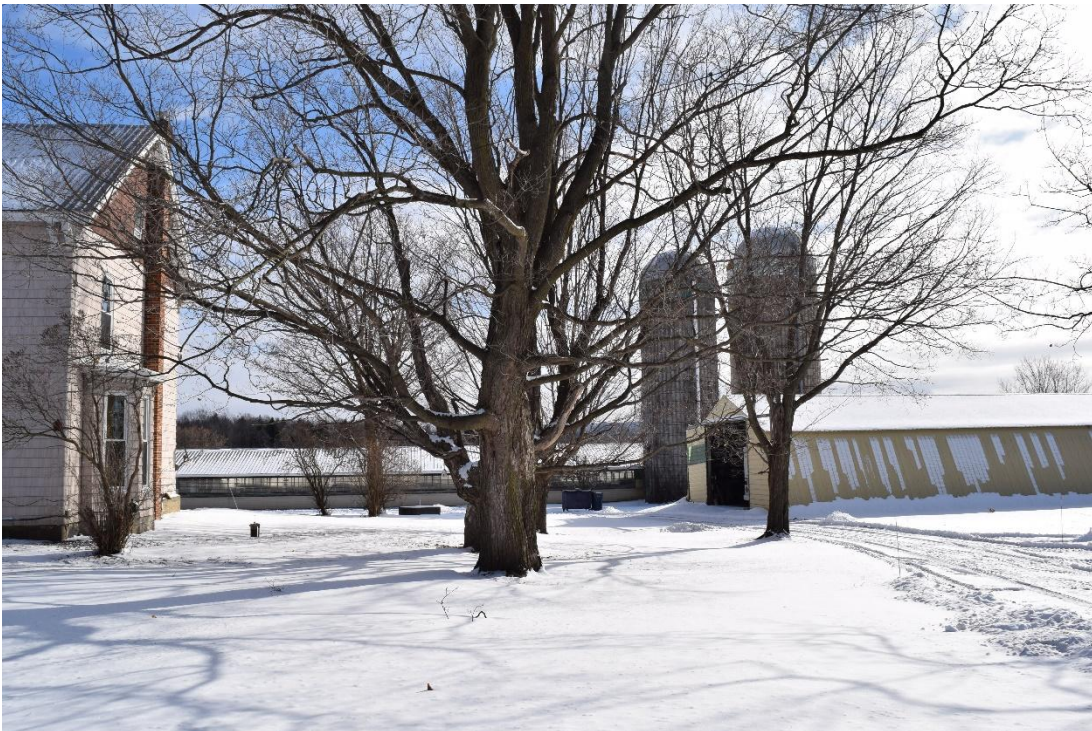
**Photograph 10:** 2684 Dunsmore Road, listed in the State Register (#0613-21) showing house at left and barns, looking east.

2684 Dunsmore Road is located on a rise on the east side of Dunsmore Road, approximately 1,500 feet east of the proposed array. It is mostly separated from the Project by hedgerows and a thick stand of trees lining the west side of Dunsmore Road. There is also a non-historic house (2589 Dunsmore Road) situated between 2684 Dunsmore Road and the access road to the south. The Project will be slightly visible from the house and southerly barn during leaf-off conditions. However, based on the breadth of the intervening stand of trees, the Project will be mostly masked and therefore it would only be a very minor alteration to the property's setting. Due to its location on the east side of Dunsmore Road, the property and the Project will not be visible within the same field of view when seen from Dunsmore Road. Based on the above facts, the Project will not adversely impact the agricultural setting and character-defining features of the property that render it State Register eligible, as described in the VHSS form.

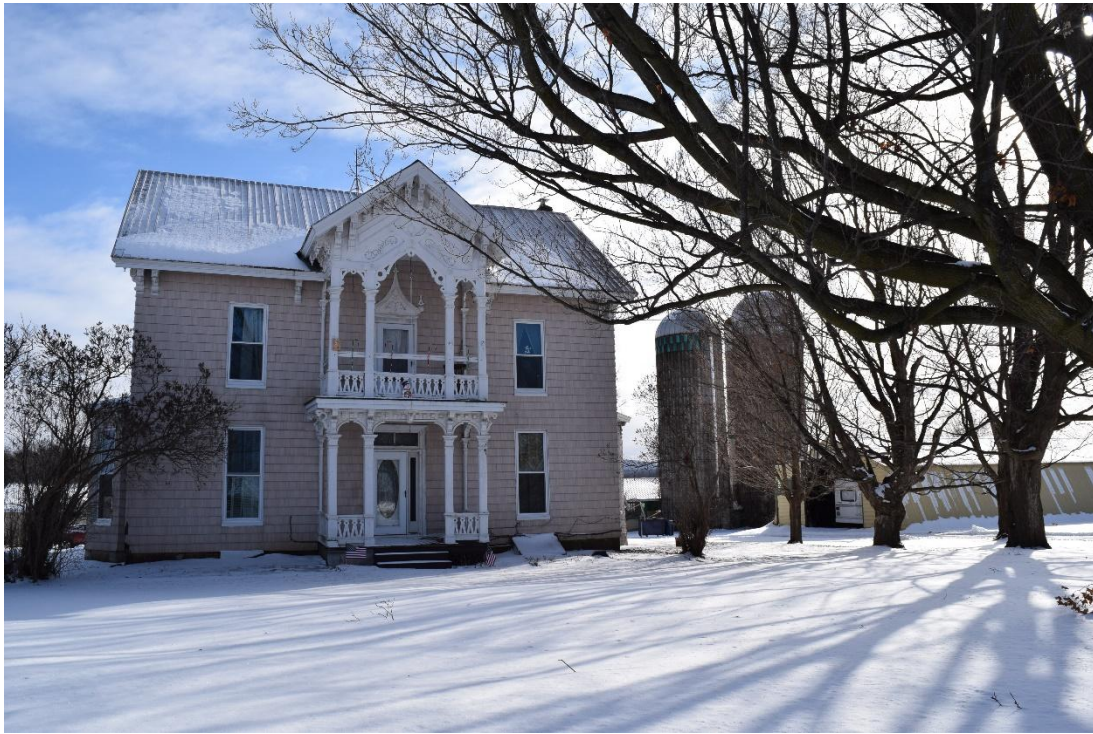
**Photograph 11:** 2684 Dunsmore Road, looking east-southeast.

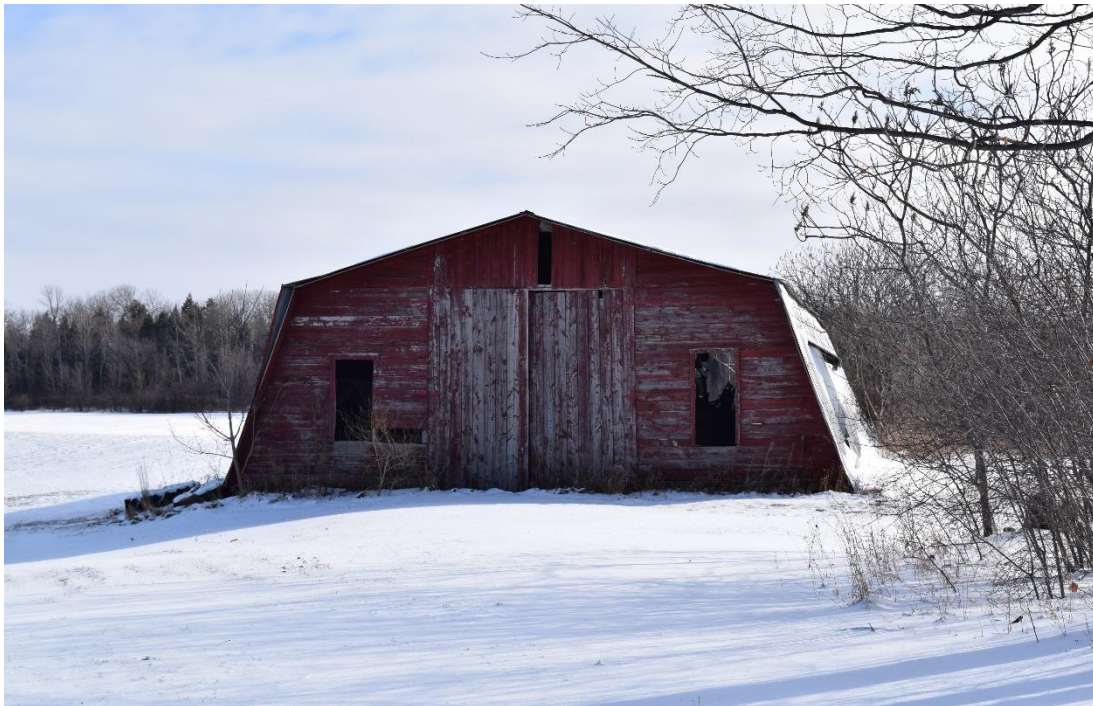
**Photograph 12:** Barn on the east side of Dunsmore Road historically associated with 2789 Dunsmore Road. It was built sometime after 1966, replacing an older barn that stood here. Currently this barn and the barn in Photograph 13 are located on a separated parcel than the house at 2789 Dunsmore Rd. Looking east.

Based on the VHSS form which was informed by an interview with the property owner at the time the property was recorded (1985), the house was built in 1927. There are two barns across the street which were reportedly associated with the house but are currently on a separate parcel; the house is no longer functioning as a farmstead. Historic aerial photographs from the 1960s (see Figures 4 and 5) and information in the VHSS form show that the larger of the two barns was built ca. 1965 while the smaller of the two barns was built ca. 1970, replacing an older gabled barn at this location (see Figure 5).

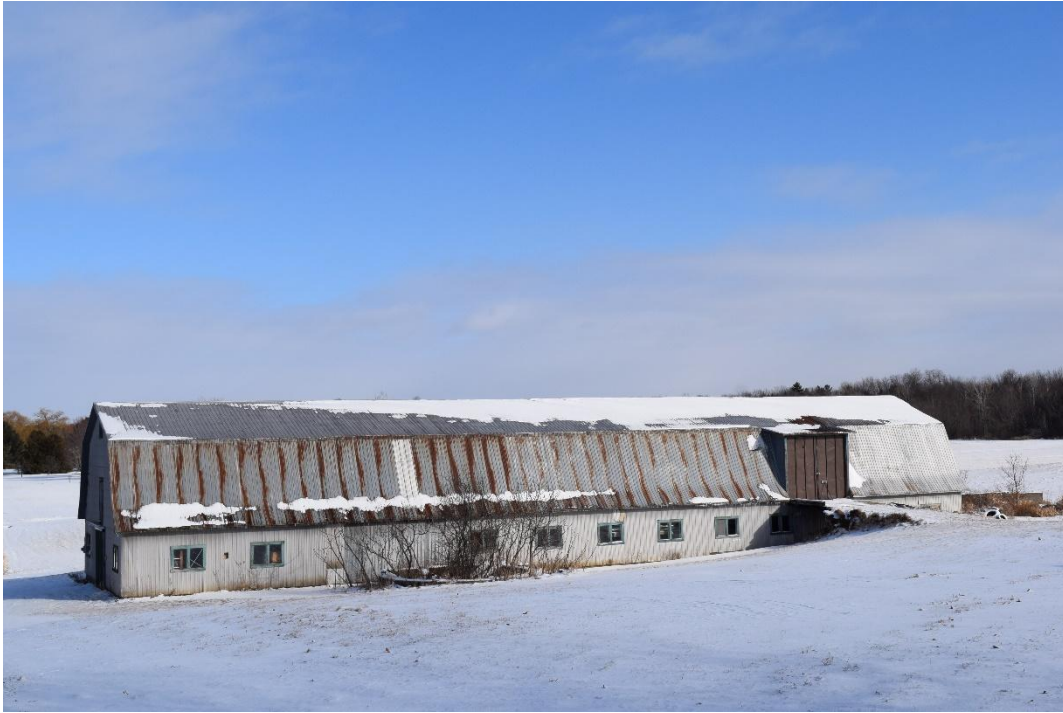
**Photograph 13:** Barn on the east side of Dunsmore Road historically associated with 2789 Dunsmore Road. It was built in the mid-1960s. Currently this barn and the barn in Photograph 12 are located on a separated parcel than the house at 2789 Dunsmore Rd. Looking northeast.

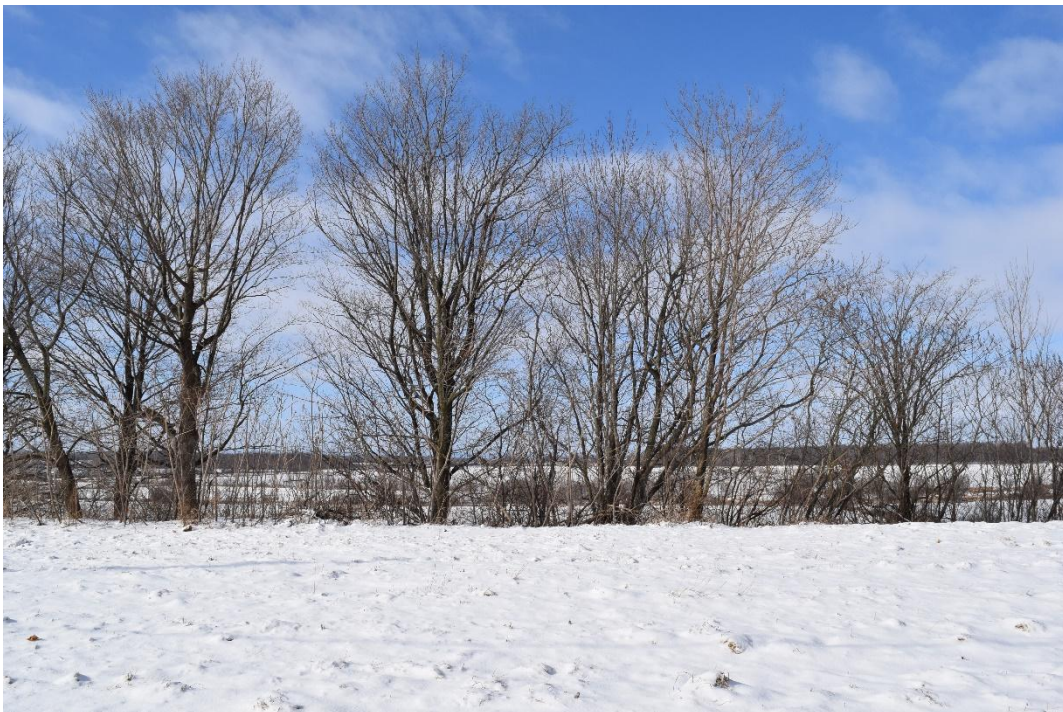
**Photograph 14:** View looking west from 2684 Dunsmore Road to the Project. The solar array would be largely masked by the intervening vegetation.

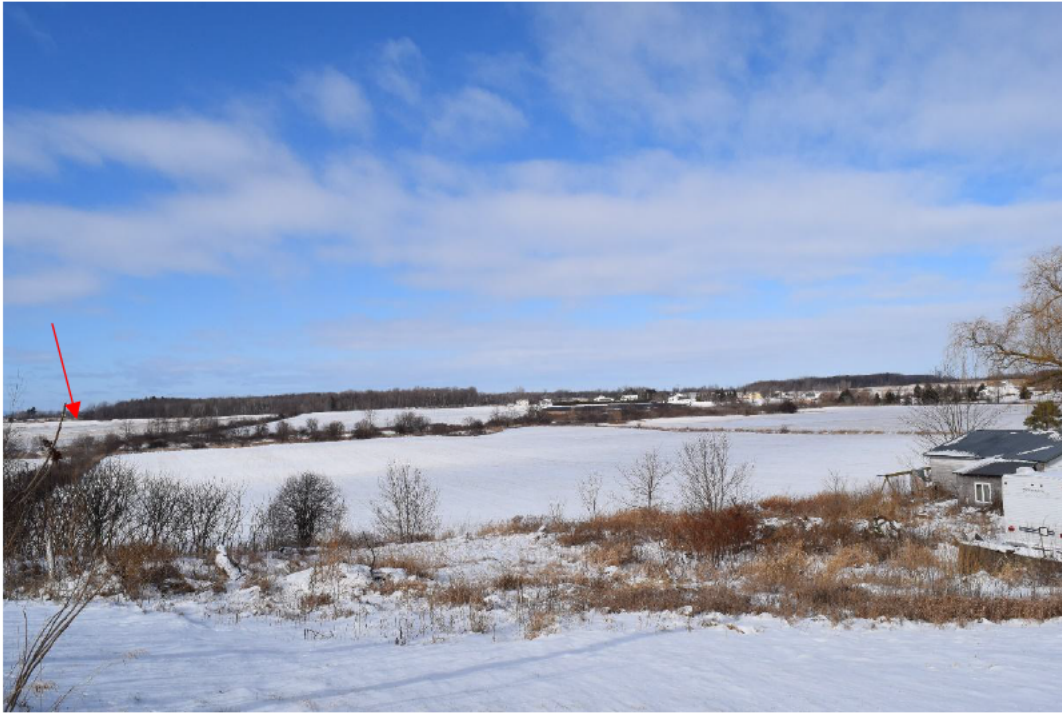
**Photograph 15:** View looking west towards the Project from the barns shown in Photographs 12 and 13. The approximate location of the solar array is indicated by the red arrow. At center is another smaller solar array which is not highly visible.

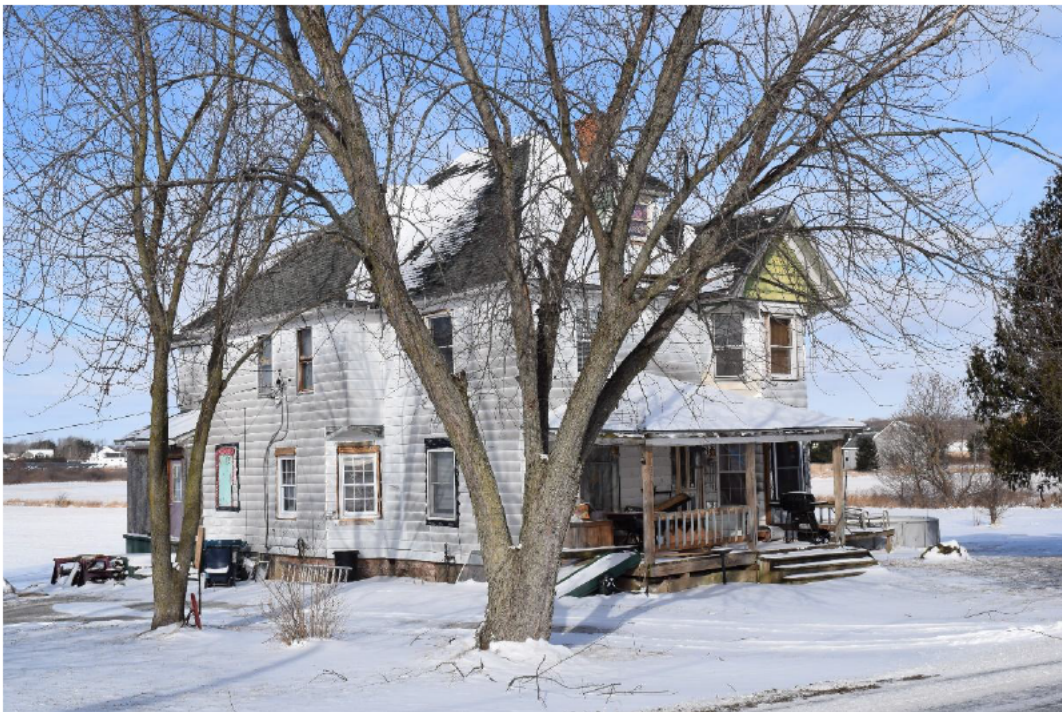
**Photograph 16:** 2789 Dunsmore Road, listed in the State Register (#0613-22). VHB recommends that this property is no longer State Register eligible due to alterations and loss of integrity. Looking northwest.

The alterations to the house have resulted in a loss of integrity of design, materials, workmanship, and feeling as an example of Colonial Revival architecture. The alterations described above were done after the property was documented and listed in the State Register. The removal and addition of barns and the division of parcels have resulted in diminished association as an early to mid-20<sup>th</sup> century farmstead. Due to a loss of historic integrity resulting in the property's inability to convey its feeling and association as a mid-20<sup>th</sup> century Colonial Revival house and farmstead, the property is recommended ineligible for listing in the State Register.

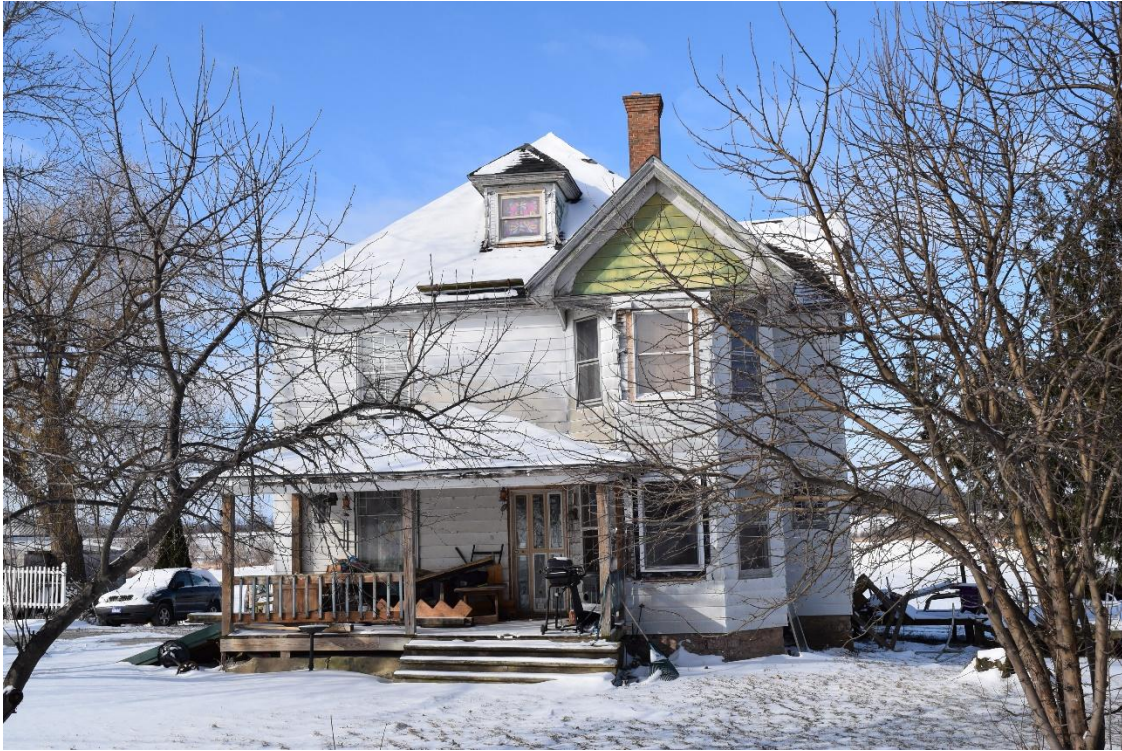
**Photograph 17:** 2789 Dunsmore Road façade showing multiple alterations resulting in a loss of integrity, looking west.

2789 Dunsmore Road is a 2.5 story, hipped roof, Colonial Revival style house with irregular massing. The main block is a modified hipped roof Four-Square with a 2-story hipped roof rear wing. A 2-story, gable roof, polygonal bay projects at the northeast corner of the façade and 2.5-story gable roof rectangular bay projects from the north elevation at the northeast corner. These two projecting bays create an L shape at the northeast corner of the house. On the south elevation is a clipped corner hood on the first story where the rear block projects beyond the main block. The hipped roof front porch is supported by pressured treated lumber with plank and post balustrades. The house sits on a stone foundation and is clad in aluminum siding, other than a portion of the rear block. Wood siding can be seen in places where the aluminum is in need of repair. Throughout the building, windows vary. Most of the windows are vinyl replacement 1/1, 6/6, and 8/8. Some Colonial Revival style multi-windows remain such as in the rectangular bay and the front fixed window. An interior brick corbelled chimney rises from the north side of the main hipped block.

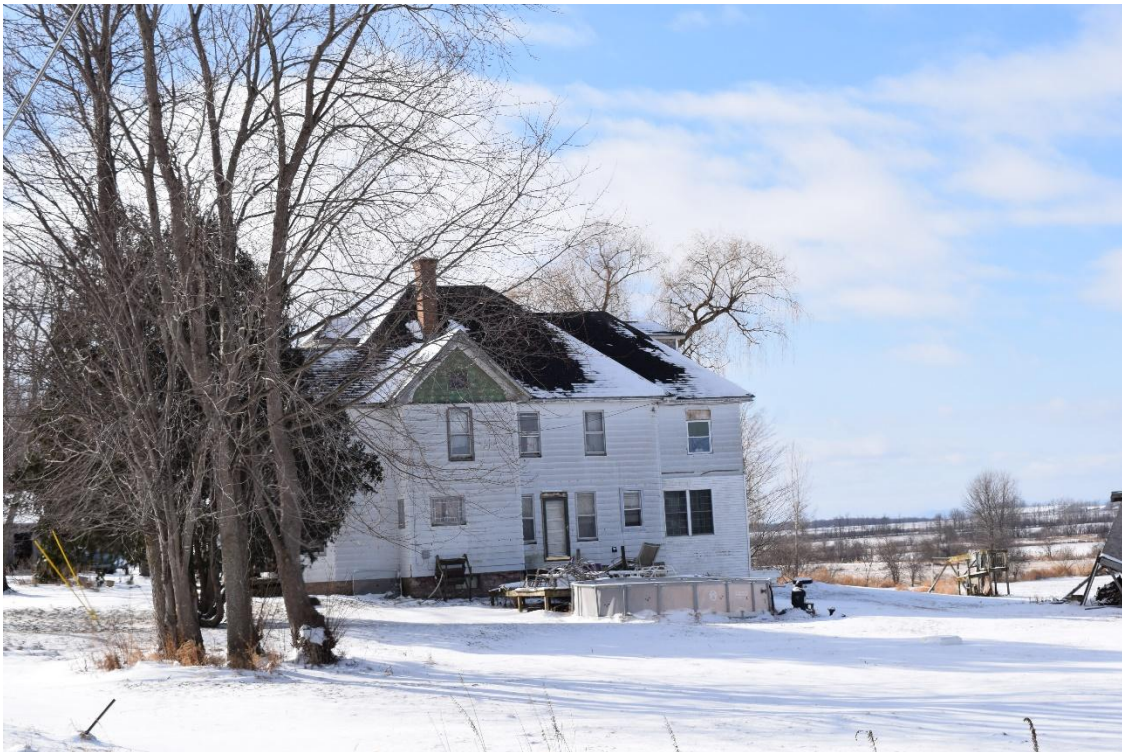
**Photograph 18:** 2789 Dunsmore Road, looking southwest.

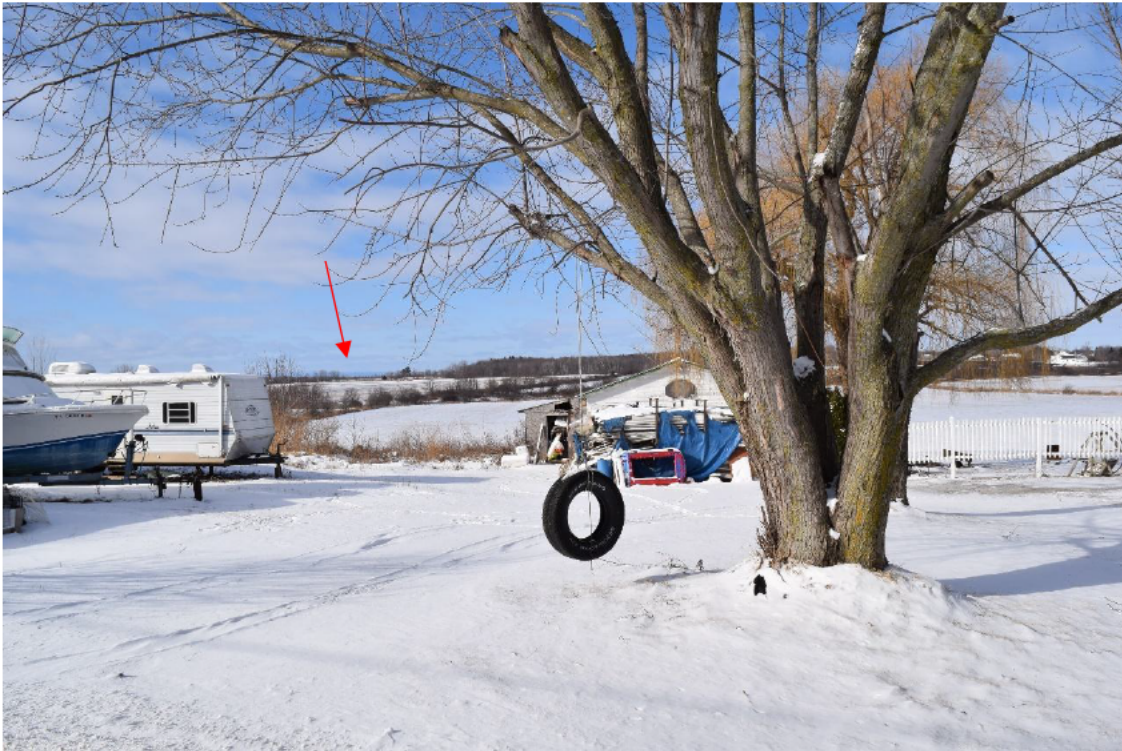
**Photograph 19:** Garage southwest of the house at 2789 Dunsmore Road, looking west. The approximate Project location is indicated by red arrow.

There are two small outbuildings south of the house: a ca. 1960 gable front, two-car garage and a shed built into a rise near the road sometime after 2012 on an earlier structure's foundation.

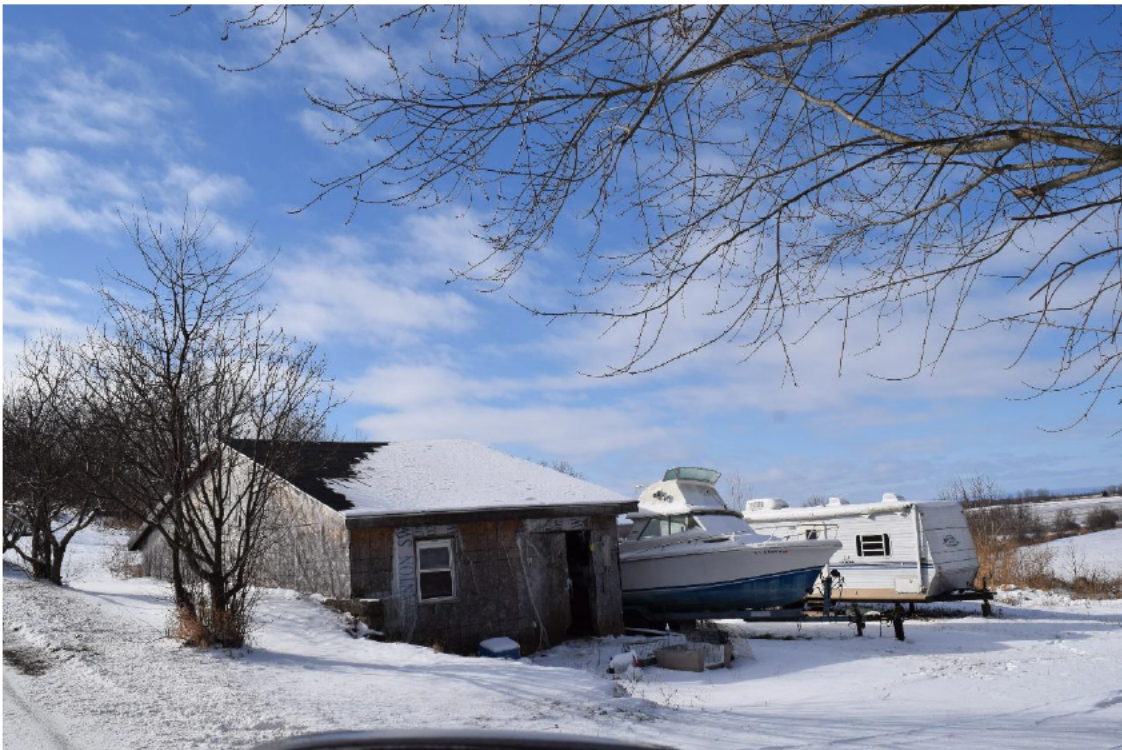
**Photograph 20:** Non-historic outbuilding south of the house at 2789 Dunsmore Road, looking southwest.
