## Memorandum

From: Britta Tonn and Kaitlin O'Shea, Preservation Planners    Re: ER Dunsmore Solar Historic Resources Assessment

ER Dunsmore Solar | St. Albans, Vermont

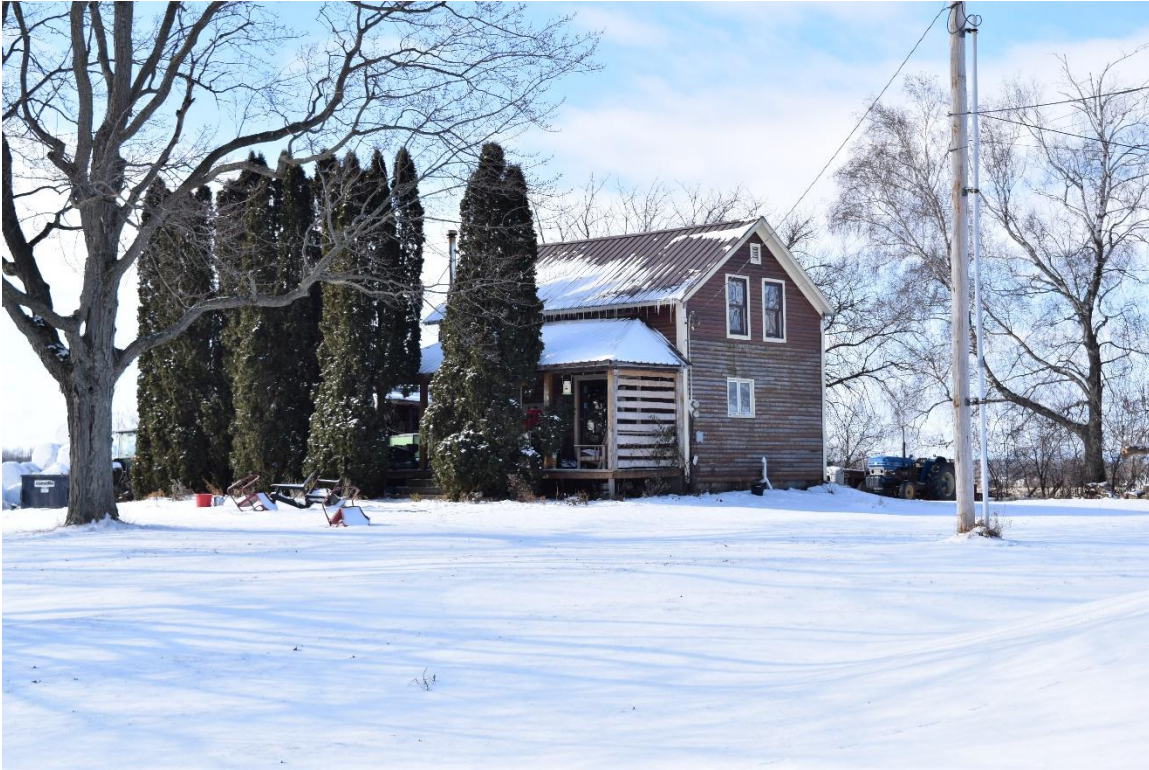
**Photograph 21:** 578 Perry Road, looking southeast.

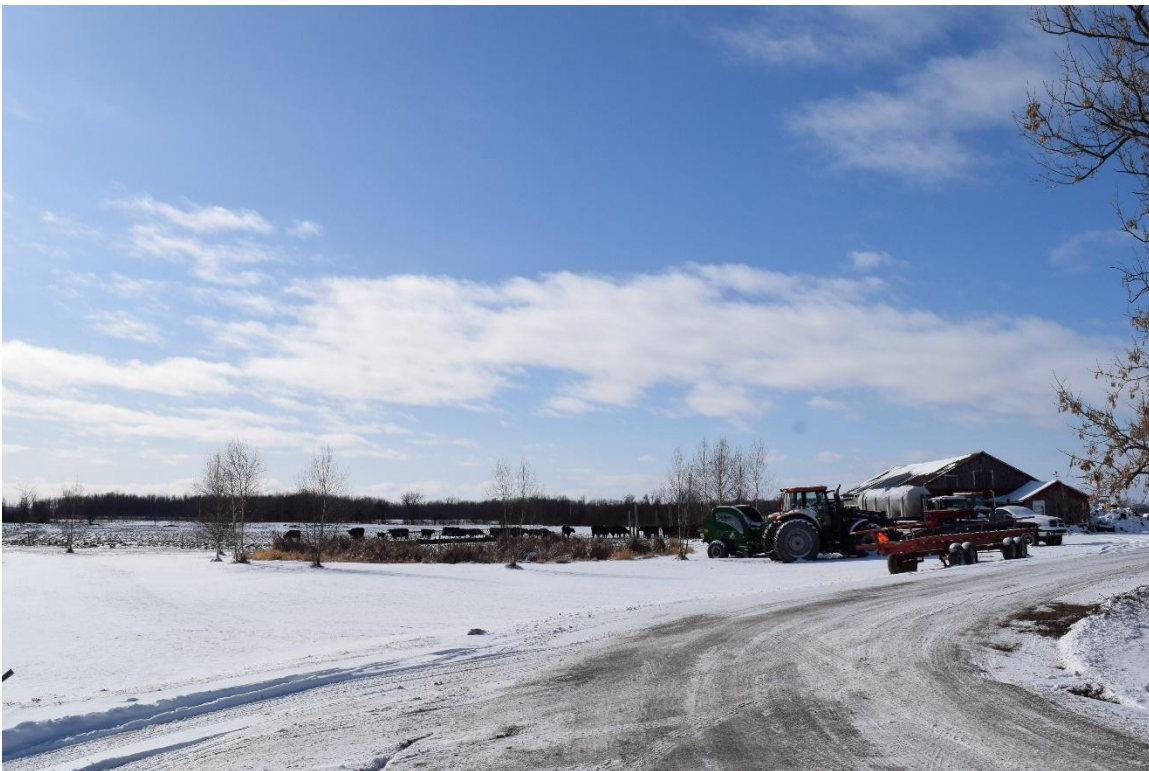
**Photograph 22:** Barn associated with 578 Perry Road, looking south.
