To: GlobalFoundries Williston G Katie Lane  
Solar Project File

## Memorandum

Re: Section 248 Natural Resources Assessment

Natural Resources Map - GlobalFoundries Williston G Katie Lane Solar

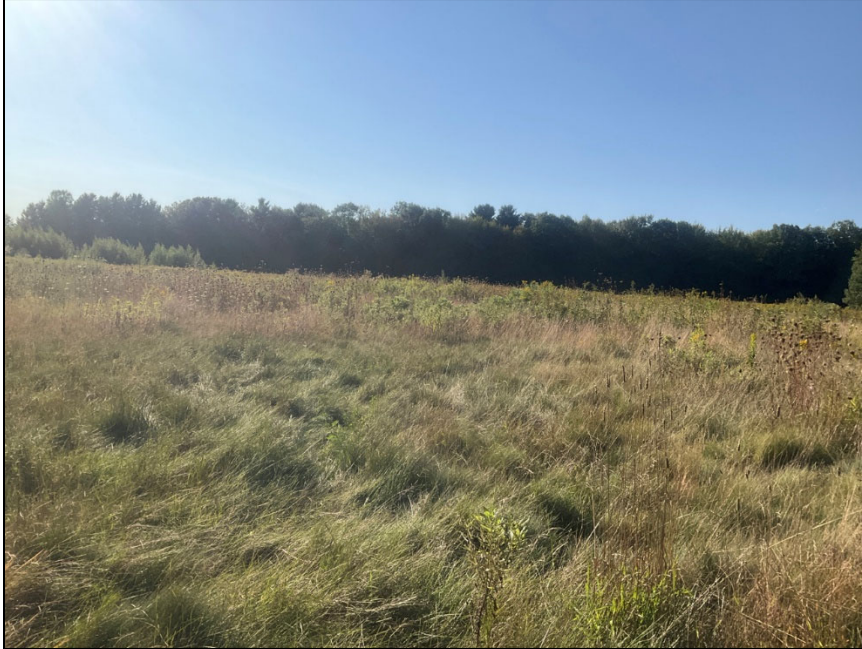
NO. 1 / 9.15.2022

Representative view of fallow field in northern portion of Study Area where the array would be sited, view is looking east.

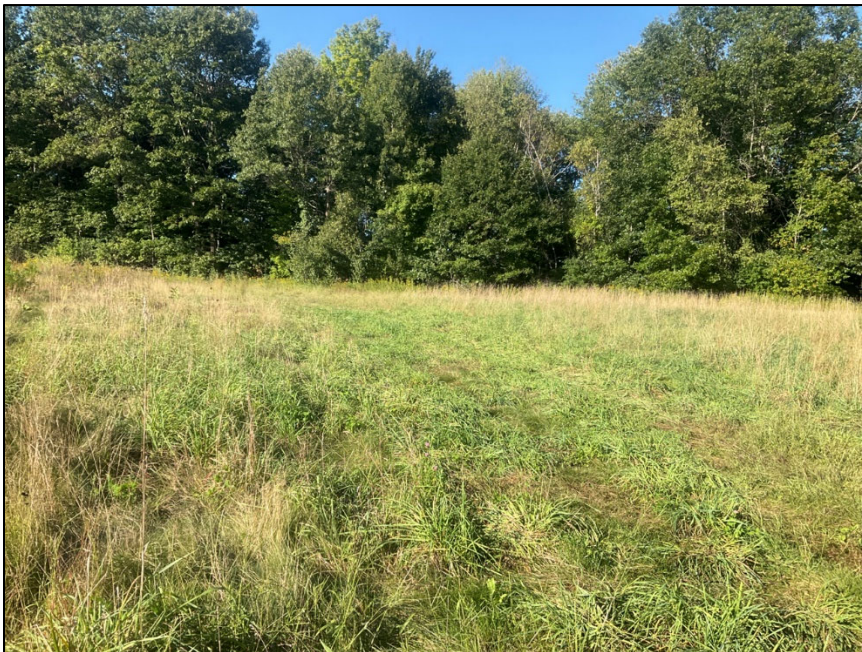
NO. 2 / 9.15.2022

Representative view of fallow field in northern portion of Study Area, view is looking north.

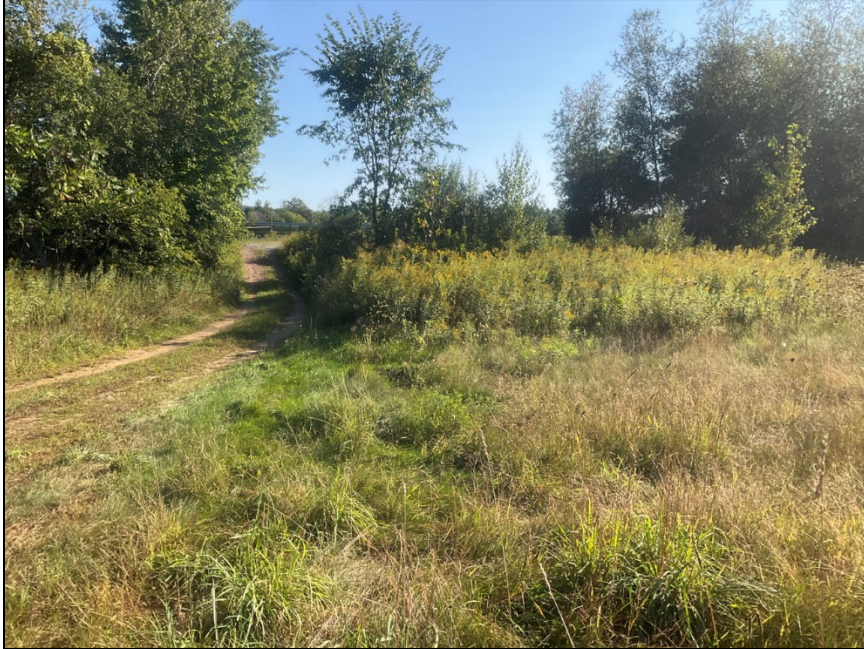
NO. 3 / 9.15.2022

Representative view of existing access road in southern portion of Study Area, view is looking south toward the buffer at the existing wetland crossing. The elm tree to the right of the road (center of photo view) may need to be cut for the proposed access road improvements).

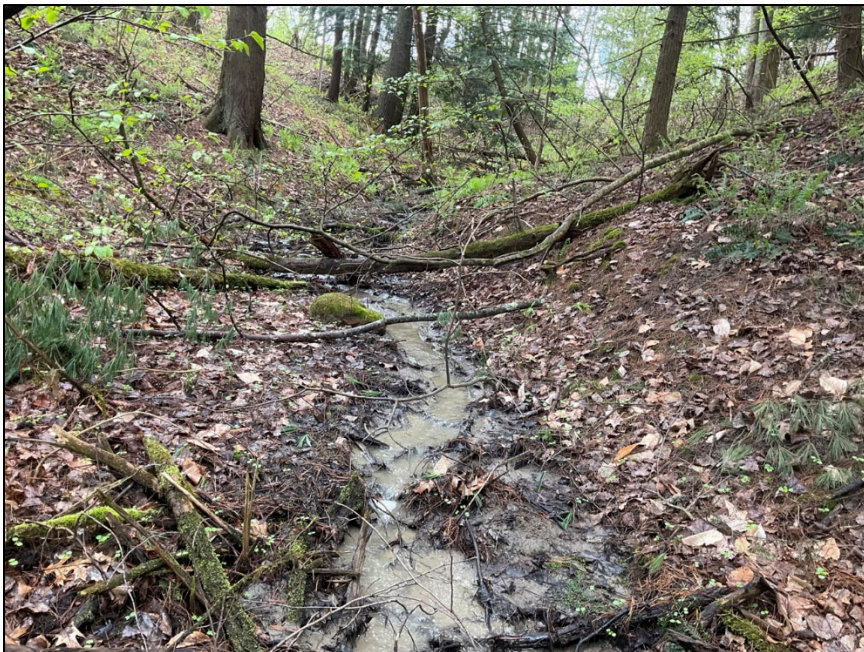
NO. 4 / 5.15.2024

Representative view of intermittent Stream 2024-SC-11, view is looking south.

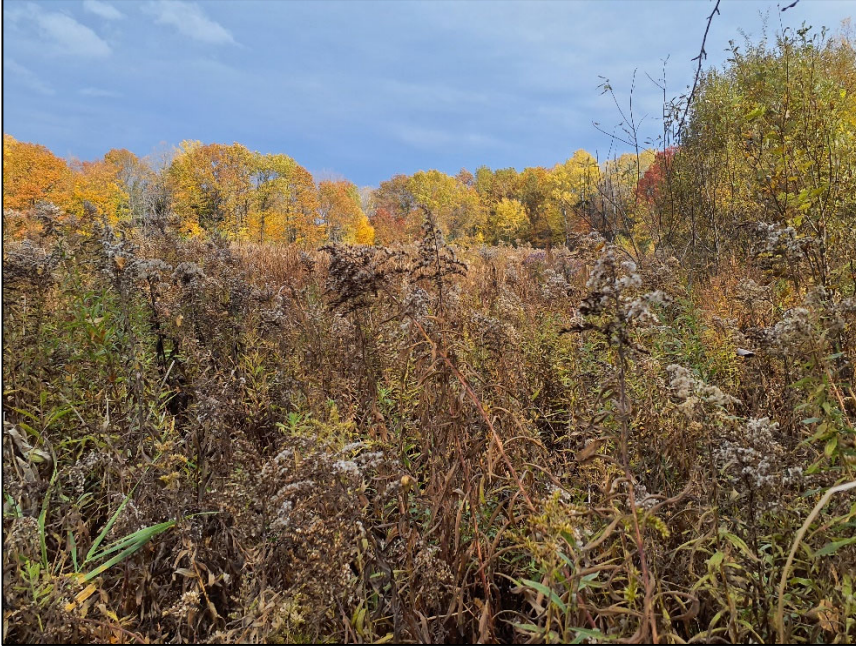
NO. 5 / 10.18.2022

Representative view of Wetland 2024-101 within the emergent portion of the wetland, view is looking west.

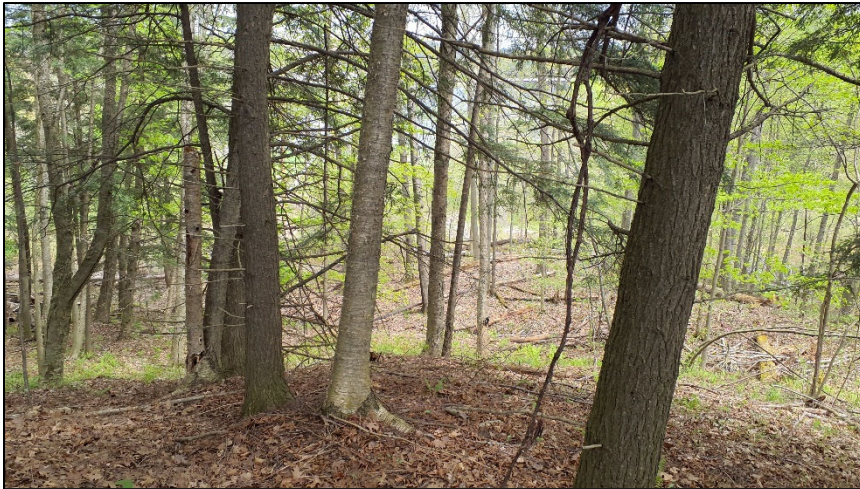
NO. 6 / 5.10.2024

Representative view of sloping topography and mixed hardwood and softwood cover within the ANR-mapped DWA in the forested area north of the proposed northern array (area does not support suitable DWA habitat conditions).

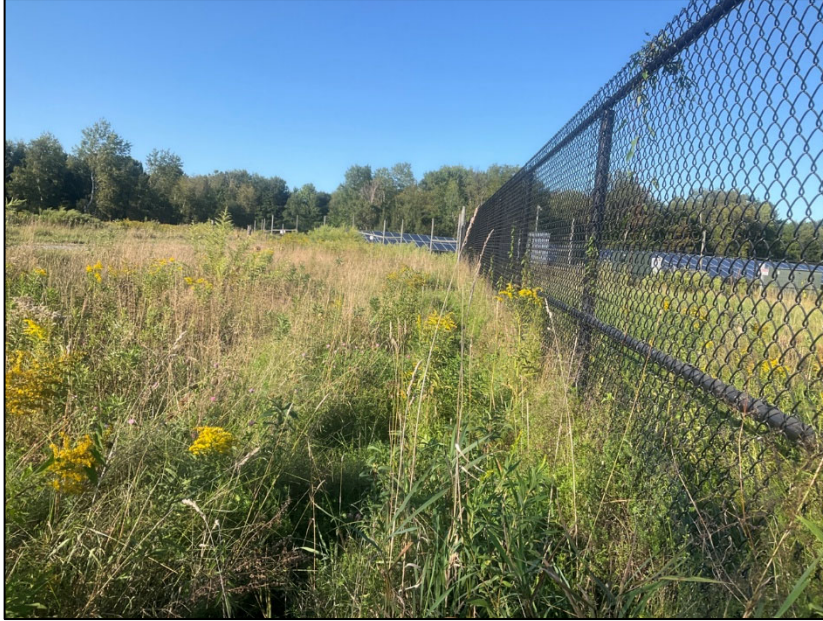
NO. 9 / 8.19.2025

Representative view of the existing fence that encloses the existing IBM RTC solar project.

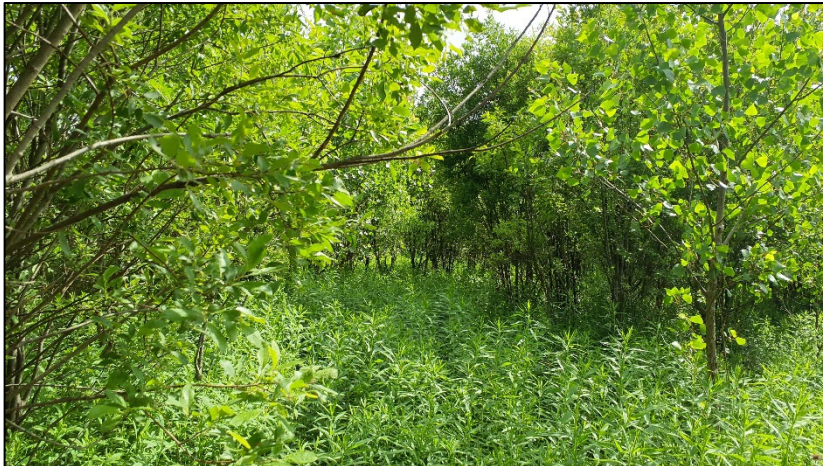
NO. 10 / 7.19.2025

Representative view of the existing vegetative cover within the fallow early successional area at the southernmost end of the Study Area near Mountain View Road.
